## **ALERT SERVICE BULLETIN**

# 206L-16-176

MODEL AFFECTED:	206L, 206L-1, 206L-3 and 206L-4		
SUBJECT:	Air Conditioner Blower Motor Connector, Inspection of		
HELICOPTERS AFFECTED:	Serial numbers 45001 through 45153, 46601 through 46617, 45154 through 45790, 51001 through 51612, and 52001 through 52496.		
	See attached Service Bulletin (SB) 206-110414 Revision C dated January 13, 2017.

Title:	SB 206-110414; Bell 206 Air Conditioner Blower Motor Connector
Date:	January 13, 2017
Applicability:	Bell Helicopter Model 206 Equipped with the Air Comm Corporation 206EC-200 thru -212 air conditioning systems
Reference:	FAA / STC # SH2750NM, Bell Helicopter 206 Air Conditioning System.
Compliance:	Inspection within 20 flight hours unless already replaced with new ES59112 connector

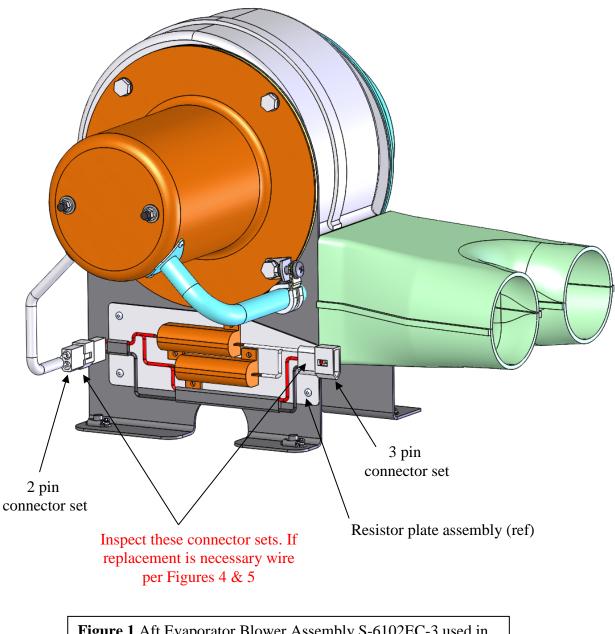
Figure 1 Aft Evaporator Blower Assembly S-6102EC-3 used in 206EC-200-9,-10,-11 AC kits

Field reports have indicated that in some rare occurrences the aft evaporator blower motor connectors may have overheated due to an improper contact crimp or loose fitting terminations. This Bulletin requires a visual inspection and basic pull test of the connectors on the evaporator and condenser blowers to determine if there is evidence of overheating or a loose wire-to-contact interface. If any signs of overheating or loose contacts are found, the A/C system must be made inoperable until the connector is replaced with new replacement connectors.

Locate each connector shown in Figures 1, 2, and 3. De-mate each connector and inspect both mates for signs of overheating, discoloration or plastic deformation. Gently pull (estimated 5-7 lb force) on each wire to verify the integrity of the contact's crimp. The contacts should be fully seated and locked in the housing so pulling gently on the wires will not dislodge the contacts from the housings.

If any signs of overheating of the housing are present or if the pull test fails, the system must be rendered inoperative and the connector housings and contacts replaced with new replacement connectors using Deutsch HDT-48-00 Crimping tool or equivalent MIL-DTL22520 Type 1 crimping tool before further operation. See Section B for information on how to contact Air Comm Corporation.
