ALERT SERVICE BULLETIN

206L-19-181

MODEL AFFECTED: 206L, 206L-1, 206L-3 and 206L-4

SUBJECT: TAIL ROTOR DRIVESHAFT DISC PACK
COUPLING NUTS, REPLACEMENT OF

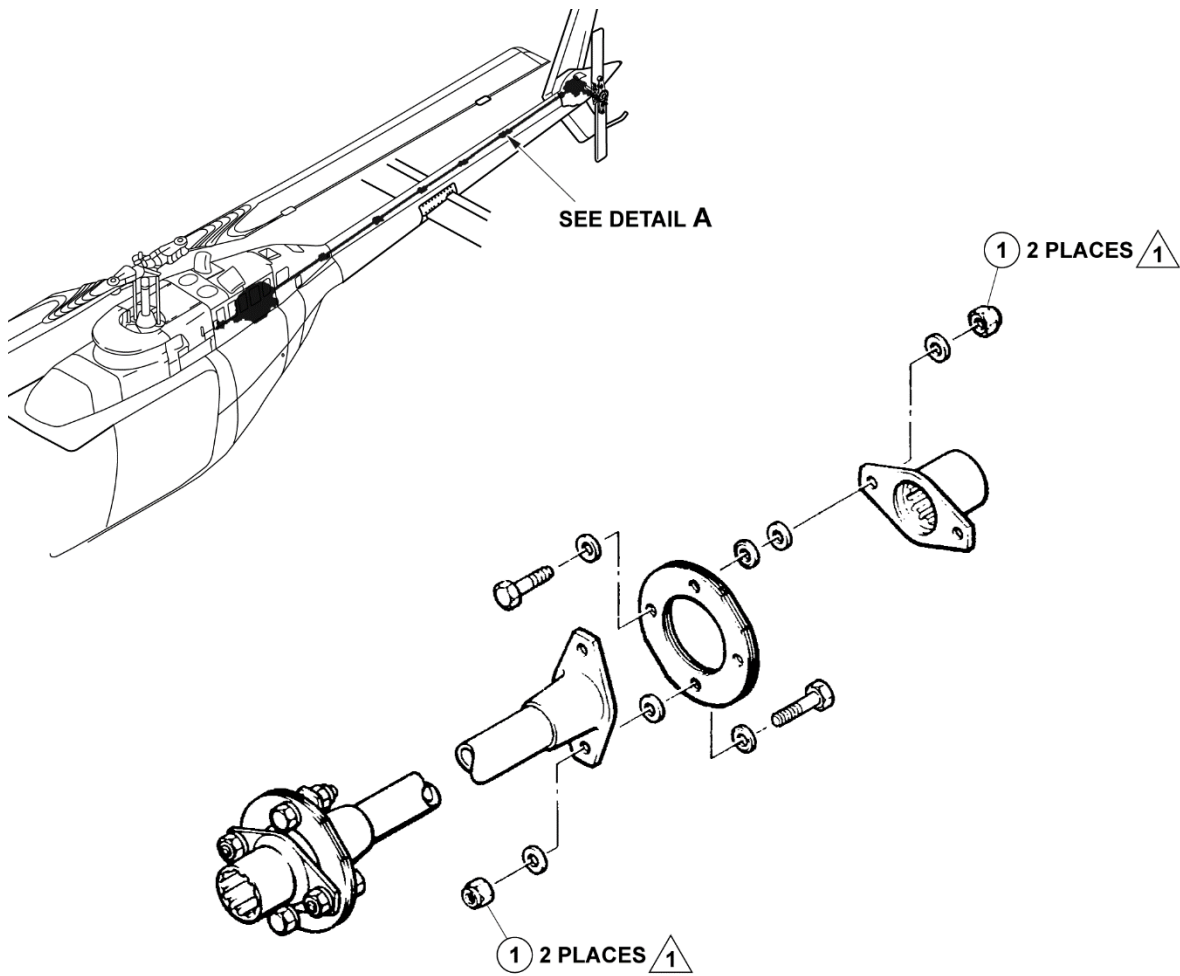
Figure 1 - Typical Tail Rotor Driveshaft Disc Pack Coupling Attachments

Bell has received reports of cracked or missing MS21042 series nuts. Conditions leading to cracked or missing MS21042 nuts may be attributed to improper torque applied, low tare torque, or hydrogen embrittlement. A review of several Service Difficulty Reports has concluded that the events were related to the loss of hardware from tail rotor disc pack (Thomas) couplings.

**DETAIL A
(9 PLACES)**

2. Remove and replace the MS21042L4 nuts at each tail rotor driveshaft disc pack coupling with the 12-point NAS9926-4L nuts (refer to applicable 206L Maintenance Manual, Chapter 65). There are four (4) nuts at each disc pack coupling attachment (Figure 1).
3. After torquing nuts, apply a torque stripe (witness mark) to each nut using the torque seal lacquer (C-049), or equivalent (Figure 2). Application of the torque seal lacquer (C-049) is used to mark the nuts that have been torqued to visually identify movement of the nuts. Torque seal is brittle and will crack if the fastener moves.
4. If any MS21042L4 nuts are found loose or damaged, report at which location and provide the information to Product Support Engineering at productsupport@bellflight.com
