ALERT SERVICE BULLETIN

206L-19-182

MODEL AFFECTED: 206L, 206L-1, 206L-3 and 206L-4

SUBJECT: TAIL ROTOR BLADE ROOT END, INSPECTION OF

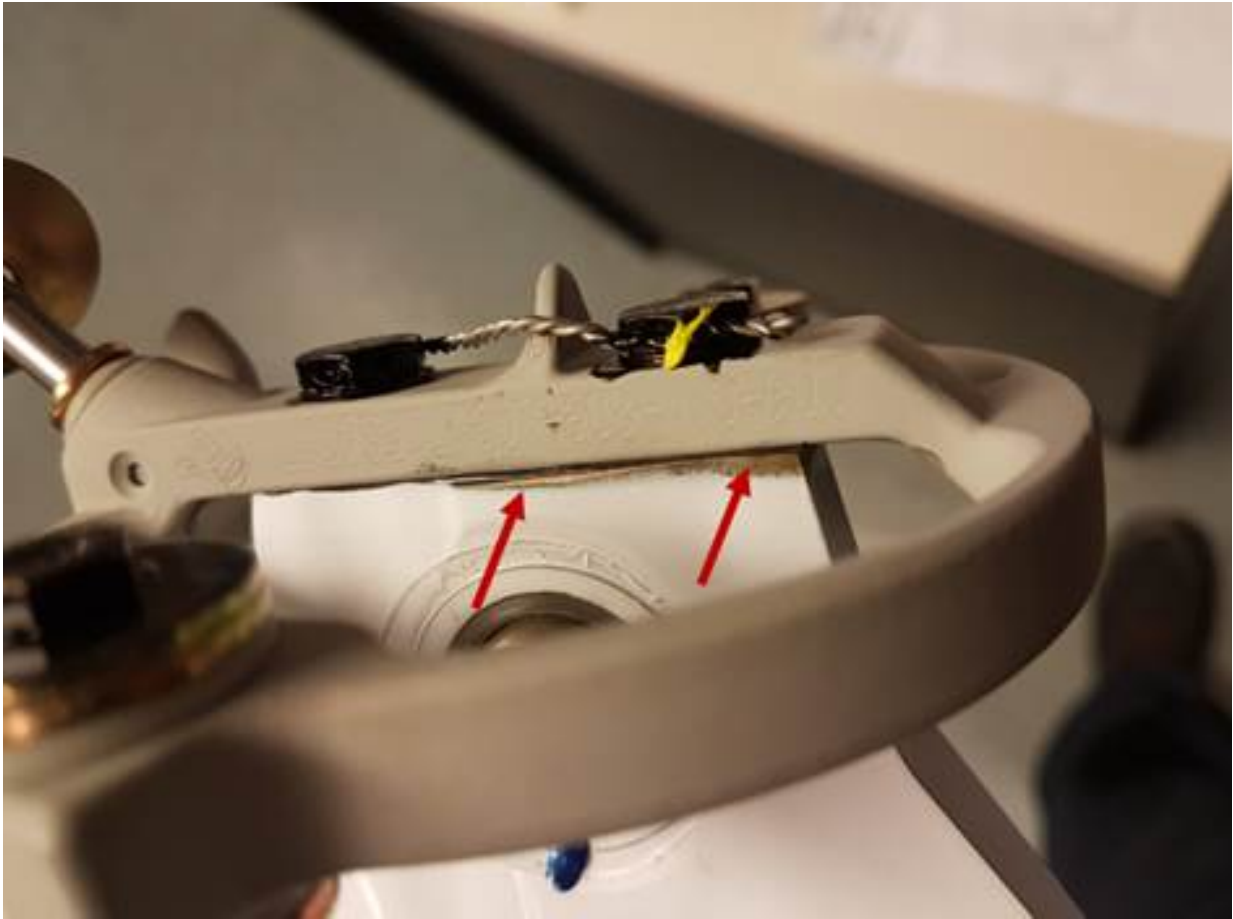
- b. Confirm there is no exposed unpainted tail rotor blade root end surfaces adjacent to the pitch horn (Figure 1).
 - c. If surfaces are found properly sealed (Figure 2), go to step 3.

FIGURE 1 - Tail Rotor Blade Root End without Sealant

- d. If some bare metal surfaces are found exposed (Figure 1), inspect for corrosion.
 - (1) If no corrosion is found, apply a smooth coat of sealant (C-308) to all sections of unpainted surfaces of tail rotor blade root end. Blend into pitch horn face and fair smooth (Figure 2). Allow sufficient time for sealant (C-308) to cure before flight. Go to step 3.

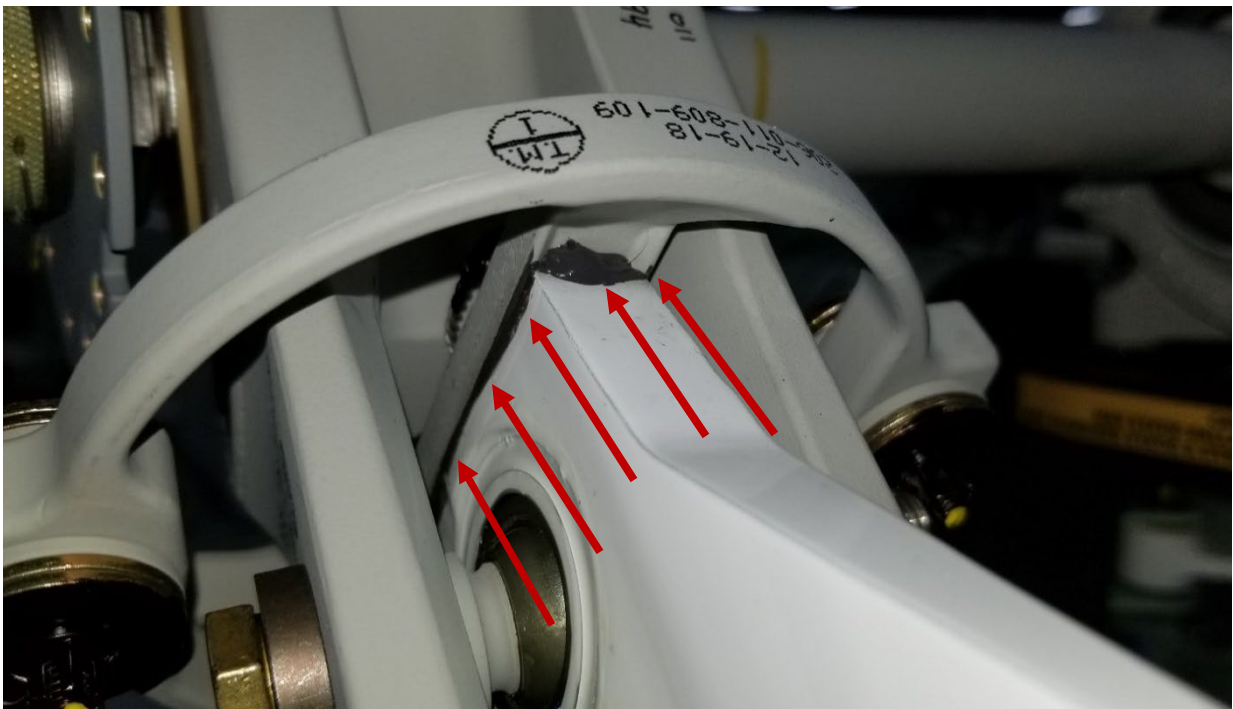
FIGURE 2 - Tail Rotor Blade Root End with Sealant Applied

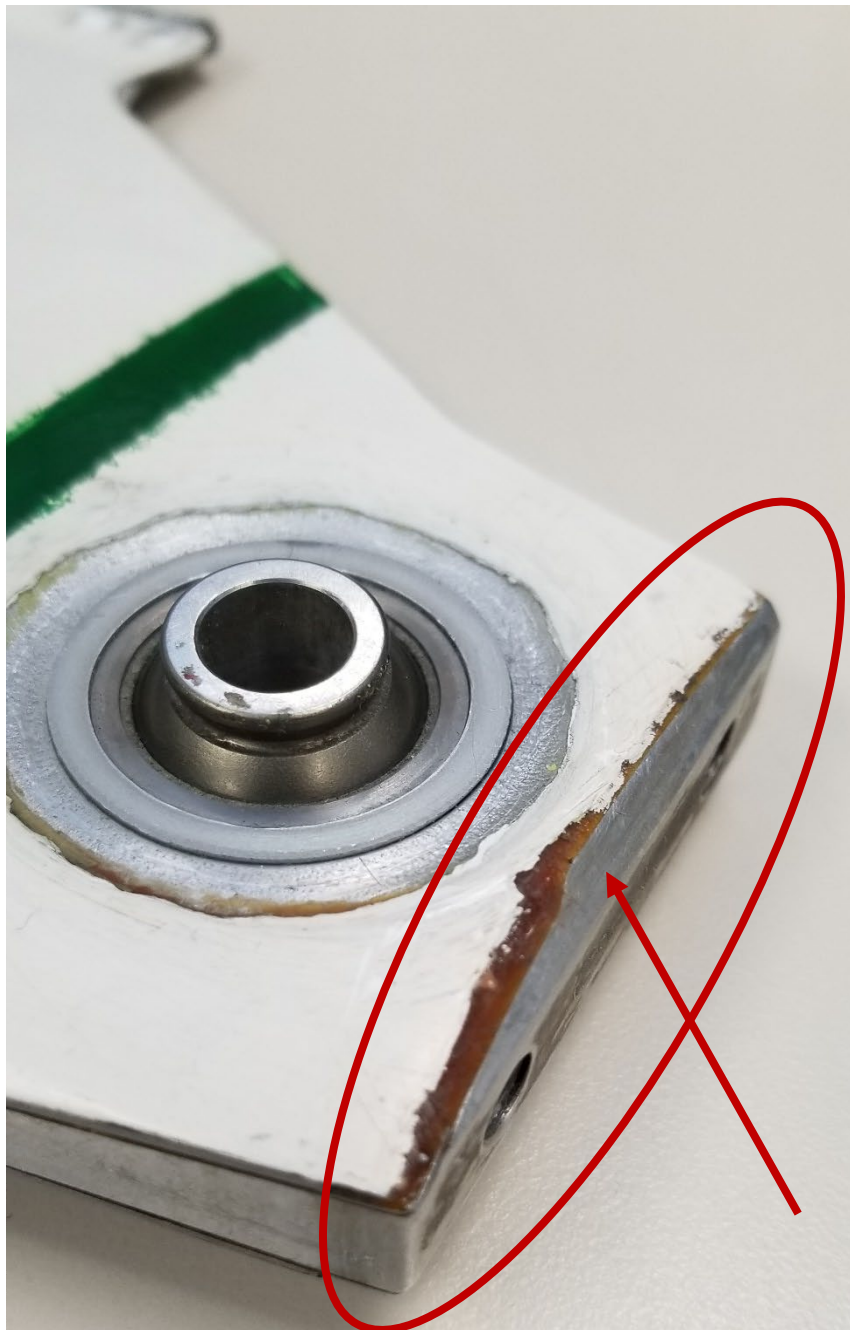
FIGURE 3 – Example of Tail Rotor Blade Root End Tapered Aluminum Butt Block

- (2) If surface corrosion is present on tapered area of the aluminum butt block of the tail rotor blade (Figure 3), remove blade(s), inspect, repair and refinish blade(s) (BHT-206L-MM, Chapter 65; BHT-206L1-MM-1, Chapter 65; BHT-206L3-MM-7, Chapter 64; BHT-206L4-MM-7, Chapter 64, as applicable).
