ALERT SERVICE BULLETIN

206L-21-186

- MODEL AFFECTED:** 206L, 206L-1, 206L-3 and 206L-4
- SUBJECT:** MAIN ROTOR PITCH LINK ASSEMBLY
206-010-360-005, INSPECTION AND
APPLICATION OF TORQUE SEAL LACQUER.
- HELICOPTERS AFFECTED:** Serial numbers 45001 through 45153, 46601
through 46617, 45154 through 45790, 51001
through 51612, 52001 through 52496.
- COMPLIANCE:** **PART I:** Within 100 flight hours or 3 months,
whichever comes first after the release date of this
bulletin.
- PART II:** Within 300 flight hours or 12 months
whichever comes first after accomplishment of **PART
I** and every 300 flight hours or 12 months thereafter.

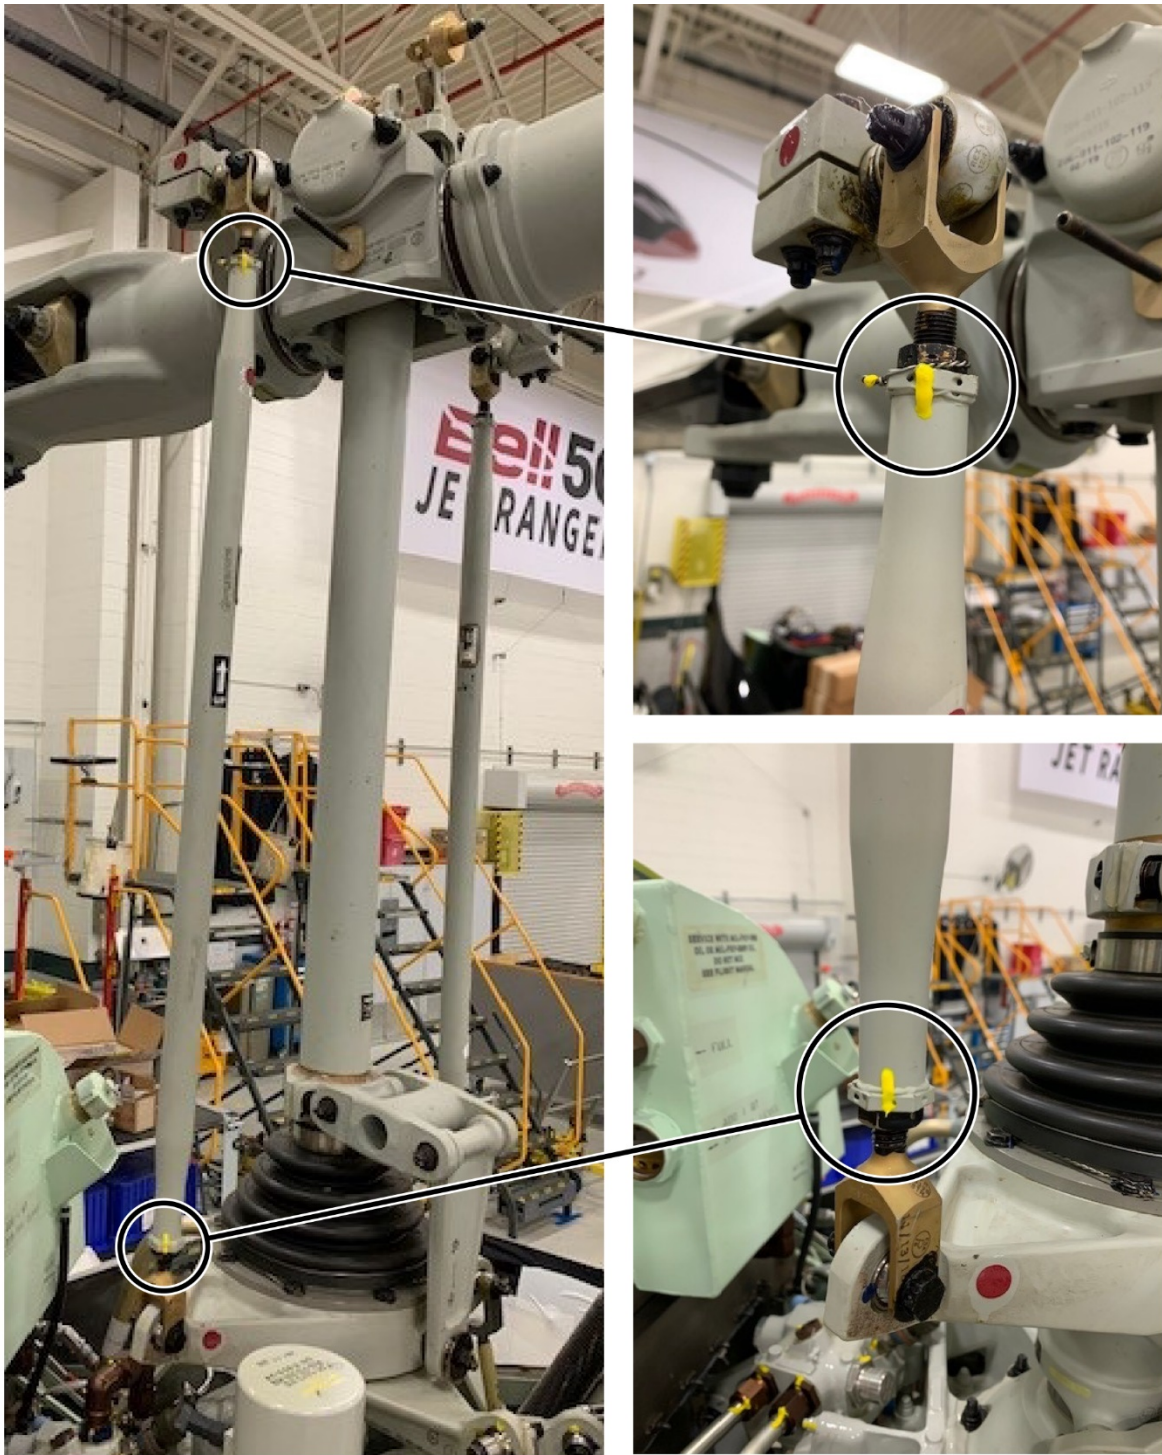
**Figure 1 – Torque Seal Lacquer (C-049) Application
(Model 505 Pitch Link Assembly Shown as an Example)**

4. Apply torque seal lacquer (C-049), or equivalent, across the main rotor pitch link tube and the upper and lower inserts as shown (Figure 1).
5. Make an entry in the helicopter logbook and historical service records indicating compliance with **PART I** of this Alert Service Bulletin.

- (2) If the insert is not debonded, re-apply torque seal lacquer (C-049), or equivalent, as shown (Figure 1).
 - (3) If the insert is found debonded, or suspected to be, go to step 2.c.
