A Textron Company

ALERT SERVICE BULLETIN

206L-24-190

- MODEL AFFECTED:** 206L, 206L-1, 206L-3 and 206L-4
- SUBJECT:** SWASHPLATE OUTER RING AND COLLECTIVE LEVER, CLEARANCE CHECK OF
- HELICOPTERS AFFECTED:** Serial numbers 45001 through 45153, 46601 through 46617, 45154 through 45790, 51001 through 51612, 52001 through 52496.
- COMPLIANCE:**
- PART I:** Within the next 100 flight hours or 180 days, whichever occurs first, after the release date of this bulletin.
- PART II:** After accomplishment of main rotor flight controls rigging.

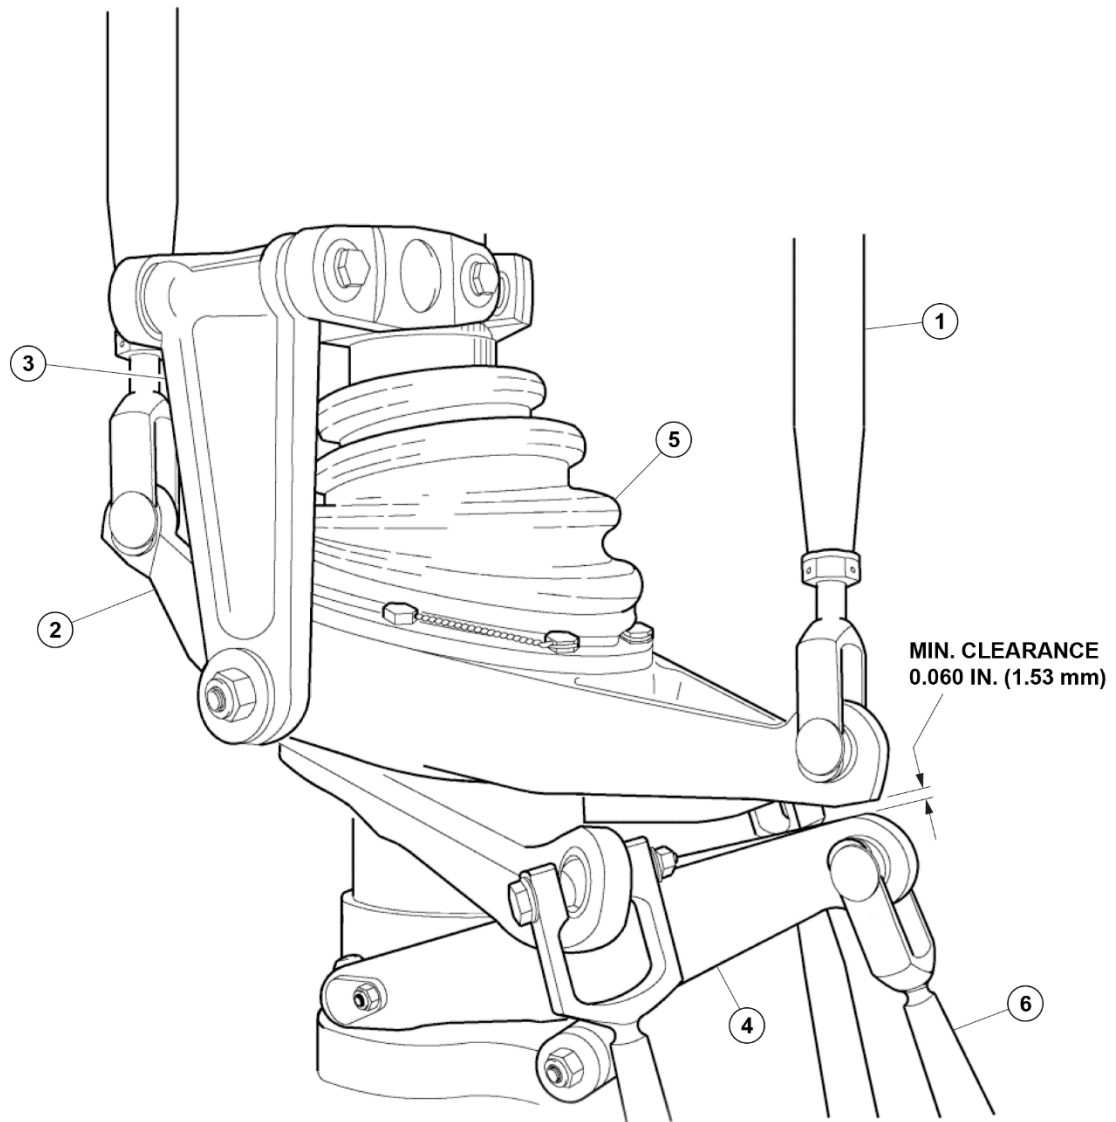
Figure 1 - Collective lever assembly - clearance check

Bell has received reports of swashplate drive collar set fracture due to contact between the swashplate outer ring and collective lever assembly. Incorrect rigging and lack of clearance check between the swashplate outer ring and the collective lever are the suspected root causes. **PART I** of this ASB mandates a one-time clearance check for proper clearance between the swashplate outer ring and the collective lever. **PART II** introduces a new requirement to ensure proper clearance is achieved between the swashplate outer ring and the collective lever after accomplishment of main rotor flight controls rigging. All applicable Maintenance Manuals (MM) will be revised to incorporate the new clearance check requirement.

8. Slowly rotate the swashplate outer ring (2, Figure 1) until one of the pitch link attachment points is directly over the collective lever assembly (4).
9. Measure and record the clearance between the collective lever assembly (4) and the swashplate outer ring (2).

Aircrafts models 206L, 206L-1 and 206L-3 (S/N 51001 to 51307) who complied with Technical Bulletin 206L-91-153 MOD B or Service Instructions BHT-206-SI-2052 require different rigging dimensions than on the basic aircraft. Refer to OSN 206L-24-55 and Figure 2 for further details. Regardless of the aircraft rigging procedure and dimensions, the minimum clearance of 0.060 inch (1.53 mm) between the swashplate outer ring and collective lever applies.

11. If clearance is 0.060 inch (1.53mm) or more at both pitch link attachment points, go to step 13.
12. If clearance is less than 0.060 inch (1.53 mm) at one or both pitch link attachment points, rigging of the collective and cyclic flight controls (Applicable 206L-MM, Chapter 27 or 67) is required prior to next flight.

- a. If minimum clearance of 0.060 inch (1.53mm) cannot be achieved at both pitch link attachment points after collective and cyclic controls rigging, it is acceptable to adjust the length of collective link 206-001-558 (6) to obtain the minimum clearance. Tolerance for rigging dimensions of the collective lever must be maintained (Applicable 206L-MM, Chapter 67 and Figure 2).

- b. If minimum clearance of 0.060 inch (1.53mm) cannot be obtained at both pitch link attachment points without exceeding collective lever dimensions tolerances, contact Product Support Engineering.

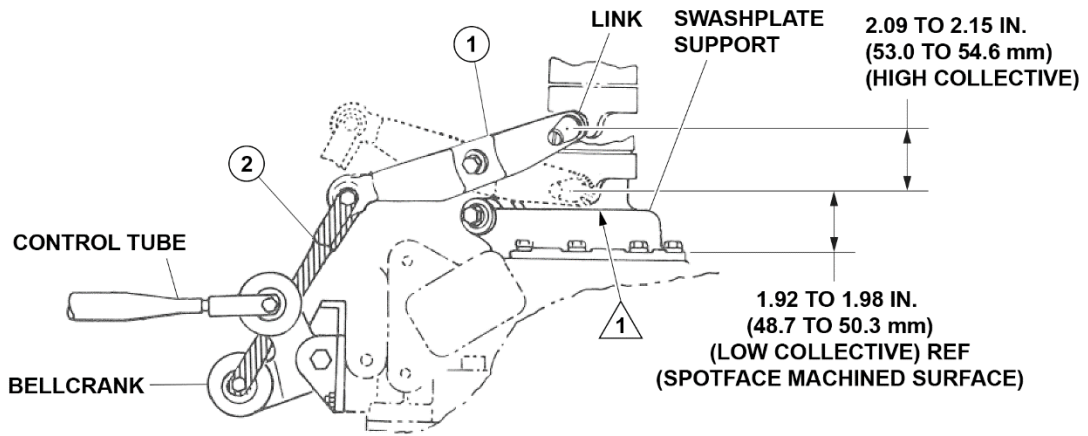
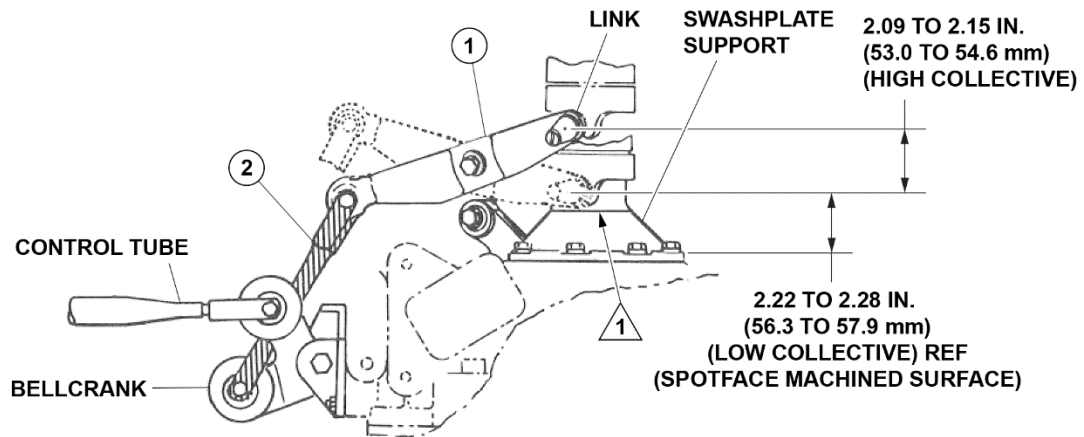
Figure 2 - Collective lever rigging dimensions

1 With full down collective applied, ensure clearance exists between swashplate support and pivot sleeve after completion of collective and cyclic rigging.
