## **ALERT SERVICE BULLETIN**

**210-20-13**  
15 April 2020

**MODEL AFFECTED:** 210

**SUBJECT:** TAILBOOM LEFT HAND FIN SPAR CAP P/N 212-030-447-117, INSPECTION OF.

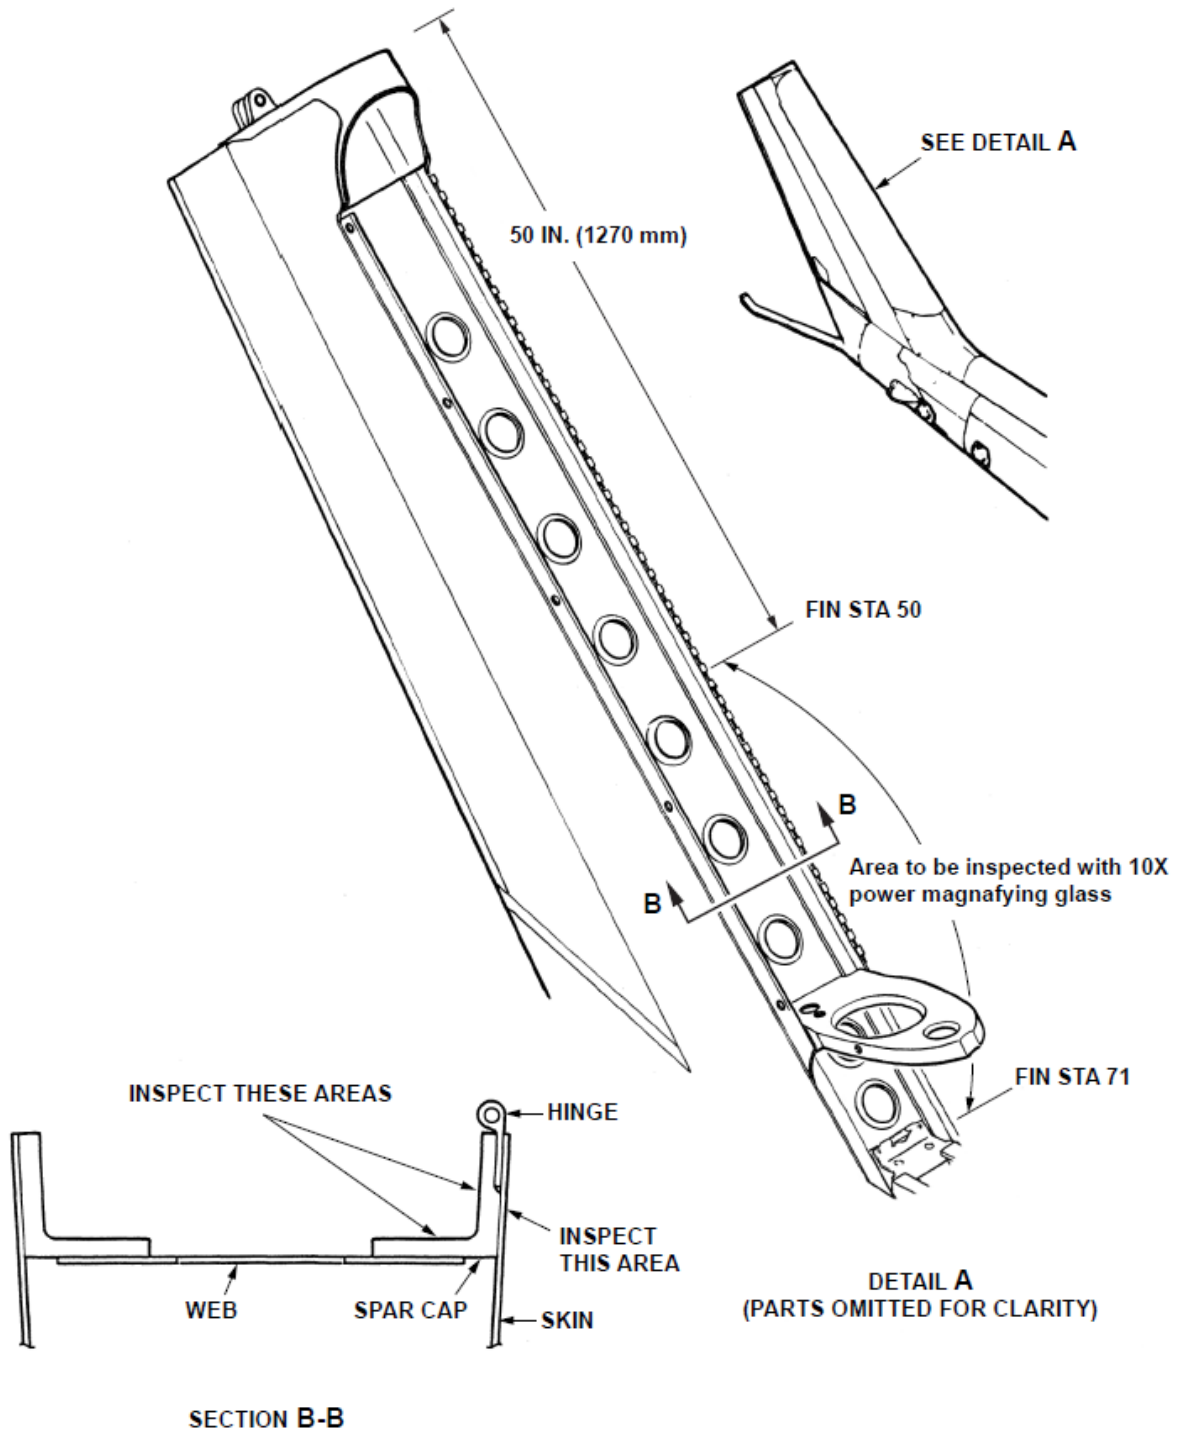
**Figure 1. Spar cap inspection.**

Bell has received a report of a fractured fin spar cap P/N 212-030-447-117. The crack occurred at vertical fin station (F.S.) 71 through the first rivet hole attaching the skin 212-030-099-105 to the spar cap. If undetected, the fin spar cap cracking may lead to additional structural damage. This bulletin introduces a 100 flight-hour inspection of the affected area of the fin spar cap using 10X magnifying glass.

2. Gain access to the spar cap angle by removing the 42-degree gearbox cover and opening the vertical fin driveshaft cover.
3. Clean exposed surfaces of spar cap to facilitate inspection.
4. Inspect both flanges of the spar cap between F.S. 50 and F.S. 71 using 10x magnifying glass and a bright light for cracks, loose rivets and other damage (Figure 1).
5. Inspect the exterior of the fin skin in the area in contact with the spar cap for cracks, loose rivets and/or distortion.
6. If no cracks or other damage is found, close the driveshaft cover, reinstall the 42-degree gearbox cover and return the helicopter to service.
7. If a crack or other damage is found, contact Product Support Engineering before further flight:
