ALERT SERVICE BULLETIN

ASB 210-23-18

MODEL AFFECTED: 210

SUBJECT: TENSION ROD ASSEMBLY P/N 205-030-249-009
OR 205-030-249-013, INSPECTION OF.

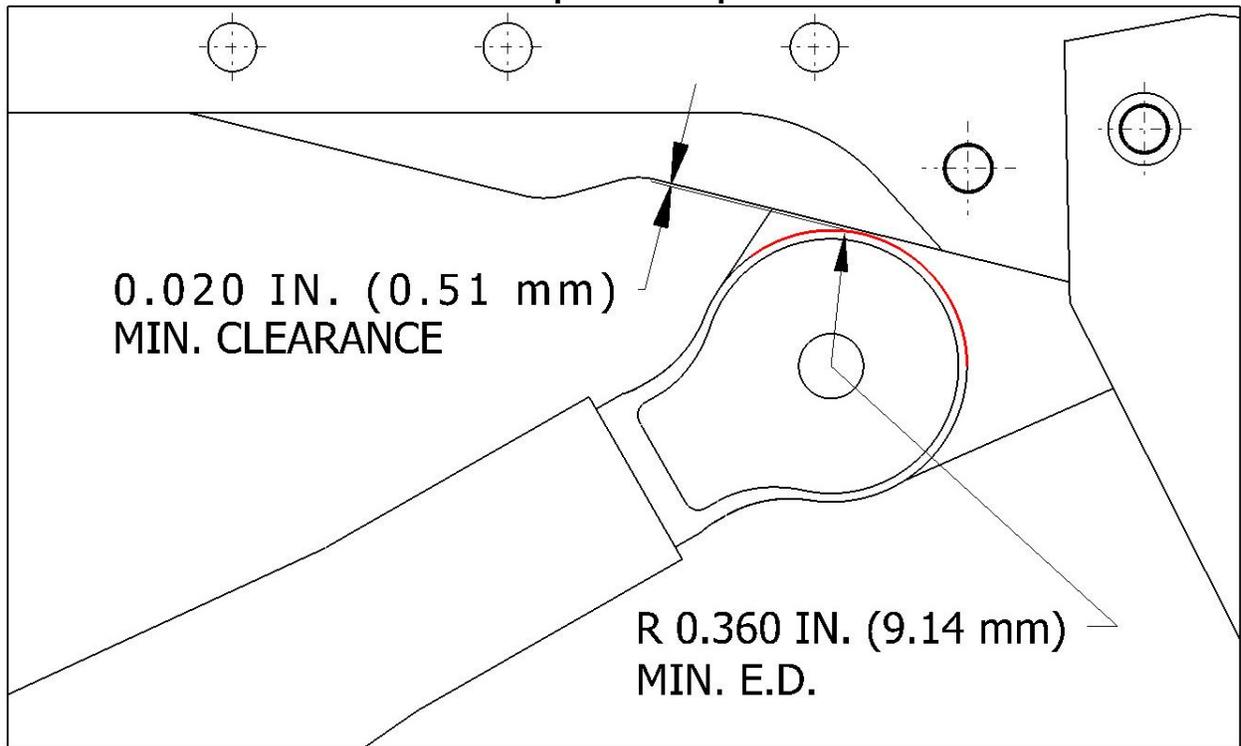
FIGURE 1. Inspection requirements.

2. Inspect the forward end (upper attachment location) of the tension rod assembly as follows:
 - a. Inspect the outboard side of the tension rod assembly rod end for a possible over trimmed condition. Minimum acceptable radius dimension measured from the bolt hole center is 0.360-inch (9.14 mm) edge distance (E.D.) (Figure 1). Removal of the attachment bolt may be required to perform this measurement. Record

- b. Check for fouling or low clearance conditions between the rod end and the structure (cap, web, angle). Minimum acceptable clearance is 0.020-inch (0.51 mm) (Figure 1). Record findings.

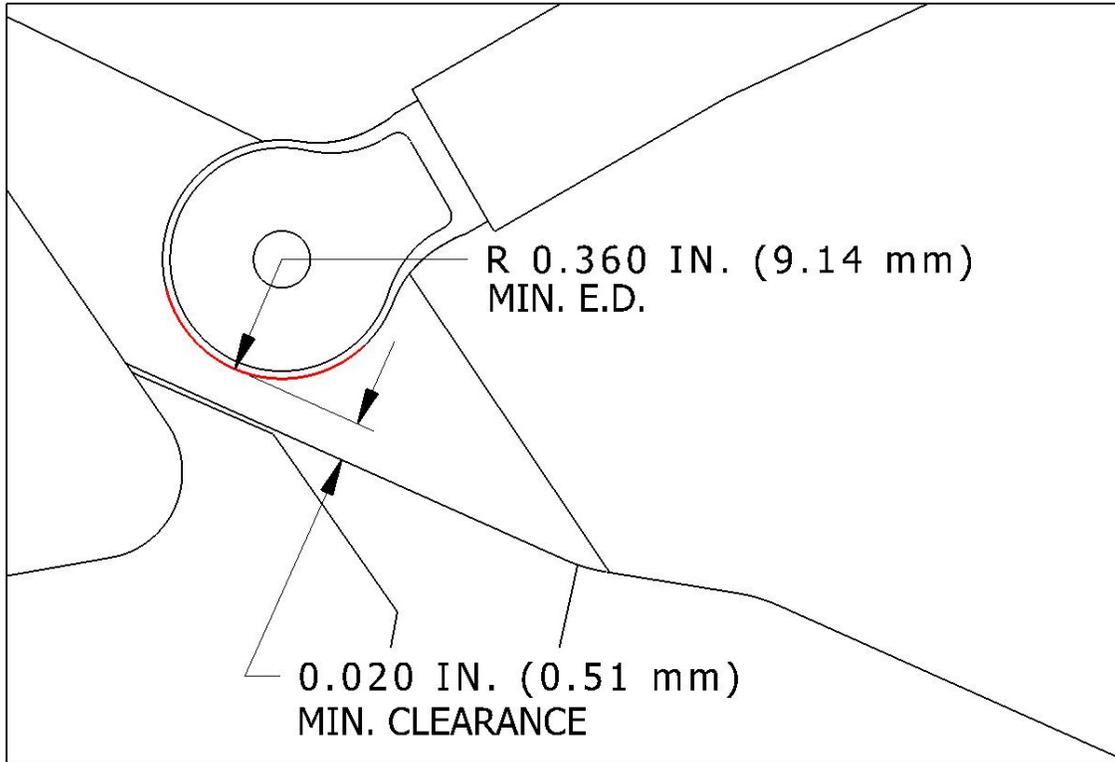
FIGURE 2. Inspection requirements

3. Inspect the aft end (lower attachment location) of the tension rod assembly as follows:
 - a. Inspect both sides of the tension rod assembly rod end for a possible over trimmed condition. Minimum acceptable radius dimension measured from the bolt hole center is 0.360-inch (9.14 mm) edge distance (E.D.) (Figure 2 and 3). Removal of the attachment bolt may be required to perform this measurement. Record findings. During reinstallation of hardware, if required, tighten the nuts IAW appropriate instructions.

- b. Check for fouling or low clearance conditions between the rod end and the structure (cap, web) on the outboard side and the fillet radius on the inboard side of the fitting. Minimum acceptable clearance is 0.020-inch (0.51 mm) (Figures 2 and 3). Record findings.

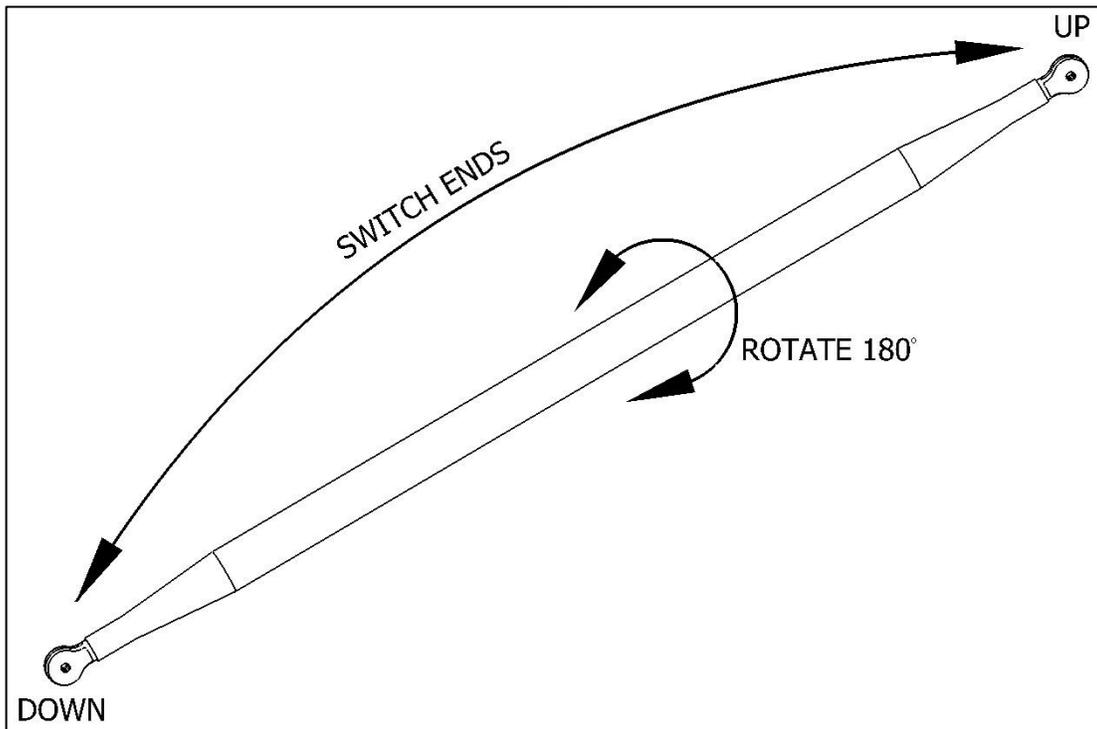
FIGURE 4. Tension rod assembly proper installation verification.

1. If a fouling or a low clearance condition exists, the tension rod assembly may have been incorrectly installed. Prior to trimming the rod ends, remove the tension rod assembly (step 1.a.) and try different orientations by rotating and/or switching ends
