ALERT SERVICE BULLETIN

214ST-12-89

SUBJECT: MAIN ROTOR HUB ASSEMBLY SPINDLE ASSEMBLY, P/N 214-010-103, MANDATORY REVISION OF INSPECTION AND OVERHAUL REQUIREMENTS.

HELICOPTERS AFFECTED: Serial number 28101 through 28200.

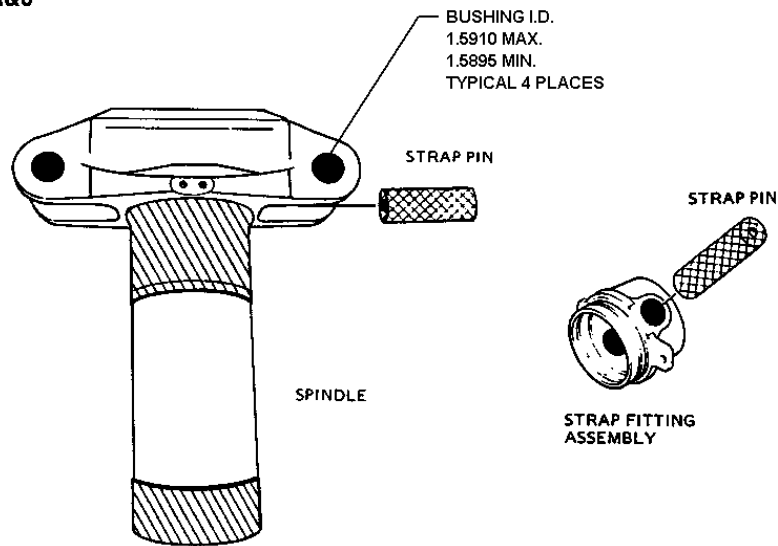
Figure 62-26. Main rotor hub mechanical and corrosion damage limits (sheet 2)

MECHANICAL DAMAGE	0.001 in. (0.0254 mm)	0.010 in. (0.254 mm)	0.004 in. (0.1016 mm)
CORROSION DAMAGE	0.001 in. (0.0254 mm)	0.010 in. (0.254 mm)	0.004 in. (0.1016 mm)
MAXIMUM AREA PER FULL DEPTH REPAIR	0.50 in. sq. (322.58 mm sq.)	Not Critical	0.50 in. sq. (322.58 mm sq.)
NUMBER OF REPAIRS	Two	Not Critical	Two Per Shaded Area
EDGE CHAMFER	0.010 in. (0.254 mm)	0.040 in. (1.016 mm)	0.010 in. (0.254 mm)
MOUNT BOLT BORE ● DAMAGE:	0.001 in. (0.0254 mm) for 1/4 circumference, size limits apply.		
CRACKS:	No cracks allowed.

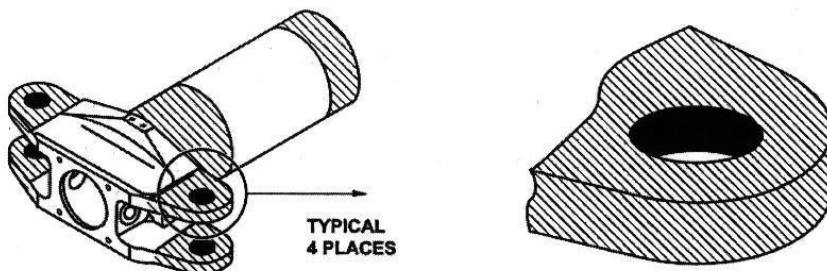
Figure 62-26. Main Rotor Hub Mechanical and Corrosion Damage Limits (Sheet 3)

214-010-103-115 SPINDLE ASSEMBLY

TYPE OF DAMAGE	MAXIMUM DEPTH AND REPAIR AREAS	REPAIR AREAS
MECHANICAL DAMAGE	0.010 INCH (0.254 mm)	0.004 INCH (0.1016 mm)
CORROSION DAMAGE	0.010 INCH (0.254 mm)	0.004 INCH (0.1016 mm)
MAXIMUM AREA PER FULL DEPTH REPAIR	NOT CRITICAL	0.50 SQ. INCH (322.588 sq. mm)
NUMBER OF REPAIRS	NOT CRITICAL	TWO PER SHADED AREA
EDGE CHAMFER	0.040 INCH (1.016 mm)	0.010 INCH (0.254 mm)
BUSHING BORE DAMAGE: ● DAMAGE MAY BE WORKED TO DIMENSIONS SHOWN BELOW ONLY.		
BORE DIAMETER		
(BUSHING REMOVED) - STANDARD 1.7775 to 1.7780 INCH (45.149 to 45.161 mm) △ 1 △ 2		
- OVERSIZE 1.7975 to 1.7980 INCH (45.657 to 45.659 mm)		
CRACKS:	NO CRACKS ALLOWED

- △ 1 Measured twice (90° apart) at top and bottom of each hole.
- △ 2 Typical 4 places.

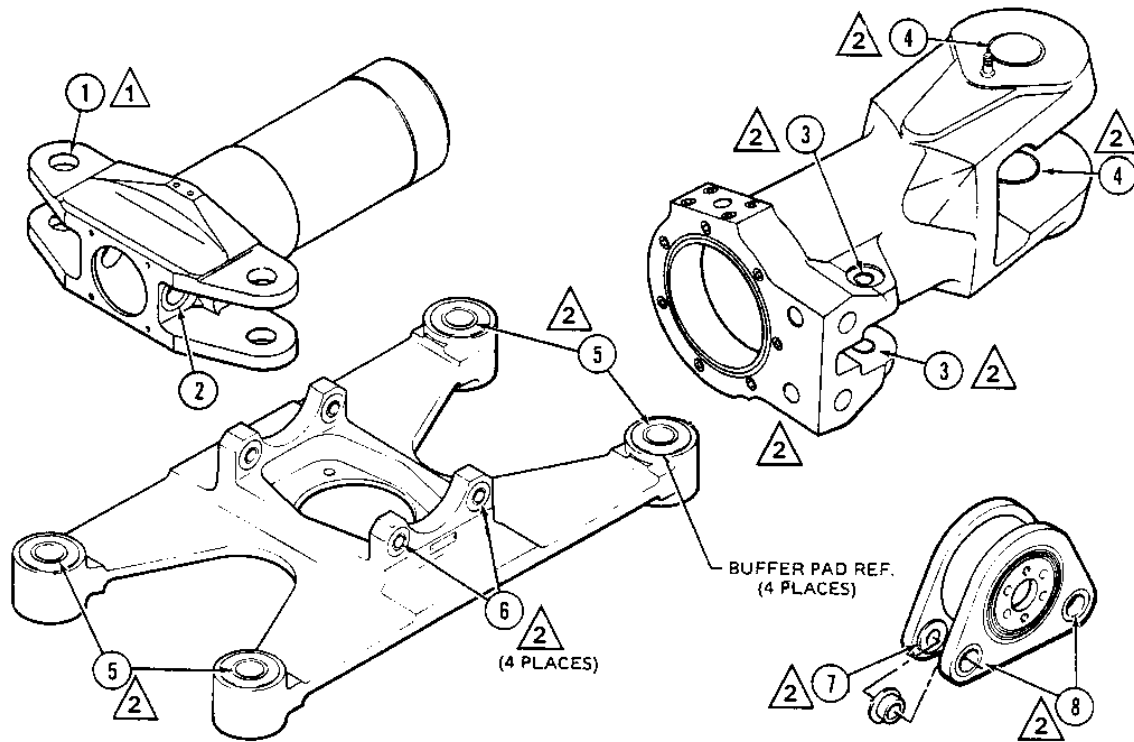
Figure 62-29. Hub components hole wear limits (Sheet 1 of 3)

HOLE NO.	NOMENCLATURE	HOLE DIAMETER	
		MIN	MAX
INCHES			
△ 1	1 Bushings, Spindle to Yoke	1.5895 (40.3733 mm)	1.5910 (40.4114 mm)
	2 Hole, Strap Pin	1.625 (41.275 mm)	1.6265 (41.3131 mm)
	3 Bushings, Drag Brace Installation	1.000 (25.400 mm)	1.002 (25.4508 mm)
△ 2	4 Bushings, Main Blade Bolt	2.875 (73.025 mm)	2.877 (73.0758 mm)
	5 Bushings, Spindle Installation	1.5895 (40.3733 mm)	1.5905 (40.3987 mm)
	6 Bushing, Bearing Installation	0.7495 (19.0373 mm)	0.7505 (19.0627 mm)
△ 2	7 Bushing, Bearing to Yoke	0.7495 (19.0373 mm)	0.7510 (19.0754 mm)
△ 2	8 Bushing, Slip Bushing Installation	1.0000 (25.400 mm)	1.0015 (25.4381 mm)

NOTE: △ 1 Any wear or damage to bushing exceeding these limits requires component be shipped to Bell Helicopter for repairs. 214ST-R-62-29-1
 △ 2 Any wear or damage to bushing exceeding these limits requires component be shipped to authorized repair station for repairs.
