ALERT SERVICE BULLETIN

214ST-13-90

MODEL AFFECTED: 214ST

SUBJECT: P/N 214-040-606-005/-101 TAIL ROTOR HANGER BEARING, INSPECTION AND REPLACEMENT OF

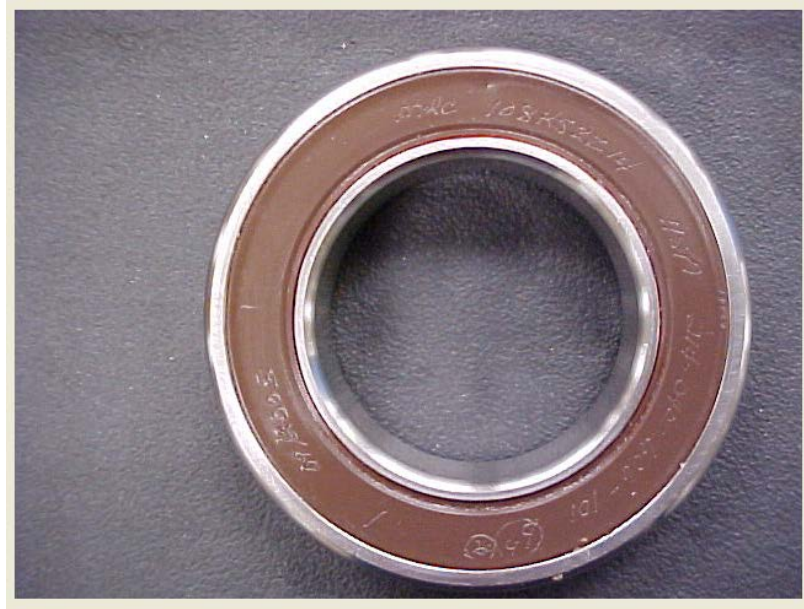
FIGURE 1

- a. The correct seal material will have a red/orange to brown color. As necessary, gently wipe the face of the seal with a clean cloth to remove any dried grease or dirt. Inspect both sides of the bearing.

BEARING SEALS MADE WITH THE CORRECT MATERIAL
WILL HAVE A RED/ORANGE TO BROWN COLOR

- b. Incorrect seal material will have a black color.
2. Bearings with the correct seal material (red/orange to brown in color) are acceptable and may be continued in service without further action.

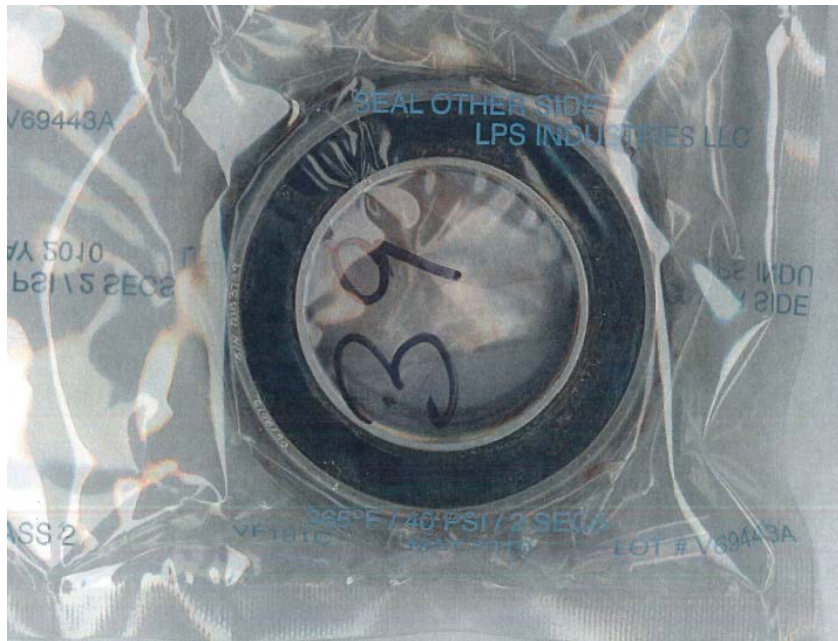
Bell Helicopter has been notified by its supplier that all P/N 214-040-606-005/-101 bearings delivered to Bell Helicopter between May 2011 and June 2012 were manufactured with the wrong seal material. This seal material does not meet the Bell operating/environmental temperature specifications and under extreme conditions could result in seal failure and grease loss. Defective bearings can be identified by a black colored seal. Bearings with the correct seal material will have a red/orange to brown colored seal.

BEARING SEALS MADE WITH THE INCORRECT MATERIAL
WILL HAVE A BLACK COLOR

3. Bearings with the wrong seal material (black) are to be disposed of as follows:
 - a. Bearings installed on the helicopter:
 - (1) Inspect each bearing with black seals for leakage/slung grease and/or evidence of damage to the bearing.

- (a) Grease leakage and/or evidence of bearing damage requires the bearing to be removed from service before further flight.
 - (b) If there is no evidence of grease leakage or bearing damage, the bearing may be continued in service subject to a visual inspection each 10 flight hours until replacement of the bearing is accomplished in accordance with Part 2. Inspect per paragraph 3.a.(1) above.

1. All installed bearings with defective seals must be replaced within 500 flight hours after receipt of this ASB or by 31 December 2013, whichever occurs first.
2. Refer to 214ST Maintenance and Component Repair and Overhaul Manuals for replacement procedures.
