ALERT SERVICE BULLETIN

214ST-18-93

MODEL AFFECTED: 214ST

SUBJECT: SPINDLE TO YOKE BOLT P/N 214-010-262-103, SERIAL NUMBERS, INSPECTION OF.

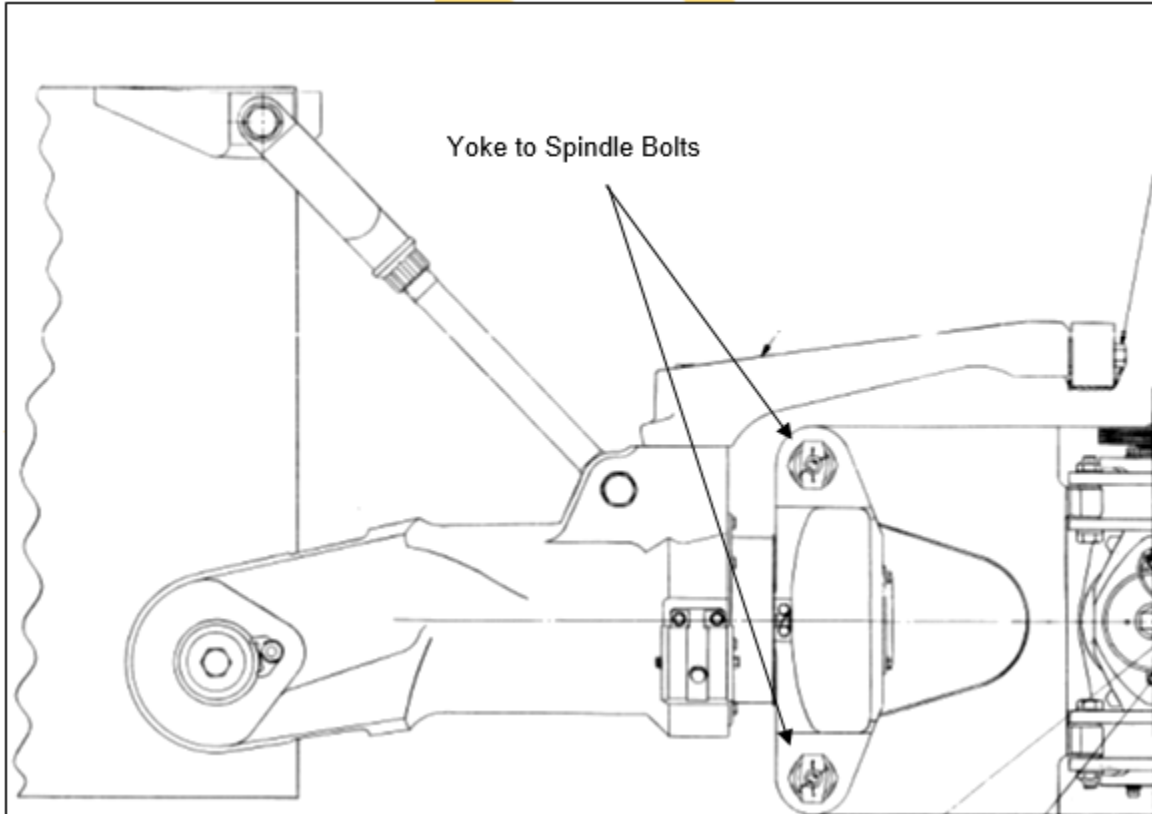
FIGURE 1 - Main Rotor Head - Bolt Locations
Two locations, on both ends of yoke. Four bolts total per aircraft.

1. Prepare helicopter for maintenance.
2. Gain access to spindle yoke bolts, total of four. (Refer to Figure 1)
3. Inspect all four spindle to yoke bolts P/N: 214-010-262-103 for physical verification of serial numbers listed in Table 1. (Refer to Figure 2)

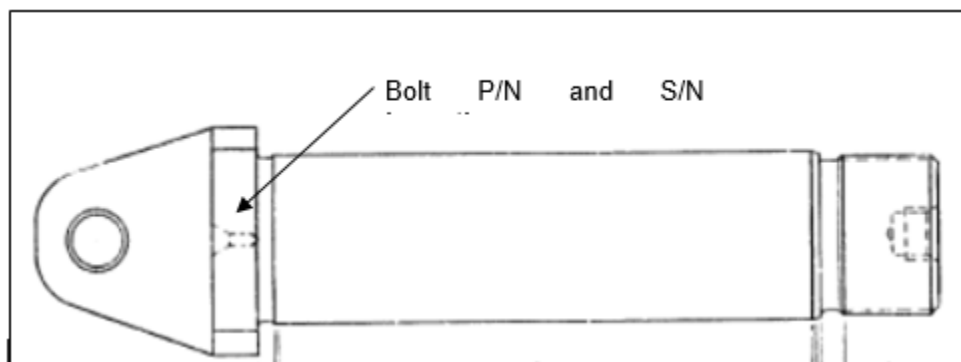
FIGURE 2 - ID Location

Bell has been made aware that a number of 214-010-262-103 bolts made by an outside supplier (now removed as a source of supply) may have non-conforming external thread root radii. **Part I** is an immediate inspection to locate the suspect bolts by serial number. **Part II** is a recurring inspection of presence and security of nut prior to every flight. **Part II** also includes a recurring torque check and incorporation of a flight hour penalty. Applicability of this bulletin to any spare part shall be determined prior to its installation on an affected aircraft.

- b. If torque check finds values below minimum requirements, the following will be required. Bolt to be removed and either replaced with an airworthy part or suspect threads inspected to confirm root radii are not less than 0.0125 inches. Suspect bolts removed for any reason shall not be re-installed unless minimum root radii are confirmed to be no less than 0.0125 inches.
