ALERT SERVICE BULLETIN

214ST-18-93

MODEL AFFECTED: 214ST

SUBJECT: SPINDLE TO YOKE BOLT P/N 214-010-262-103, SERIAL NUMBERS, INSPECTION OF.

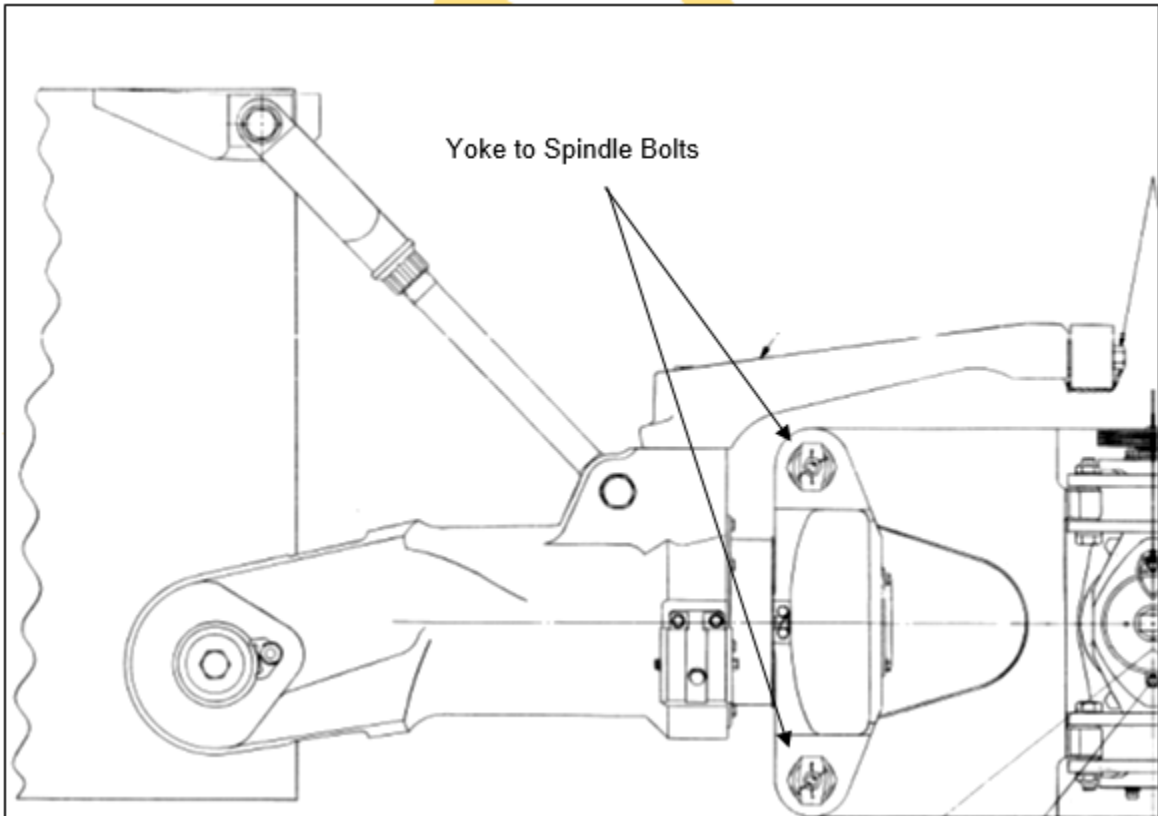
FIGURE 1 Main Rotor Head - Bolt Locations
Two locations, on both ends of yoke. Four bolts total per aircraft.

1. Prepare helicopter for maintenance.
2. Gain access to spindle yoke bolts, total of four. (Refer to Figure 1)
3. Inspect all four spindle to yoke bolts P/N: 214-010-262-103 for physical verification of serial numbers listed in Table 1. (Refer to Figure 2)
4. For all suspect serial number bolts found on aircraft, and until bolt is replaced; prior to every flight, inspect for presence and security of nut P/N: 206-011-119-005.
