ALERT SERVICE BULLETIN

407-21-123

MODEL AFFECTED: 407

SUBJECT: TAILBOOM ASSEMBLY, NEW AIRWORTHINESS LIMITATION SCHEDULE (ALS) INSPECTION REQUIREMENT.

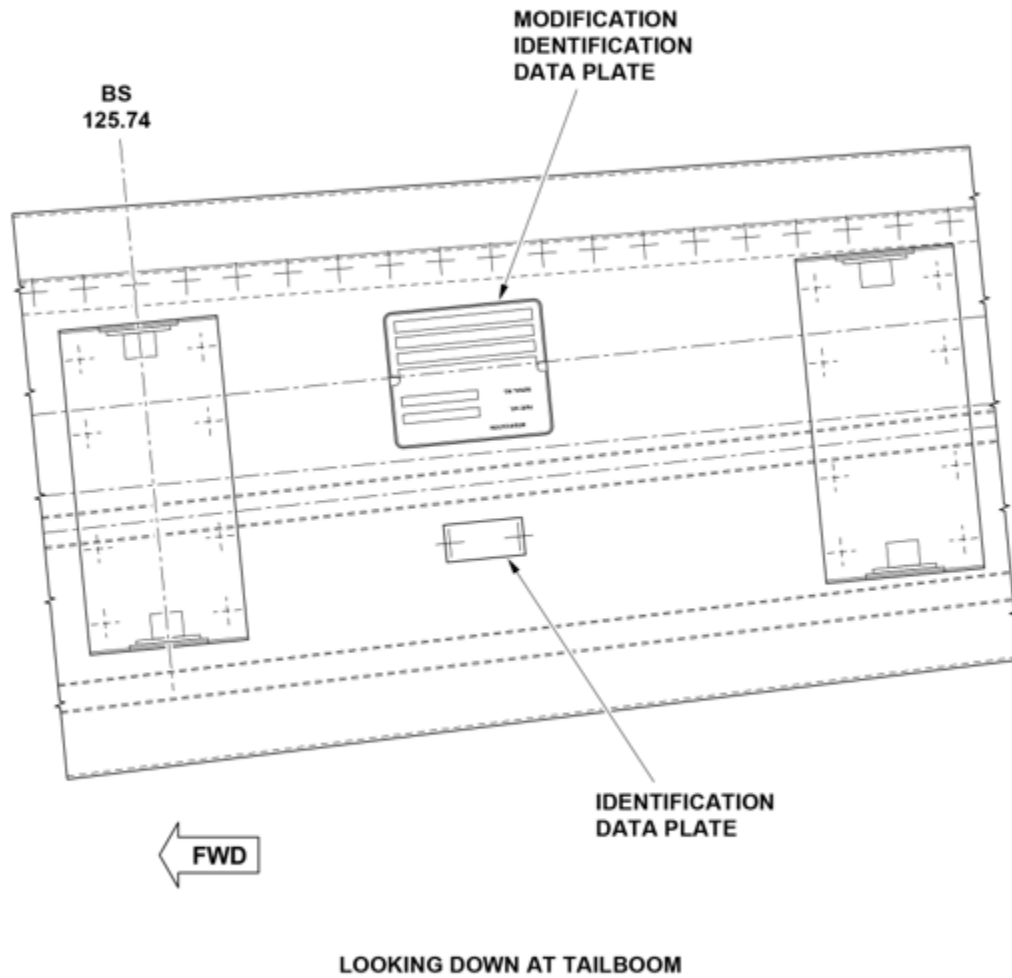
Figure 1 – Location of Identification Data Plate and Modification Identification Data Plate, Tailboom Assembly

1. Verify the helicopter historical service records to determine the part number of tailboom assembly installed. The tailboom assembly part number can also be confirmed by removing the aft tail rotor driveshaft cover (DMC-407-A-53-04-00-05A-520A-A) and looking at the identification data plate located near Boom Station (BS) 129 (Figure 1).

If the tailboom assembly has been modified from its original configuration, the part number on the identification data plate may have been re-identified, or the part number of the current configuration may be identified on a modification identification data plate which will be located near Boom Station (BS) 129 (Figure 1).

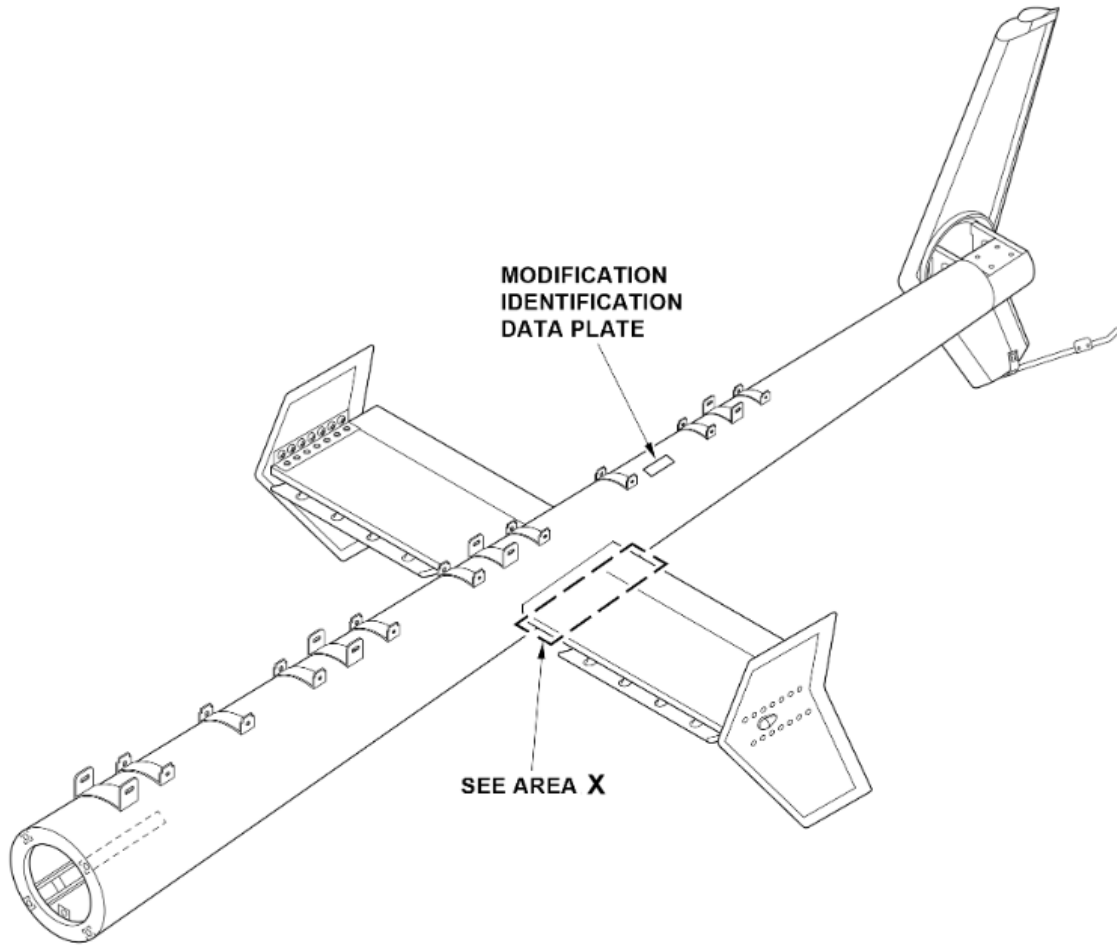
Figure 2 – Inspection Area on Tailboom Assembly (Sheet 1 of 3)

Bell has received a field report indicating an in-service crack on a tailboom lower skin. The crack was found on the lower aft corner of the left-hand cutout of the horizontal stabilizer, at Boom Station 120.75. Following analysis, it was determined that the crack was the result of fatigue which originated from the fastener hole for a nut plate.

3. Perform a detailed visual inspection (DVI) of the left side of the tailboom assembly skins and lower left closure plate of the horizontal stabilizer for signs of cracks and loose fasteners as follows:

1. Prepare the helicopter for maintenance.
2. Wash the area of the tailboom assembly to inspect (Figure 2) with cleaning compound (C-318) and water prepared in accordance with the manufacturer's recommendations to remove all traces of dirt, stains, exhaust residues and oil. Rinse thoroughly and wipe dry.

- b. Using a 10X magnifying glass and bright light source, carry out a DVI of the tailboom assembly skins for cracks just below the edge of mating horizontal stabilizer lower attachment support (Figure 2, Area X).

- (1) If a crack is found on the tailboom skins, replace the tailboom assembly with a serviceable tailboom assembly that meets the intent of this ASB prior to next flight, and report findings to Bell Product Support Engineering (productsupport@bellflight.com). Go to step 4.

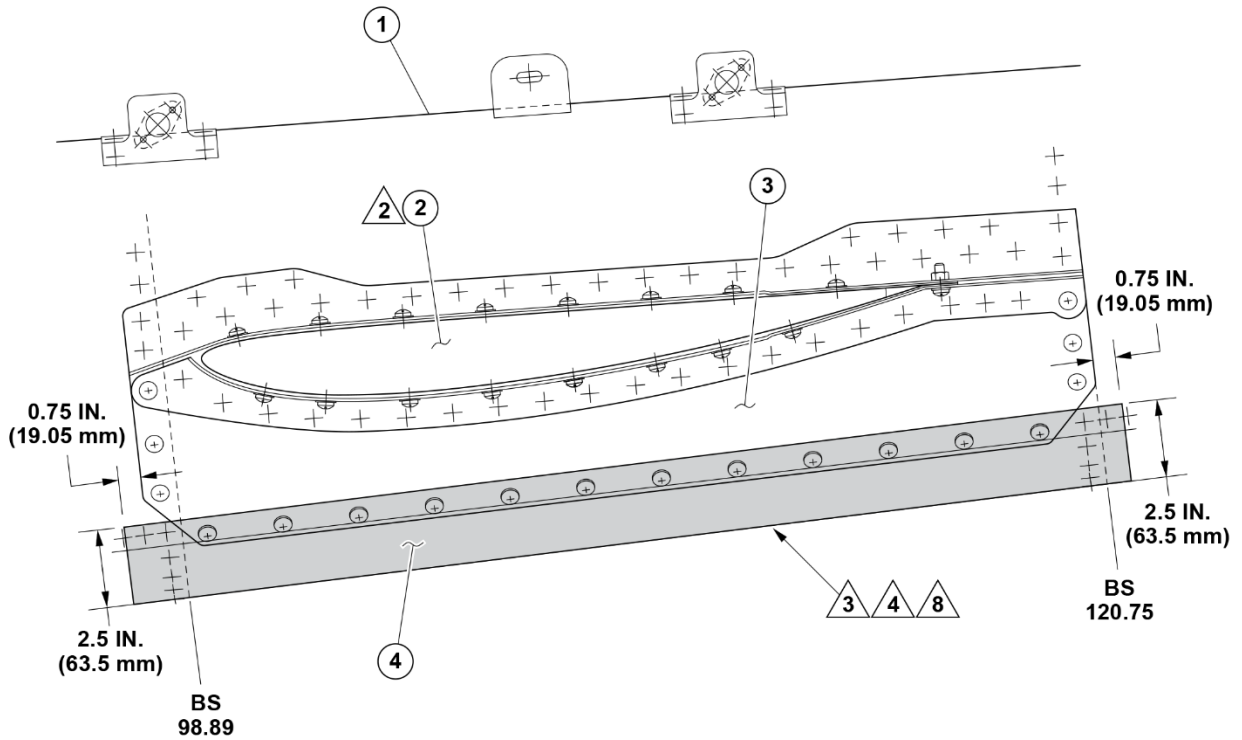
Figure 2 – Inspection Area on Tailboom Assembly (Sheet 2 of 3)

AREA X
 (HORIZONTAL STABILIZER NOT SHOWN FOR CLARITY)

CRITICAL INSPECTION AREA (10X MAGNIFYING GLASS)

- 1 On the left side of the tailboom only, do a detailed visual inspection (DVI) of area shown for cracks in the tailboom skin and loose rivets. Do not remove the paint or primer. If a loose rivet is found, remove rivet and inspect hole for cracks using a 10X magnifying glass. If no cracks are found, install correct diameter rivet. Do not exceed maximum diameter prescribed.

Use a 10X magnifying glass to inspect for cracks in tailboom skins and around fastener heads as indicated in area shown as Area X.

Pay close attention to skin just below edge of lower support.

- (2) If no crack is found on the tailboom assembly skins, but a crack is found on the lower left closure plate, do the following:
 - (a) Remove cracked lower left closure plate and discard (DMC-407-A-53-02-00-00A-921A-A). The closure plate is considered unserviceable.

- (b) Using a 10X magnifying glass and bright light source carry out a DVI of the tailboom assembly skins that are located under the closure plate for any cracks (Figure 2, Area X).

1. If no cracks are found, install a serviceable lower left closure plate (DMC-407-A-53-02-00-00A-921A-A) and go to step 4.
 2. If a crack is detected, replace the tailboom assembly with a serviceable tailboom assembly that meets the intent of this ASB.

- 6 If a crack is found on the tailboom skin, replace the tailboom before the next flight and contact Product Support Engineering using the information from the Contact Info section of this bulletin.

If left lower stabilizer support (4) is found cracked, remove support and perform inspection for cracks of the tailboom assembly skins located under the support using a 10X magnifying glass.
