## **ALERT SERVICE BULLETIN**

**407-21-125**

**MODEL AFFECTED:** 407

**SUBJECT:** COLLECTIVE PITCH TRANSDUCER 412-074-101-107, INTRODUCTION OF.

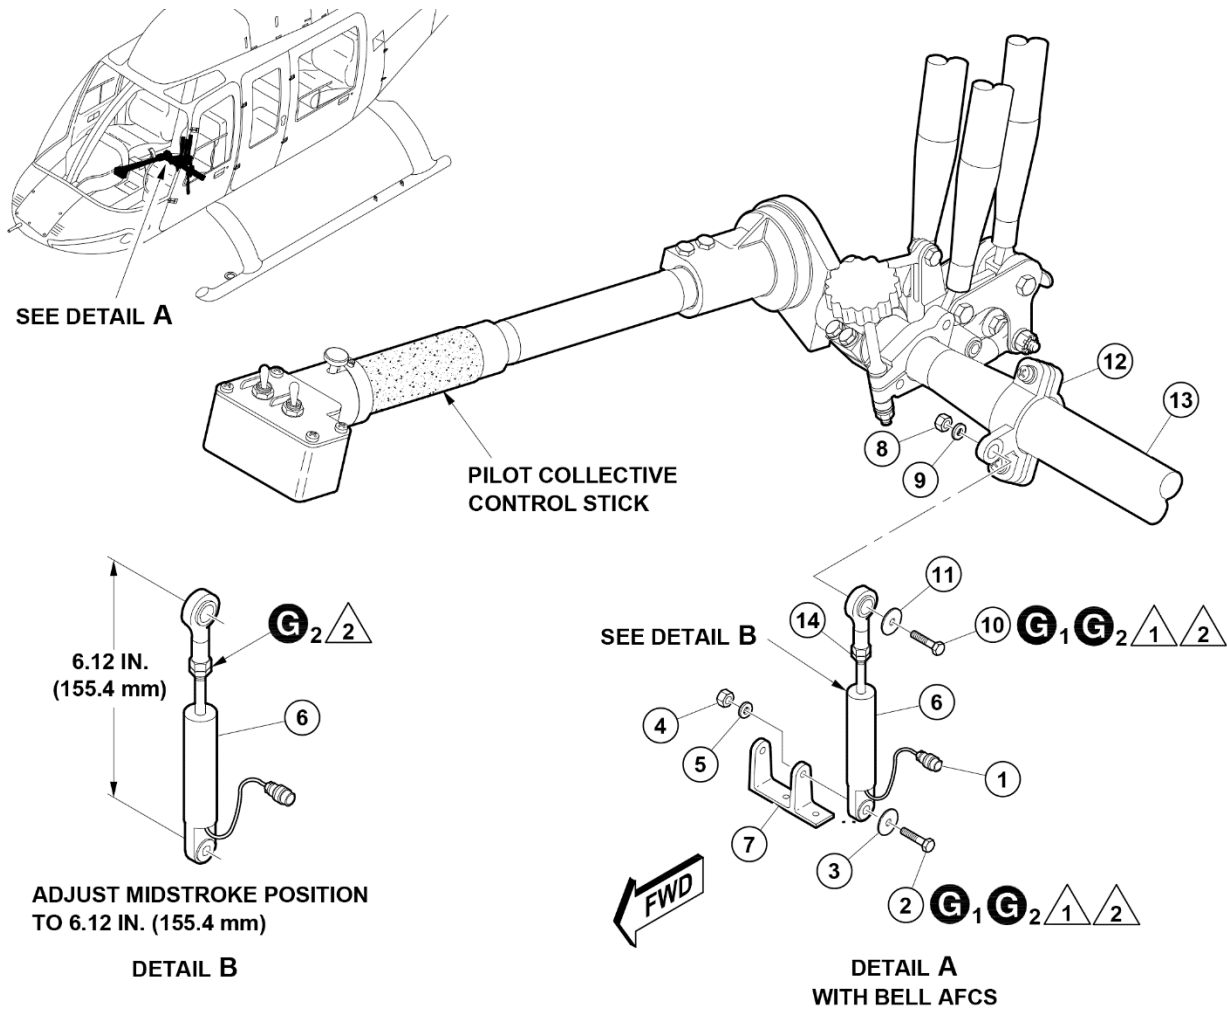
**Figure 1 – Collective Pitch Transducer (CPT) Installation**

Bell has been made aware, and has been investigating, a condition where engine parameter oscillations and FADEC faults can occur during flight operations of the 407GX<sub>i</sub> variant of the model 407. To correct the possibility of these occurrences, Bell has redesigned the collective pitch transducer assembly. This Alert Service Bulletin (ASB) provides instructions to replace the 412-074-101-103 transducer by the new 412-074-101-107 transducer on all affected helicopters.

7. Install 412-074-101-107 transducer as follows (Figure 1):

- a. Loosen the nut (14).
- b. Adjust the collective pitch transducer (4R1) (6), as applicable, to obtain a 6.12 inch (155.4 mm) dimension between the centers of the grounded bearing and adjustable rod end bearing with the collective pitch transducer movable rod at the mid stroke position (Figure 1, Detail B).
- c. Tighten the nut (14).
- d. Make sure the clamp assembly (12) has not moved and is not loose on the collective jackshaft (13). If the clamp assembly is loose or has moved, position the clamp assembly ([DMC-407-A-76-05-06-00A-276A-A](#)).
- e. Position the collective stick in the full down position.
- f. Position the collective pitch transducer (4R1) (6), as applicable, between the support (7) and the clamp assembly (12).

- g. Apply corrosion preventative compound (C-104) to shank of bolt (2) (Figure 1, Note 1). Install the spacer (3) and the bolt (2) through the support (7) and the collective pitch transducer (4R1) (6), as applicable.
- h. Install the washer (5) and the nut (4) on the bolt (2). Tighten the nut.

- i. Before you install the collective pitch transducer (4R1) (6), as applicable, to the clamp assembly (12), make sure the collective pitch transducer rod end will fit the clamp assembly mounting hole position with the collective full up and the collective full down without causing restriction to collective travel or damage to the collective pitch transducer.

- j. Apply corrosion preventative compound (C-104) to shank of bolt (10) (Figure 1, Note 1). Install the spacer (11) and the bolt (10) through the collective pitch transducer (4R1) (6), as applicable, and the clamp assembly (12).
- k. Install the washer (9) and the nut (8). Tighten the nut.
- l. Apply corrosion preventative compound (C-101) to all bolt heads (2 and 10), washers (3, 5, 9, and 11), nuts (4 and 8), exposed threads of bolts (2 and 10), and nut (14) (Figure 1, Note 2).
- m. Remove protective caps and/or plugs from the collective pitch transducer electrical connector (4R1J1) (1).
- n. Connect the collective pitch transducer electrical connector (4R1J1) (1). Fold and secure the excess connector harness wiring with lacing cord or plastic cable ties.
