ALERT SERVICE BULLETIN

407-22-127

MODEL AFFECTED: 407

SUBJECT: FREEWHEEL ASSEMBLY AFT CAP 406-040-509-101, INSPECTION OF.

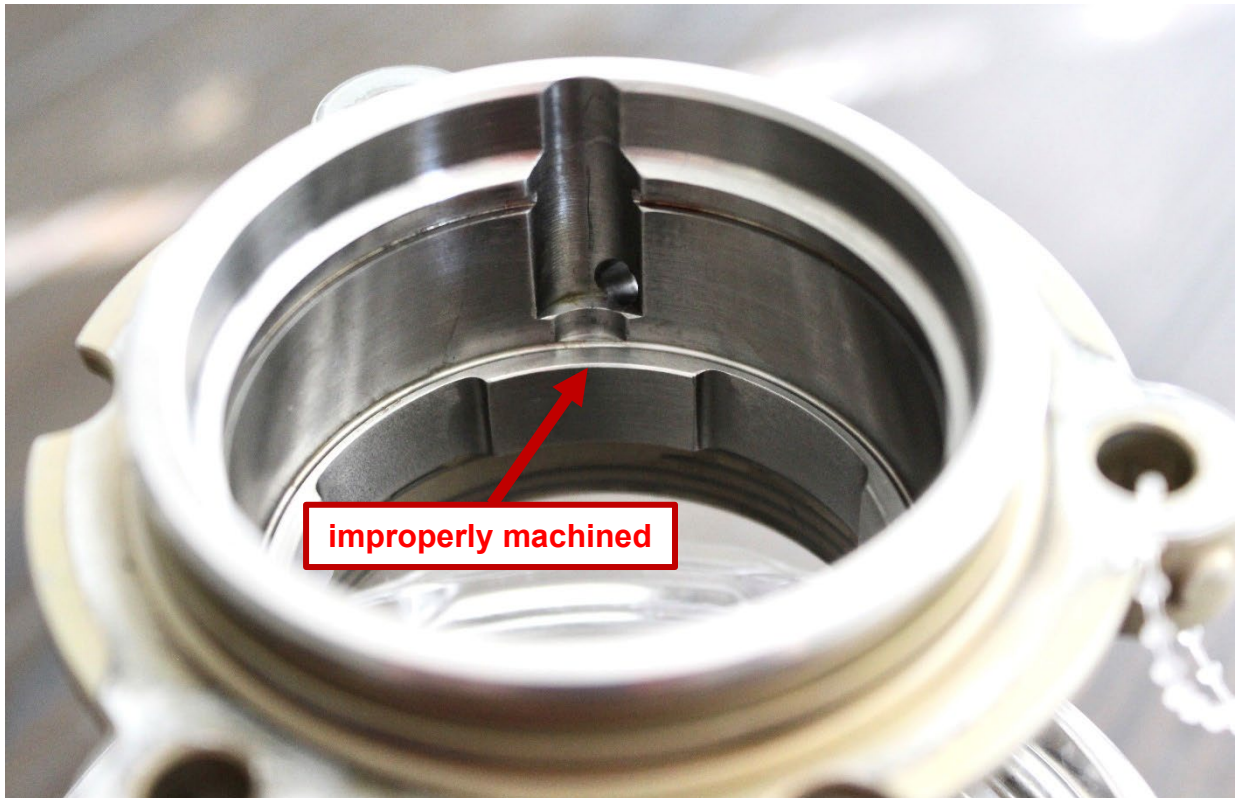
Figure 3 – Improper Machining of Aft Cap Scallop (sheet 1 of 2)

Bell has been made aware of a quality escape in the manufacturing process of the freewheel assembly aft cap 406-040-509-101. Some aft caps may have improperly machined scallops that are designed to allow oil to flow between the aft face of the support assembly bearing and the aft cap seal.

5. Inspect the freewheel assembly aft cap for a correctly machined scallop (Figure 3).
 - a. If the aft cap is correctly machined, go to step 10.
 - b. If the aft cap is **not** correctly machined, go to step 6.

6. Remove the elbow (11, Figure 2), nut (10), and preformed packing (9) from the freewheel support assembly (8).
7. Replace aft cap (8) with a serviceable cap that meets the intent of this bulletin.
