## **ALERT SERVICE BULLETIN**

**407-24-134**  
12 February 2024

- MODEL AFFECTED:** 407
- SUBJECT:** Tailboom Attachment Hardware and Fittings, Inspection of
- HELICOPTERS AFFECTED:** Serial numbers 53000 through 53900, 53911 through 53999, 54000 through 54166, 54300 through 54752, 54805 through 54999 and 56300 and subsequent.
- COMPLIANCE:**
- PART I:** Within 50 flight hours or 30 days whichever occur first, following the release of this bulletin or if TB 407-17-125 is completed thereafter.
- PART II:** Within 50 flight hours or 30 days whichever occur first and every 300 flight hours thereafter following the release of this bulletin.
- PART III:** Within 50 flight hours or 30 days whichever occur first and every 50 flight hours thereafter following the release of this bulletin.

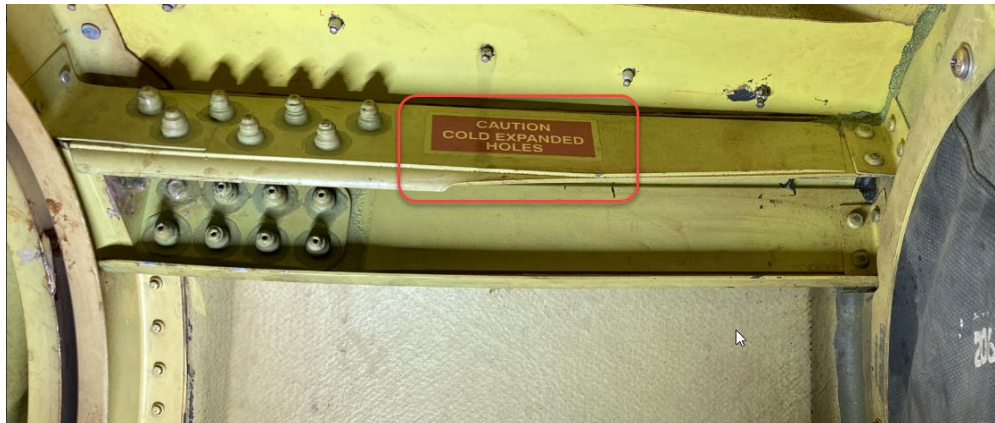
**Figure 2 – Upper Left Longeron 206-031-314-237  
“CAUTION COLD EXPANDED HOLE” decal**

407 S/N: 53001 through 54061 did not have the 206-031-314-237 longeron assembly installed from factory with the "Caution Cold Expanded Holes" decal as shown in Figure 2. If the decal "Caution Cold Expanded Holes" is present on upper left longeron as shown in Figure 2 (Analog 407 prior to S/N: 54062), the longeron assembly was field replaced per the above Technical Bulletins.

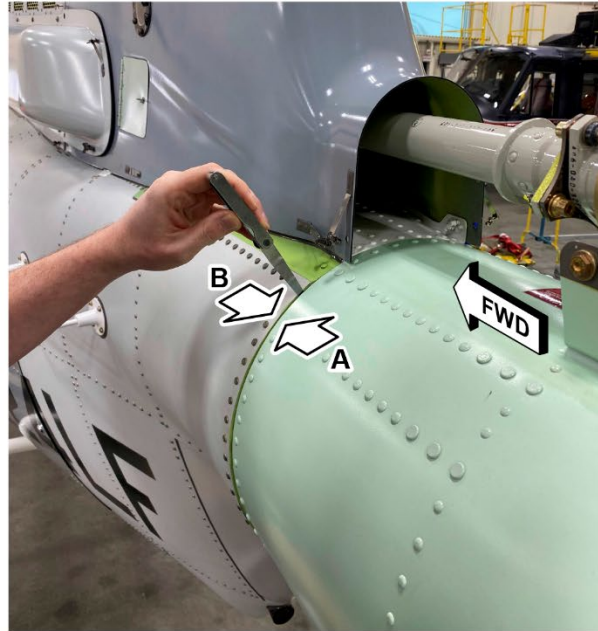
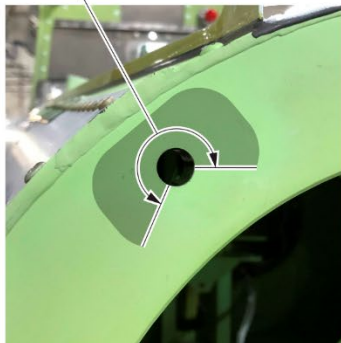
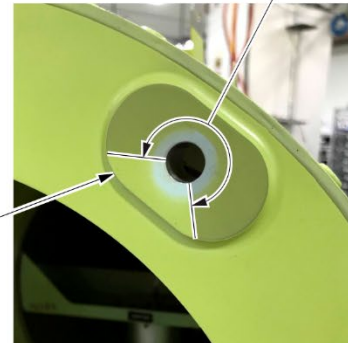
**Figure 3 - Gap check at the upper left tailboom attachment interface with tailboom and hardware installed.**

1. From the left side of the fuselage, using a strong light source and a feeler gauge, inspect for a gap at the upper left attachment interface between the aft fuselage and the tailboom. The entire tailboom forward bulkhead machined / hot bonded shim surface must be in contact with the aft fuselage bulkhead. Figure 3 shows the inspection area for possible gap between the machined / hot bonded shim and the

aft fuselage bulkhead. If a 0.003 inch (0.076 mm) feeler gauge or thicker can be inserted in the joint up to the bolt shank, contact Product Support Engineering for further instructions.

1. View A and B show the inspection area for possible gap.

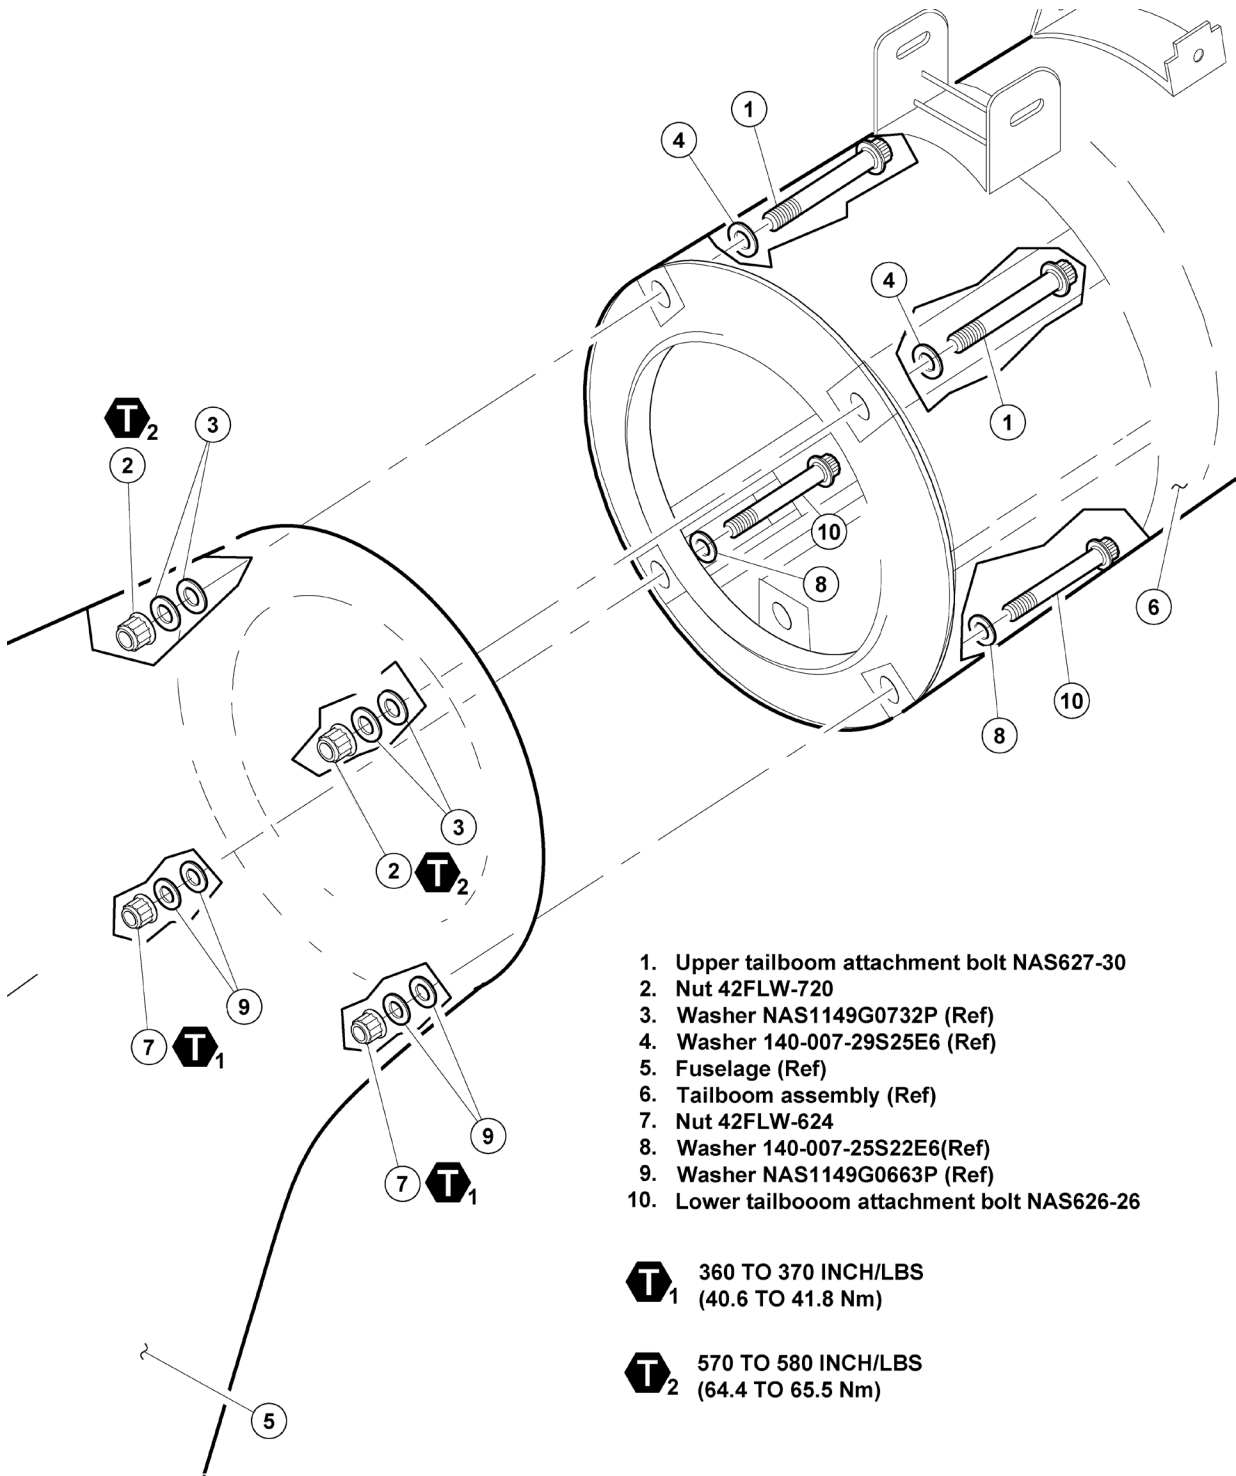
**Figure 4 Tailboom Attachment Hardware**

The torque values of the upper and lower nuts (2 and 7, Figure 4) are different. Refer to Figure 4 for the specified torque values.

For torque check purposes, the assembly torque to be applied is the minimum specified torque, plus the minimum acceptable tare torque of 14 inch-pounds (1.58 Nm) for the upper nuts and 9.5 inch-pounds (1.07 Nm) for the lower nuts (BHT-ALL-SPM, Chapter 2, Standard Practices Manual).

- e. Do a torque check of the 3 remaining tailboom to the aft fuselage attachment nuts (2 and 7, Figure 4) ([DMC-407-A-53-01-00-00A-720A-A](#)).
  - (1) If a nut fails the torque check, replace the affected bolt(s) and nut(s) with new bolt(s), nut(s), and washer(s) as applicable. Retain removed hardware for further investigation by Product Support Engineering.
    - (a) Refer to ([DMC-407-A-53-01-00-00A-720A-A](#)) for hardware installation procedures.
- f. After final torque is applied, apply corrosion preventive compound (C-586) to the head of the bolt, washers, nut, and the exposed threads.
- g. After 1 to 5 flight hours, perform the Tailboom Attachment Hardware Torque Check special inspection at every location where new hardware was installed

5. Do a torque check of the tailboom to the aft fuselage attachment nuts (2 and 7, Figure 4) ([DMC-407-A-53-01-00-00A-720A-A](#)).
  - a. If a nut fails the torque check, replace the affected bolt(s) and nut(s) with new bolt(s), nut(s), and washer(s) as applicable. Retain removed hardware for further investigation by Product Support Engineering.
