ALERT SERVICE BULLETIN

407-24-136

MODEL AFFECTED: 407

SUBJECT: STANDARD AND HIGH LANDING GEAR FORWARD CROSSTUBES – INSPECTION OF

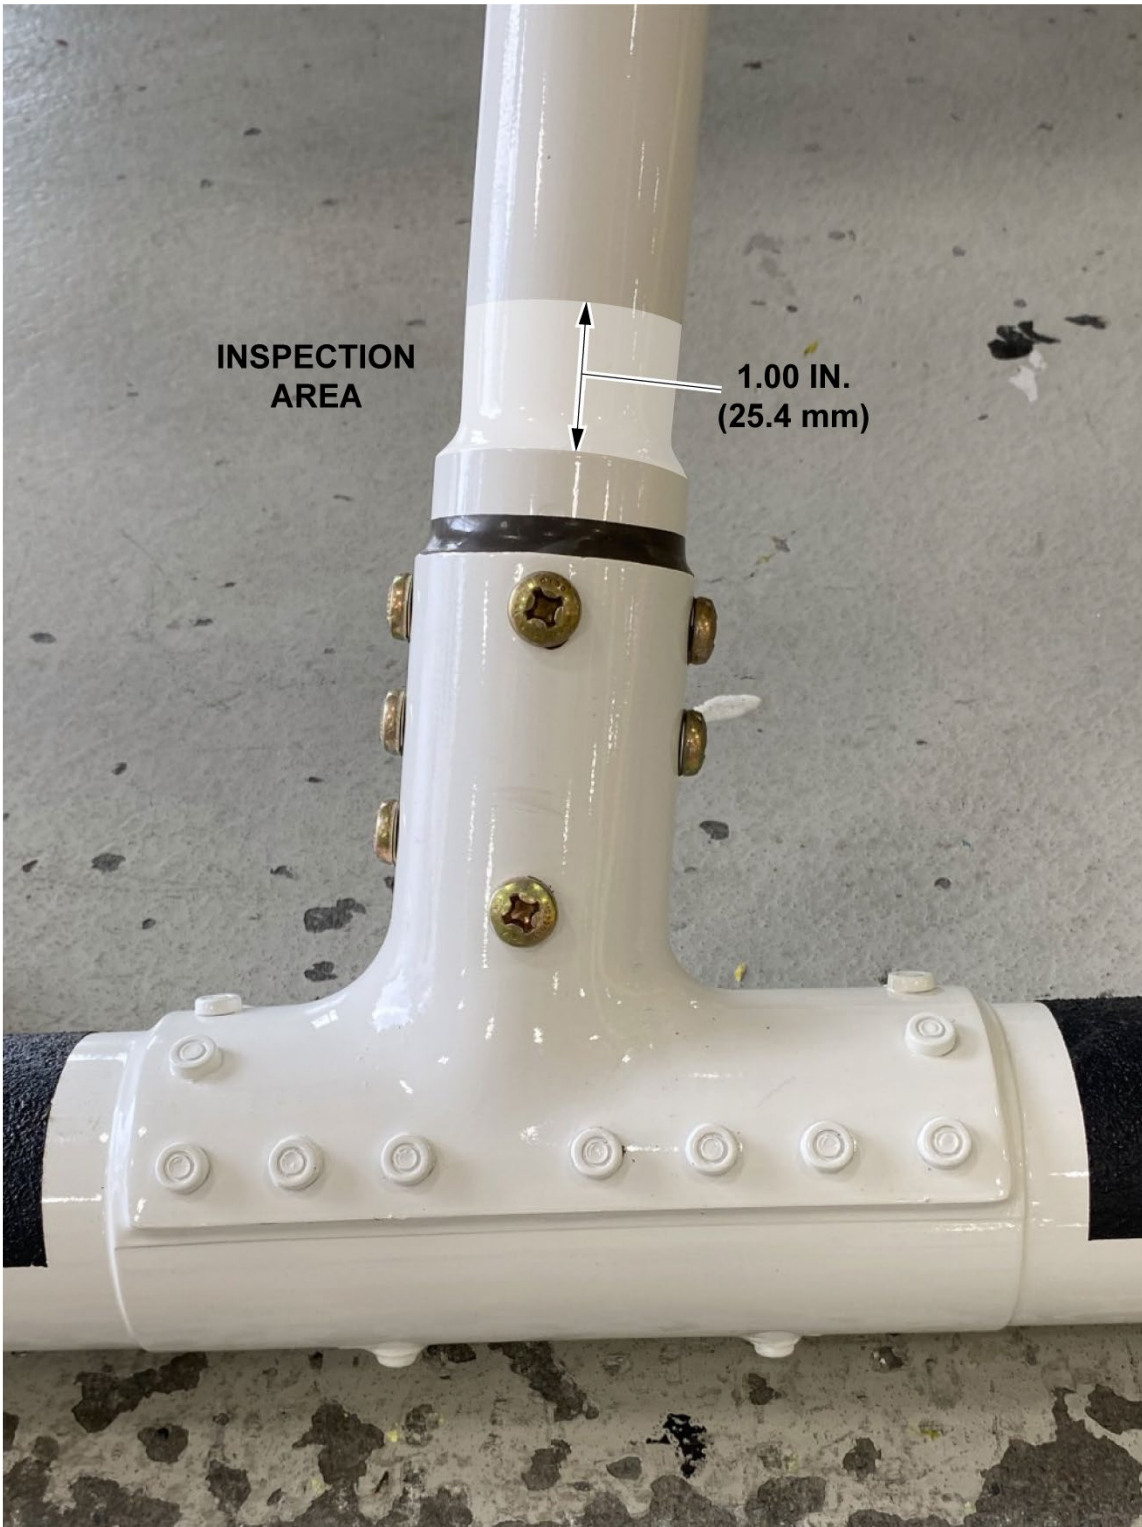
Figure 1- Forward Crosstube Inspection Area

Based on in-service data and a revised fatigue analysis of the forward crosstube, Bell is introducing a new inspection schedule of the standard and high gear forward crosstubes.

The inspection area is one inch in length just above the skid tube saddles and around the complete circumference of the crosstube (Figure 1).

6. Perform a Fluorescent Penetrant Inspection (FPI) in the stripped area around the complete circumference of the crosstube (BHT-ALL-SPM, Chapter 6)
7. Remove tape and clean the inspected areas following the FPI (BHT-ALL-SPM, Chapter 6).

3. Perform a detailed visual inspection of the affected areas using a 10X magnifying glass around the complete circumference of the crosstube.
4. If no crack is detected proceed to step 7.

5. If a crack is detected during the 10X inspection, remove the standard low gear crosstube ([DMC-407-A-32-01-02-00A-520A-A](#)) or high gear crosstube ([DMC-407-A-32-02-02-00A-520A-A](#)), as applicable. If a crack is suspected during the 10X inspection but cannot be confirmed, perform FPI per **PART II** steps 4 through 9. If a crack is detected report the findings to Product Support Engineering at productsupport@bellflight.com.
