ALERT SERVICE BULLETIN

412-00-100

MODEL AFFECTED: 412/412EP

SUBJECT: CAP ANGLE, P/N 212-030-191-001, INITIAL INSPECTION

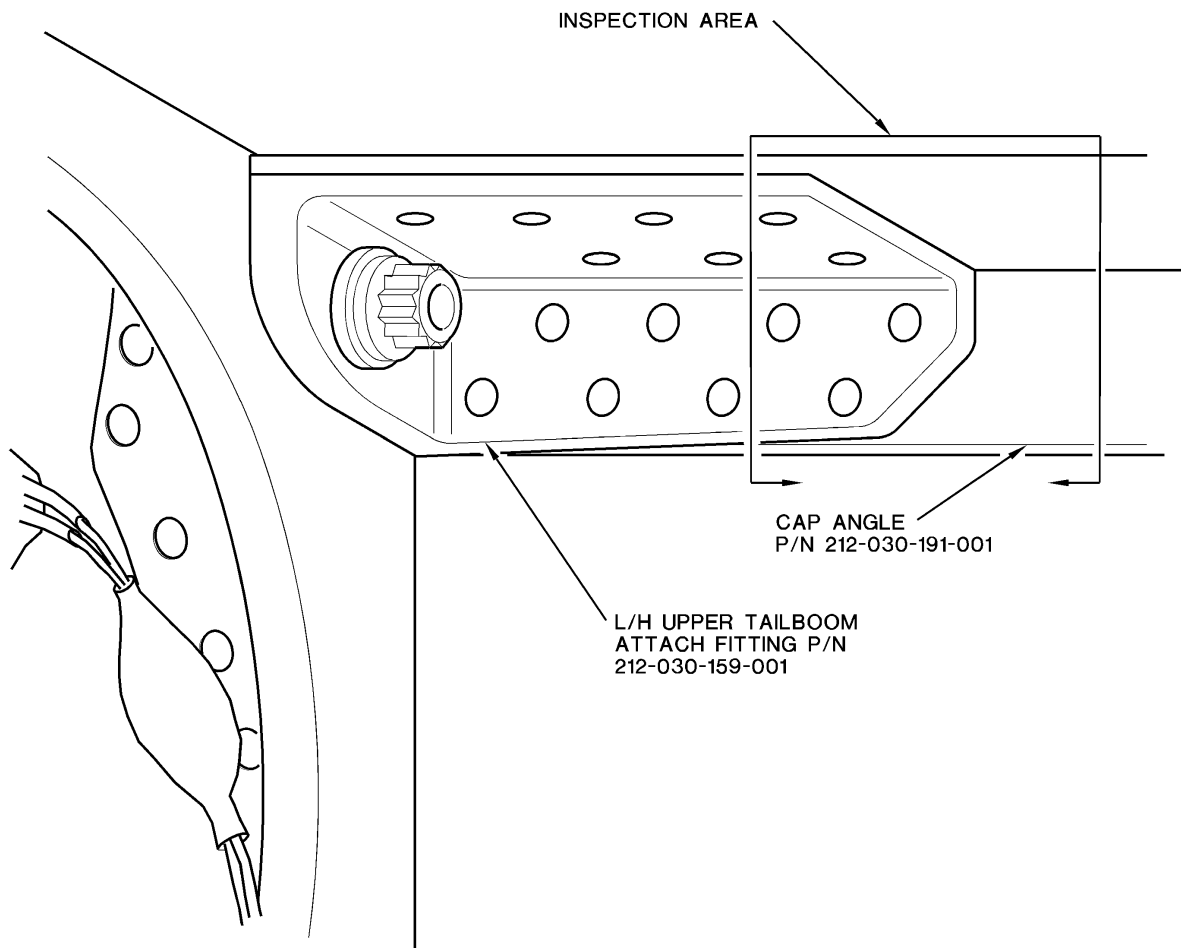
212-030-191-001. The fracture was the result of a fatigue crack, which originated from metal chips left between the bottom side of the cap and the upper side of the fittings, or between the cap angle and the adjacent structure. This has been determined to be the result of improper de-burring and cleaning during manufacture.

1. Gain access to the cap angle in the tail rotor servo compartment through the R/H aft fuselage door.
2. Inspect area noted on [figure 1](#) of cap angle, P/N 212-030-191-001, with 10x magnifying glass.
3. If no cracks are found, return the aircraft to service.
4. If a crack is found, contact Product Support Engineering before further flight:
