ALERT SERVICE BULLETIN

412-14-160

MODEL AFFECTED: 412/412EP

SUBJECT: MAIN ROTOR DRIVE, ENGINE-TO-TRANSMISSION DRIVE SHAFT RETAINING NUTS INSPECTION/REPLACEMENT OF.

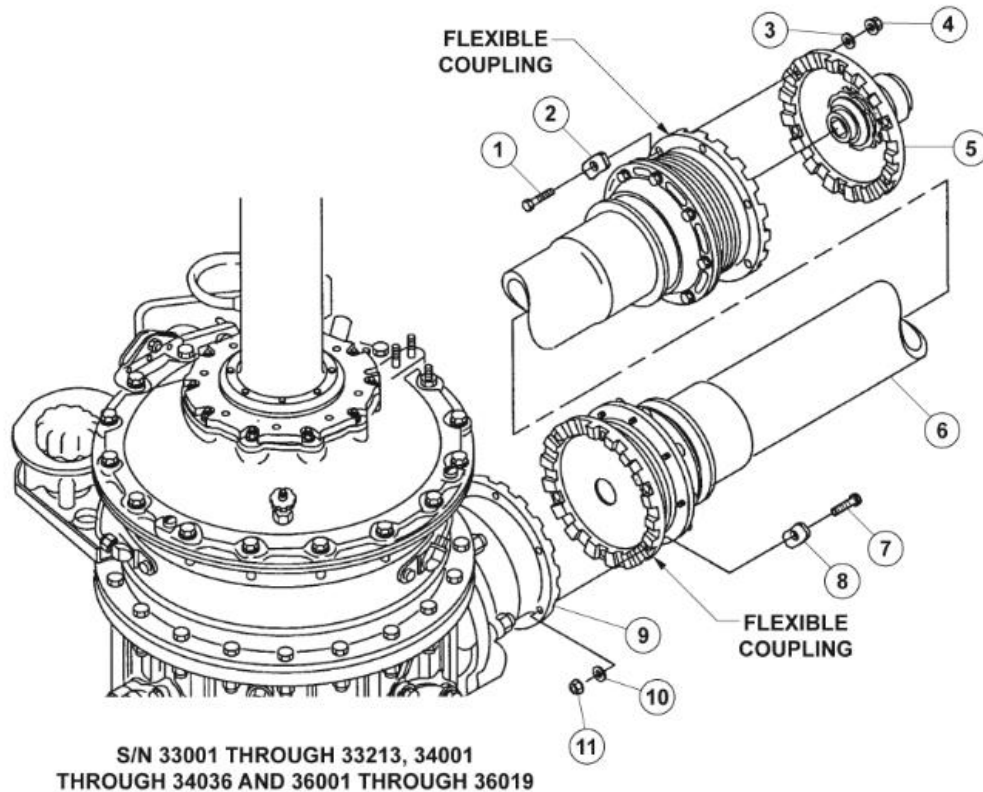
Figure 1. Main drive shaft attaching nuts (Part I).

An occurrence reported to the European Aviation Safety Agency (EASA) indicating that two nuts (P/N MS21042) attaching the flexible coupling to the coupling drive adapter of the main driveshaft were found cracked during a scheduled inspection.

If left undetected, this condition could lead to an unsecure loss of attachment between the drive shaft coupling and the drive adapter. In an extreme case; if all attaching nuts were found cracked, a loss of transmission drive from the engine and reduced ability to control the helicopter could occur. As a result of this reported occurrence, EASA released the Emergency Airworthiness Directive 2014-0118-E.

1. Gain access to the main drive shaft assembly and replace the main drive shaft attaching nuts (Figure 1) MS21042L5 with NAS9926-5L nuts (BHT-412-MM).
2. Make an entry in the helicopter logbook and historical service records indicating compliance with this Alert Service Bulletin.

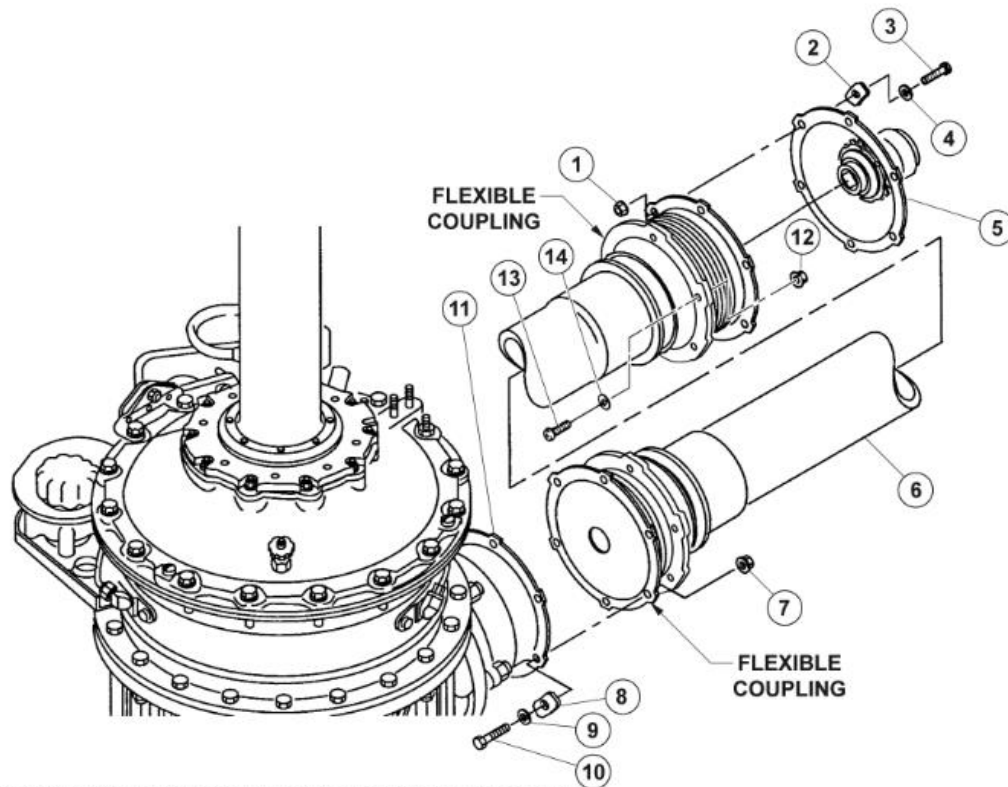
Figure 2. Main drive shaft attaching nuts (Part II).

For helicopters listed in the “**Helicopters Affected**” block **Part II**, the NAS9926 nut cannot be used due to insufficient clearance between the drive shaft flexible coupling and the nut. For this reason, the original release and the Revision A of this bulletin stated that only MS21042 nuts procured from a Bell approved supplier were authorized. When the general Illustrated Parts Breakdown (IPB) supersession took place, the IPB incorrectly showed the MS21042L4 as being replaced by the NAS9926-4L. Revision A also indicated that Bell would introduce in another revision of this bulletin, a new Bell standard nut as a direct replacement to the MS21042 for the main drive shaft and main drive shaft installation.

installed NAS9926-4L nuts as a replacement to the MS21042L4 nuts on the main drive shaft or at the drive coupling to main drive shaft attachment. This bulletin Revision B mandates the replacement of all MS21042 or NAS9926 nuts used in the main drive shaft assembly and main drive shaft installation with the new Bell standard 6 flat nut P/N 90-132L4. The Bell standard 90-132 nut is physically similar to the MS21042 nut except that the 90-132 part number is marked at the base of the nut.

1. Gain access to the main drive shaft and replace the currently installed main drive shaft and main drive shaft attaching MS21042L4 or NAS9926-4L nuts (Figure 2, items 1, 7 and 12) with nuts P/N 90-132L4 (BHT-412-MM).
2. Make an entry in the helicopter logbook and historical service records indicating compliance with this Alert Service Bulletin Revision B.
