ALERT SERVICE BULLETIN

412-20-181

MODEL AFFECTED: 412/412EP

SUBJECT: MAIN ROTOR EXPANDABLE BLADE BOLT 412-010-137-103, ONE-TIME INSPECTION OF.

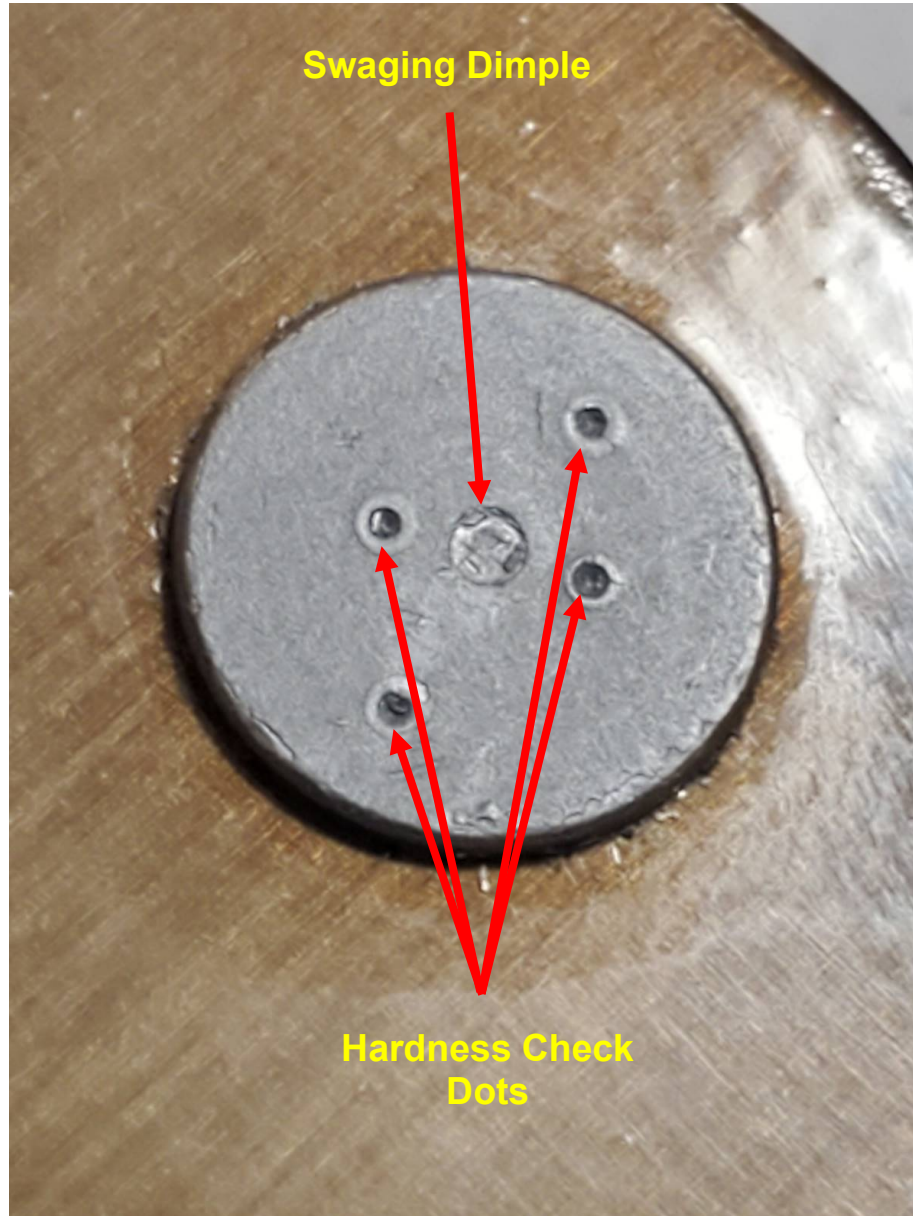
Some pivot pins may have one or more hardness check dots on the head (Figure 1). These should not be confused with the swaging dimple that should be in the center of the head of the pivot pin. The presence of a dimple indicates that the pin has been swaged properly. In some cases, there may be no dimple, or the dimple may be difficult to see. The absence of a dimple is not necessarily an indication that the pin was not swaged properly. In doubt, do the proof load check in accordance with step 7 of this ASB.

Figure 1 – Hardness check dots and swaging dimple

5. Perform a visual inspection of the pivot pin to verify if it has a swaging dimple in the center of the head of the pivot pin (Figure 1 and 3).
6. If the head of the pivot pin has the swaging dimple, go to step 8.
7. If the pivot pin does not have the swaging dimple, proceed as follows.
 - a. Remove the safety pin and un-latch the bolt handle (Figure 2). Ensure the handle is in a relax position and the bolt can turn freely indicating that the tension has been removed from the collars and the handle.
 - b. Using a rounded rigid object that can fit in the in the concave shank end of the pivot pin (Figure 4), apply hand pressure to attempt pushing out the pivot pin.

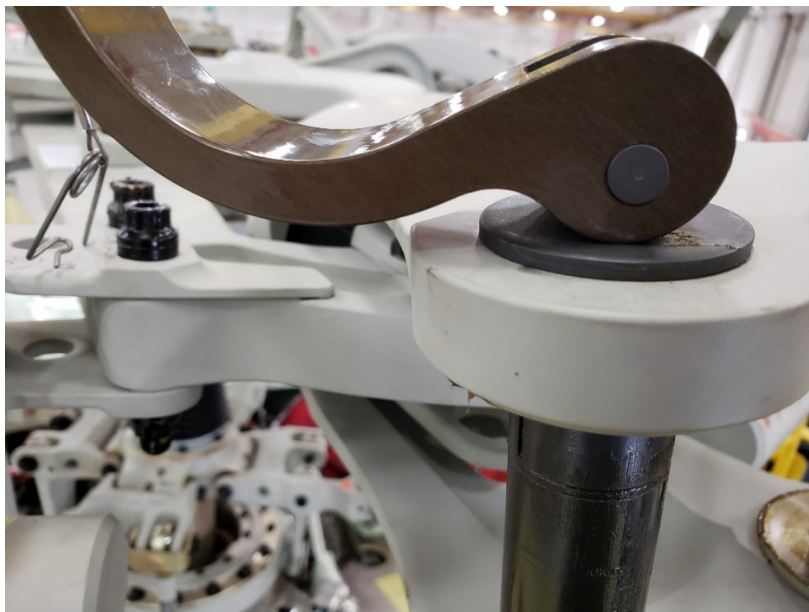
Figure 2 - Blade bolt handle in a relaxed position

8. Make an entry in the helicopter logbook and historical service records indicating findings and compliance with this Alert Service Bulletin.
 9. Remove the safety pin and un-latch the bolt handle (Figure 2). Ensure the handle is in a relaxed position and the bolt can turn freely indicating that the tension has been removed from the collars and the handle.

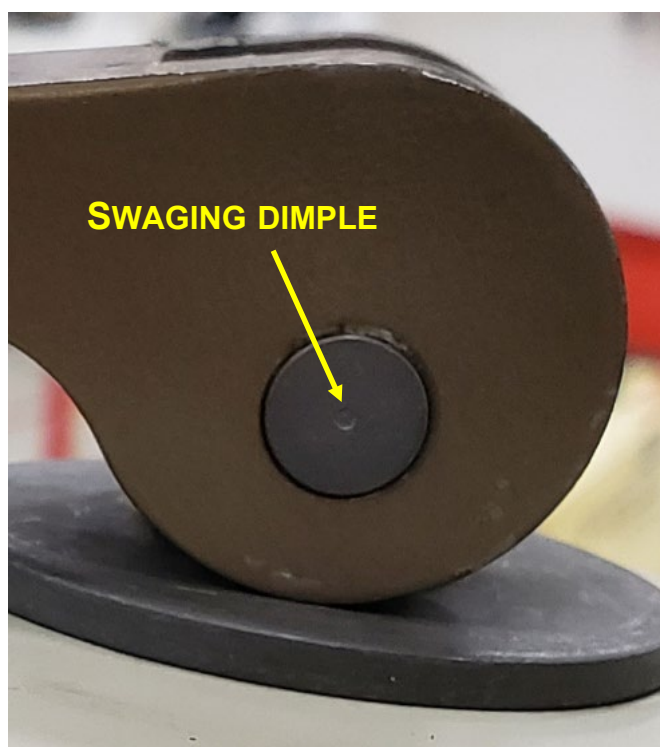
Figure 3 - Swaging dimple

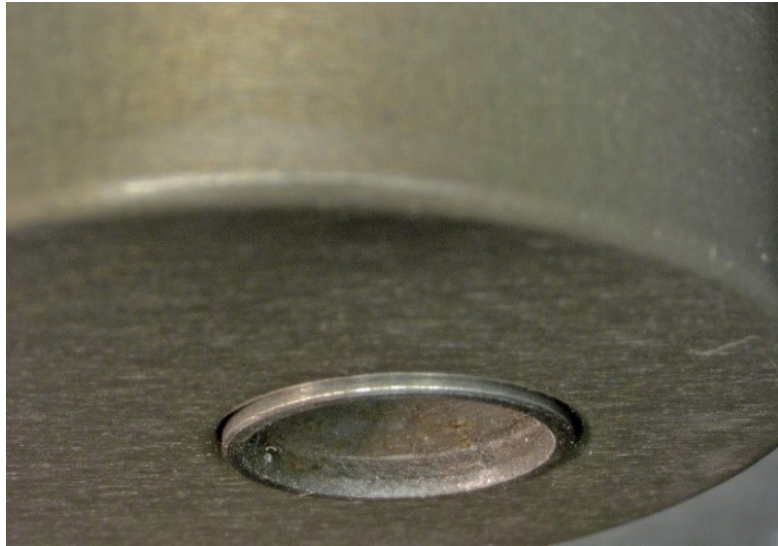
Figure 4 - Pivot Pin Concave End (correctly swaged)

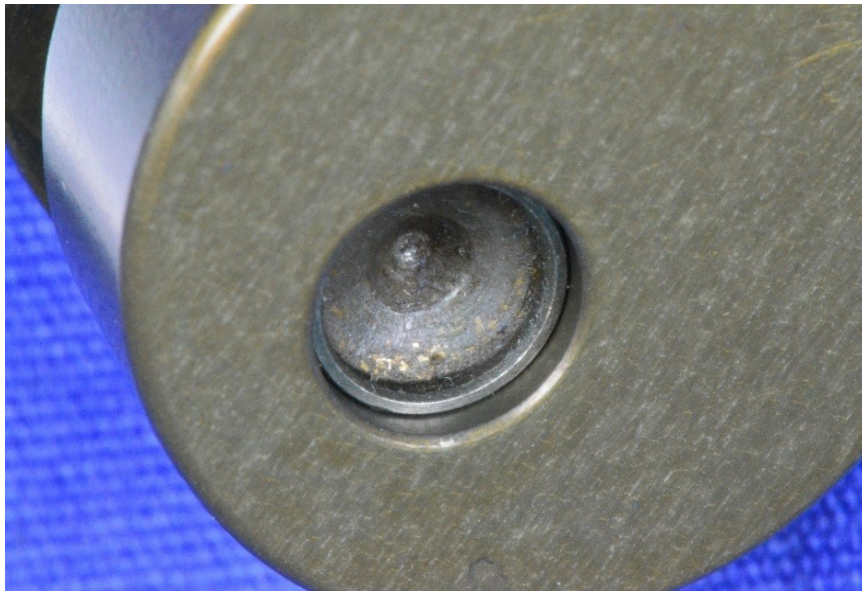
Figure 5 - Pivot Pin Out of Position

- c. If the pivot pin remains in position, re-install and secure the expandable blade bolt (BHT-412-MM). Go to step 8.
 - d. If the pivot pin moves out of position (Figure 5), remove and replace the main rotor expandable blade bolt assembly with a serviceable part that meets the intent of this ASB before next flight.

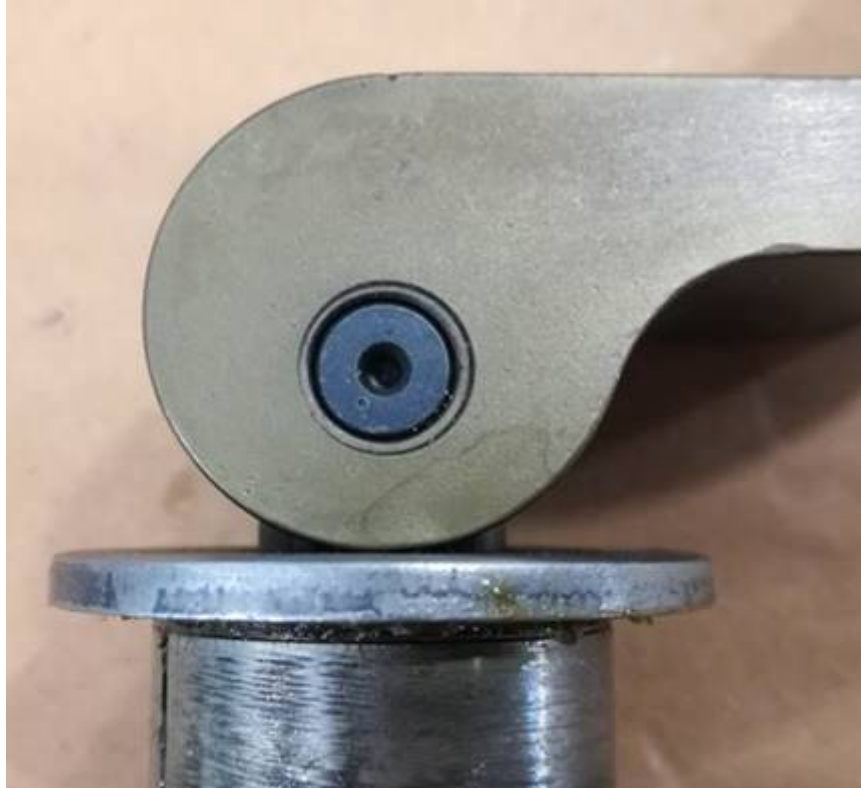
Figure 6 - Earlier Design Expandable Blade Bolt.

After the original release of this bulletin Bell was made aware that the expandable blade bolt pivot pin for bolts manufactured in 1991 and prior was a different design. This earlier design pivot pin was press-fitted with countersunk blind holes at each end for staking. Revision A of this bulletin mandates a visual inspection and a push test of the earlier style pivot pin.

Note: Earlier expandable blade bolts (1991 and prior) had a press-fitted pivot pin with countersink blind holes at each end for staking. To verify proper staking, push on the pin one side at a time.

10. Visually inspect the pivot pin for any sign of movement. Using a rounded rigid object that can fit in the countersunk blind holes of the pivot pin (Figure 6), apply hand pressure in both directions to attempt pushing out the pivot pin.

11. If the pivot pin remains in position, re-install and secure the expandable blade bolt (BHT-412-MM). Go to step 13.
 12. If the pivot pin moves out of position, remove and replace the main rotor expandable blade bolt assembly with a serviceable part that meets the intent of this ASB before next flight.
