## **ALERT SERVICE BULLETIN**

**412-20-184**

**MODEL AFFECTED:** 412EP

**SUBJECT:** CIRCUIT BREAKER PANEL P/N 412-589-101, INSPECTION OF.

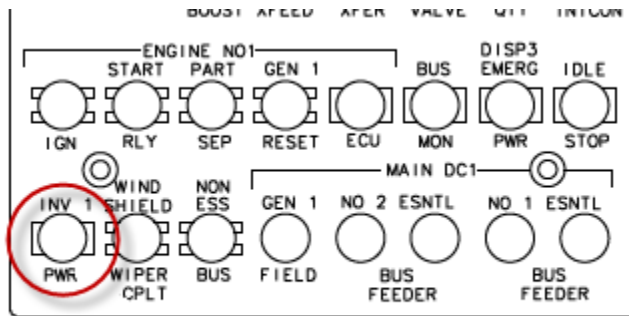
Bell has discovered that some left-hand overhead circuit breaker panel assemblies 412-589-101 may have the inverter number 1 power (INV 1/PWR) bus incorrectly identified. In some cases, the symbol shows the INV 1/PWR as being on the “Essential Bus” while it should show the symbol for the “Emergency Bus”.

1. Prepare the helicopter for maintenance.
2. Disconnect the helicopter battery.
3. Inspect the left-hand circuit breaker panel. The INV 1/PWR circuit breaker should be identified as shown in Figure 1. Figure 2 shows the incorrect bus symbol.

Figure 1 - Correct INV 1/PWR bus symbol.

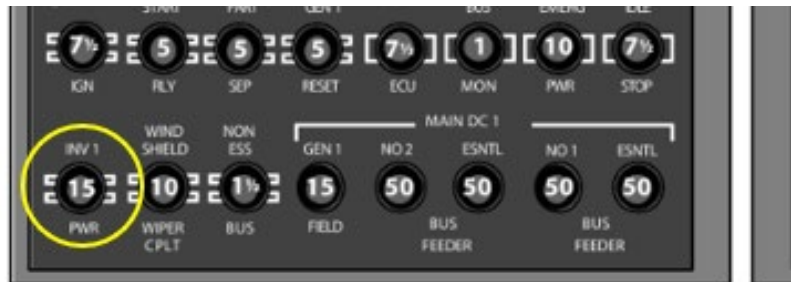
Figure 2 - Incorrect INV 1/PWR bus symbol.

4. If the INV 1/PWR circuit breaker is identified as shown in Figure 1, go to step 10, otherwise proceed with the following steps.
5. Remove mounting screws (2, Figure 3) from circuit breaker panel (1). Retain the screws for future use.

6. Remove the circuit breaker panel (1) by gently pulling downward until it releases from the integrated lighting connector.
7. Install the new circuit breaker panel (1) by gently pushing upward until the integrated lighting connector is engaged.

8. Install the previously removed mounting screws (2) onto the circuit breaker panel (1).
9. Perform the overhead console lights system operational check in accordance with the BHT-412-MM-10.
