ALERT SERVICE BULLETIN

412-21-185

- MODEL AFFECTED:** 412/412EP
- SUBJECT:** TAIL ROTOR DRIVE SHAFT ASSEMBLY 412-040-620-103 INSPECTION AND REMOVAL FROM SERVICE
- HELICOPTERS AFFECTED:** Serial numbers 34025 through 34036, 36020 through 36687, 36689 through 36999, 37002 through 37018, 37021 through 37051 and helicopters with upgrade kit 412-704-052 installed per BHT-412-SI-74 or modified in accordance with drawing 412-570-001 or 412-706-100 (412SP to HP upgrade).

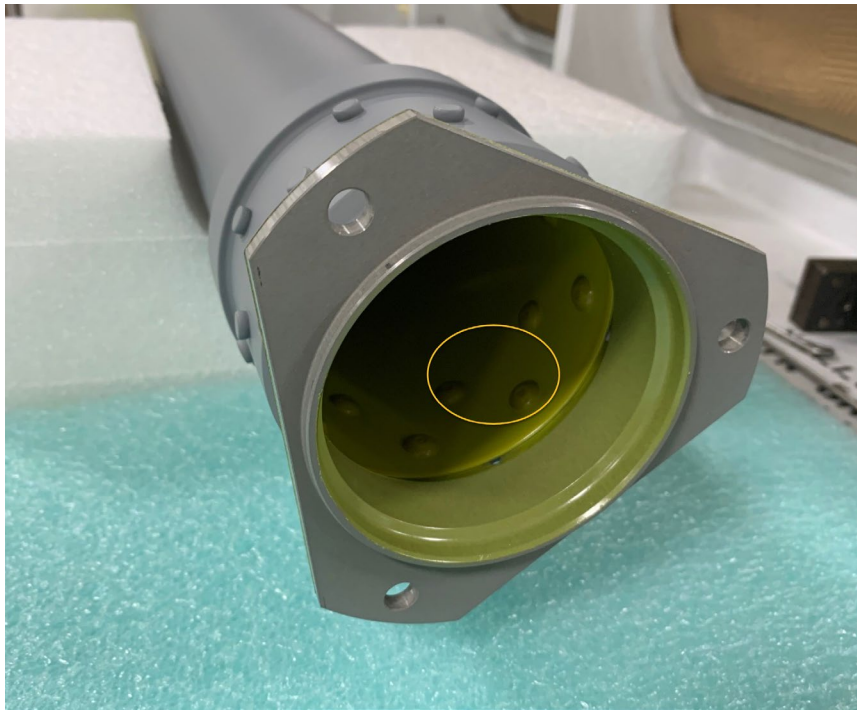
Bell examined a tail rotor drive shaft assembly 412-040-620-103 Serial Number (S/N) A-814 found with severe corrosion on the inside diameter of the drive adapter. The investigation indicates that the root cause of the corrosion damage was a lack of primer applied to the faying surfaces of the shaft outside diameter and the drive adapter inside diameter. The tail rotor drive shaft assembly serial numbers listed in the "PARTS AFFECTED" section of this bulletin and the drive shaft assembly found with the corrosion were part of the same manufacturing lot. These tail rotor drive shaft assemblies were manufactured in the 1999 timeframe and may have been sold as spares or installed on a helicopter at delivery.

- b. Remove the drive shaft assembly (Maintenance Manual, Chapter 65) and inspect the inside diameter of the drive shaft assembly at both ends for any evidence of corrosion. Figure 2 shows the location where the corrosion was found on the drive shaft assembly serial number A-814.

Figure 2. Location of corrosion on shaft assembly S/N A-814

- c. If corrosion is found, contact Product Support Engineering for disposition.
 - d. If no corrosion is found, accomplish PART 2 immediately or re-install the drive shaft assembly (Maintenance Manual Chapter 65) and accomplish Part 2 within the timeframe stated in the "COMPLIANCE" section of this bulletin.

1. Prepare the helicopter for maintenance and gain access to the drive shaft assembly 412-040-620-103 by opening the vertical fin drive shaft cover and removing the intermediate gearbox cover.
2. Remove and replace the drive shaft assembly with a serviceable drive shaft assembly (Maintenance Manual, Chapter 65). Send the affected drive shaft to Bell as instructed in the "Warranty" section.
3. Make an entry in the helicopter logbook and historical service records indicating compliance with this Alert Service Bulletin.
