ALERT SERVICE BULLETIN

412-23-192

MODEL AFFECTED: 412EP

SUBJECT: WIRE HARNESS INSTALLATION, MODIFICATION OF.

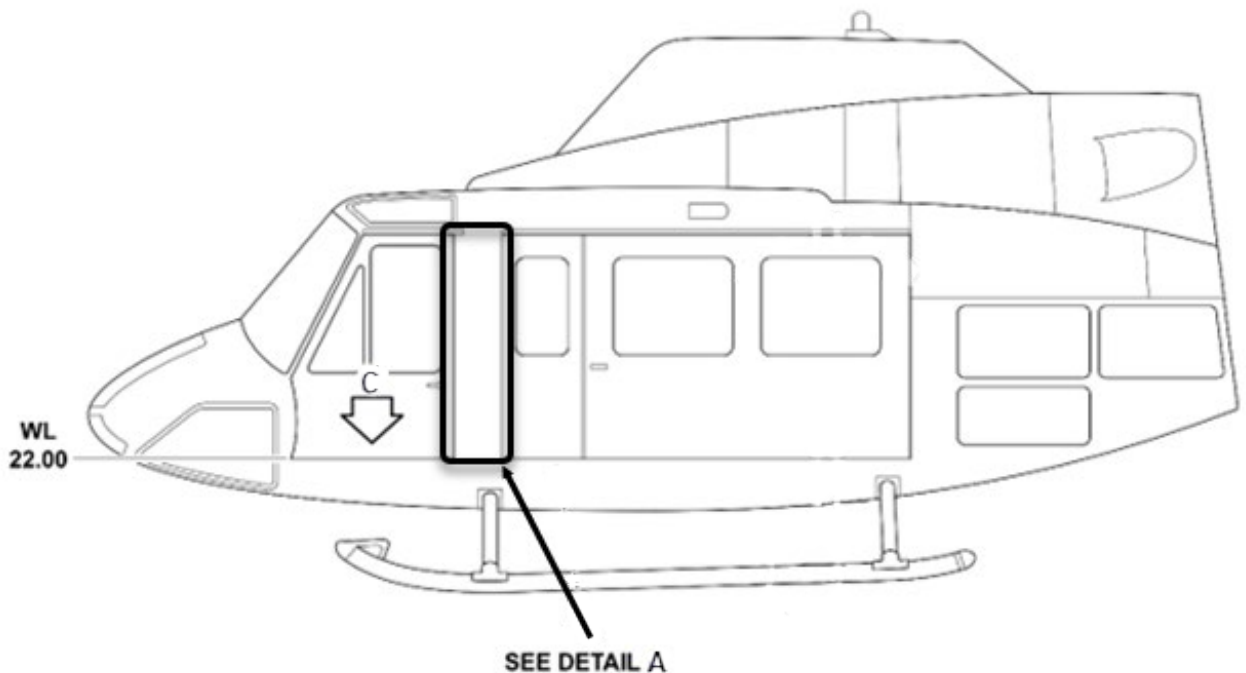
Figure 1 (Sheet 1 of 3) Location of possible low clearance or fouling condition.

Bell has discovered a possible wire chafing conditions for the items describe herein. For the affected helicopters due to an incorrect installation, there is a potential wire chafing condition in the left-hand door post at water line (WL) 38.60. Helicopters equipped with the Emergency Float retrofit Kit 412-704-138-101 (BHT-412-SI-108) may also have a wire chafing condition below the floor (WL 22.0) at STA 52.0 and STA 63.3.

1. Prepare the helicopter for maintenance.
2. Refer to Figure 1, Detail A and View B, gain access to clamping arrangement in the left-hand door post at Water Line (WL) 38.60.
3. Inspect the wire harness (412-079-711) in the left-hand door post at WL 38.60 (View B) clamping arrangement for chafing damage with the structure.
4. Refer to Figure 1, View C, View D and View E, gain access to clamping arrangement below the floor (WL 22.0) at STA 52.0 and STA 63.3.
5. Inspect the wire harnesses (412-079-711 and 412-079-713) below the floor (WL 22.0) at STA 52.0 and 63.3 (View D and View E) clamping arrangement for chafing damage with the structure (lightening holes).

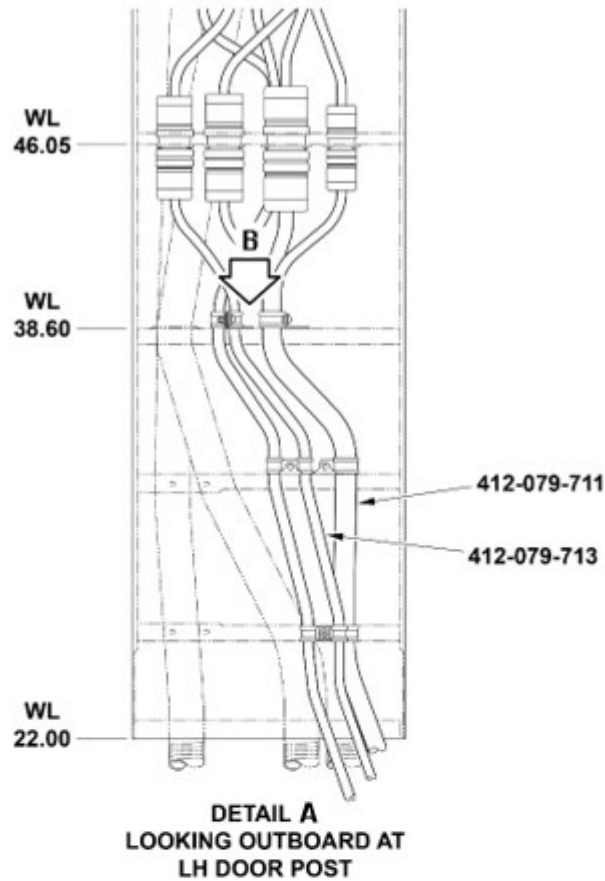
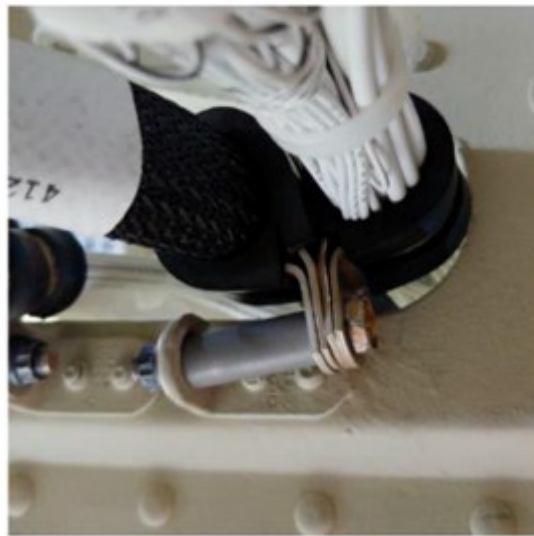
Figure 1 (sheet 2 of 3) Location of possible low clearance or fouling condition at the left door post.

VIEW B
LOOKING DOWN AT
WL 38.60

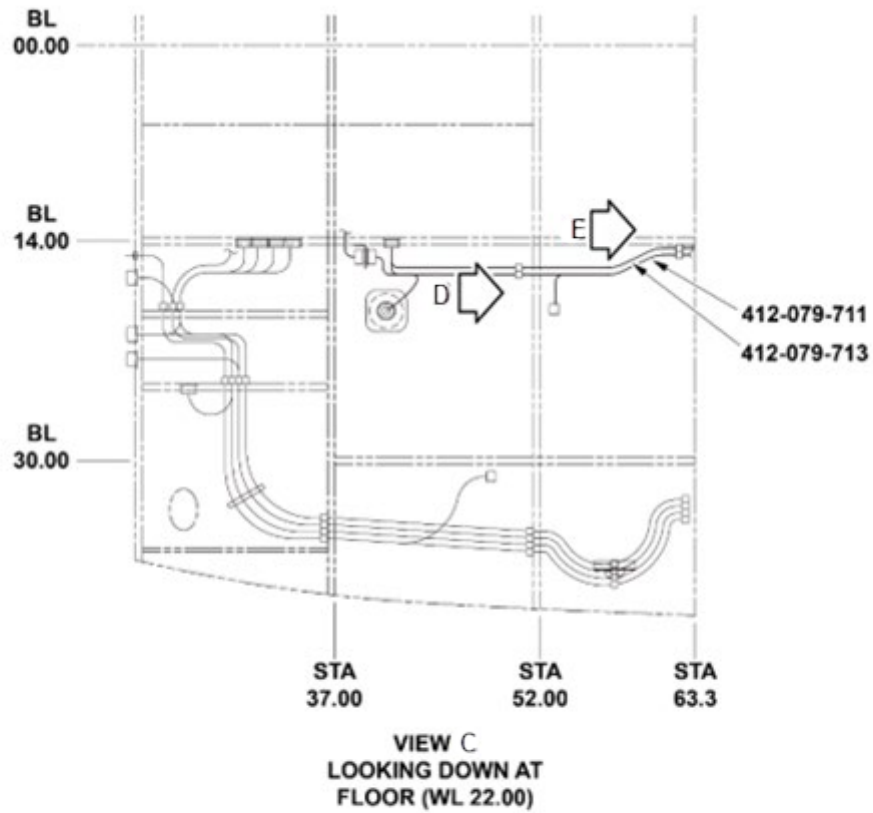
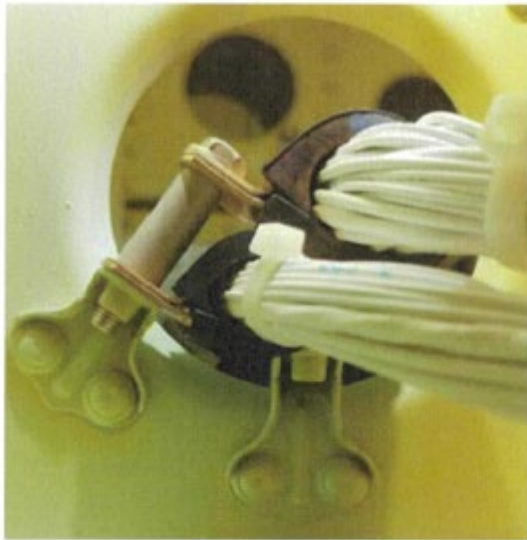
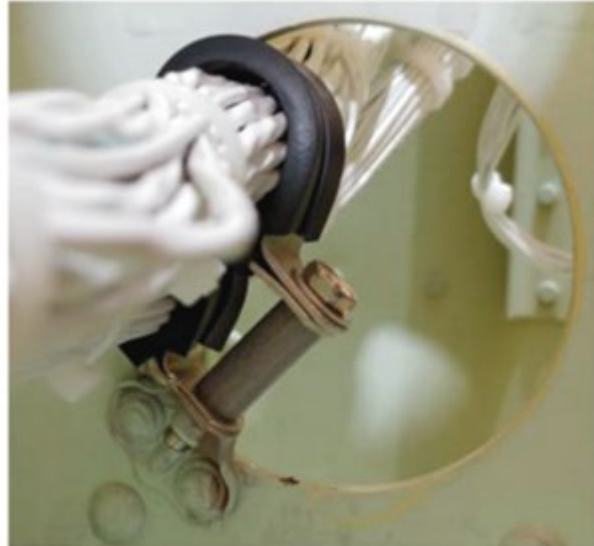
Figure 1 (sheet 3 of 3) Location of possible low clearance or fouling condition at STA 52.00 and STA 63.3

VIEW D
LOOKING AFT AT
STA 52.00

VIEW E
LOOKING AFT AT
STA 63.3
