ALERT SERVICE BULLETIN

412CF-14-56

MODEL AFFECTED: 412CF

SUBJECT: MAIN ROTOR DRIVE, ENGINE-TO-TRANSMISSION DRIVE SHAFT RETAINING NUTS REPLACEMENT OF.

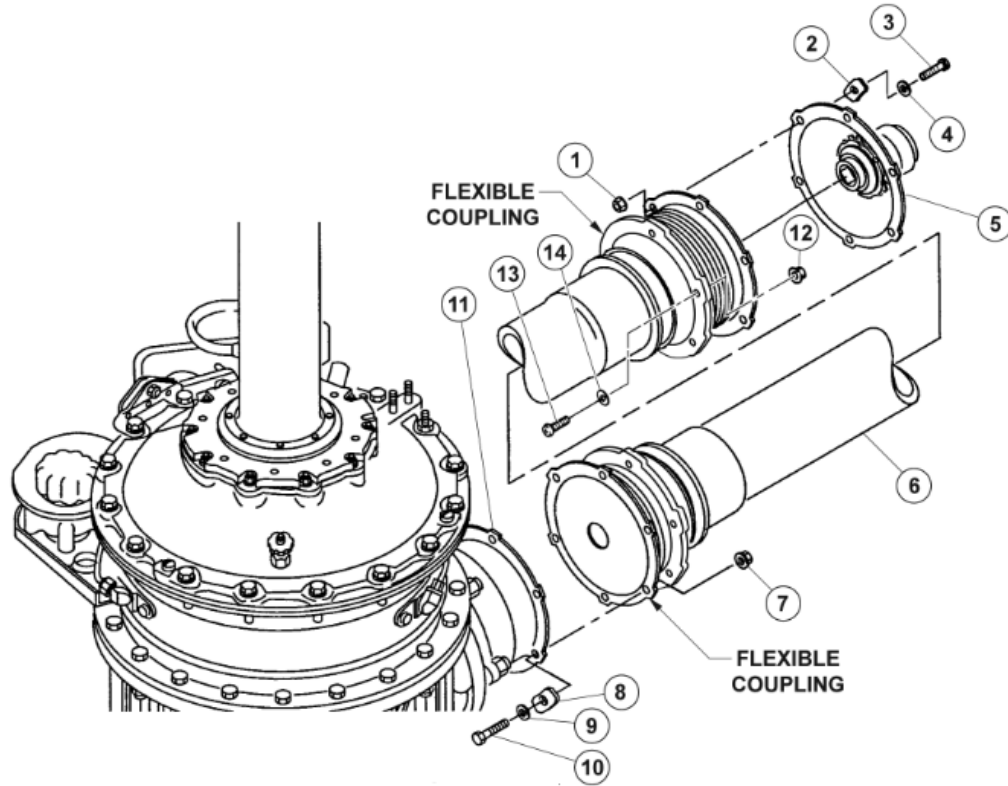
Figure 1. Main drive shaft attaching nuts.

An occurrence reported to the European Aviation Safety Agency (EASA) indicating that two nuts (P/N MS21042) attaching the flexible coupling to the coupling drive adapter of the main driveshaft were found cracked during a scheduled inspection.

If left undetected, this condition could lead to an unsecure loss of attachment between the drive shaft coupling and the drive adapter. In an extreme case; if all attaching nuts were found cracked, a loss of transmission drive from the engine and reduced ability to control the helicopter could occur. As a result of this reported occurrence, EASA released the Emergency Airworthiness Directive 2014-0118-E.

1. Gain access to the main drive shaft and replace the currently installed main drive shaft and main drive shaft attaching MS21042L4 or NAS9926-4L nuts (Figure 1, items 1, 7 and 12) with nuts P/N 90-132L4 (C-12-146-000/MF-001).
2. Make an entry in the helicopter logbook and historical service records indicating compliance with this Alert Service Bulletin Revision B.
