ALERT SERVICE BULLETIN

412CF-20-68

MODEL AFFECTED: 412CF

SUBJECT: MAIN ROTOR EXPANDABLE BLADE BOLT 412-010-137-103, ONE-TIME INSPECTION OF.

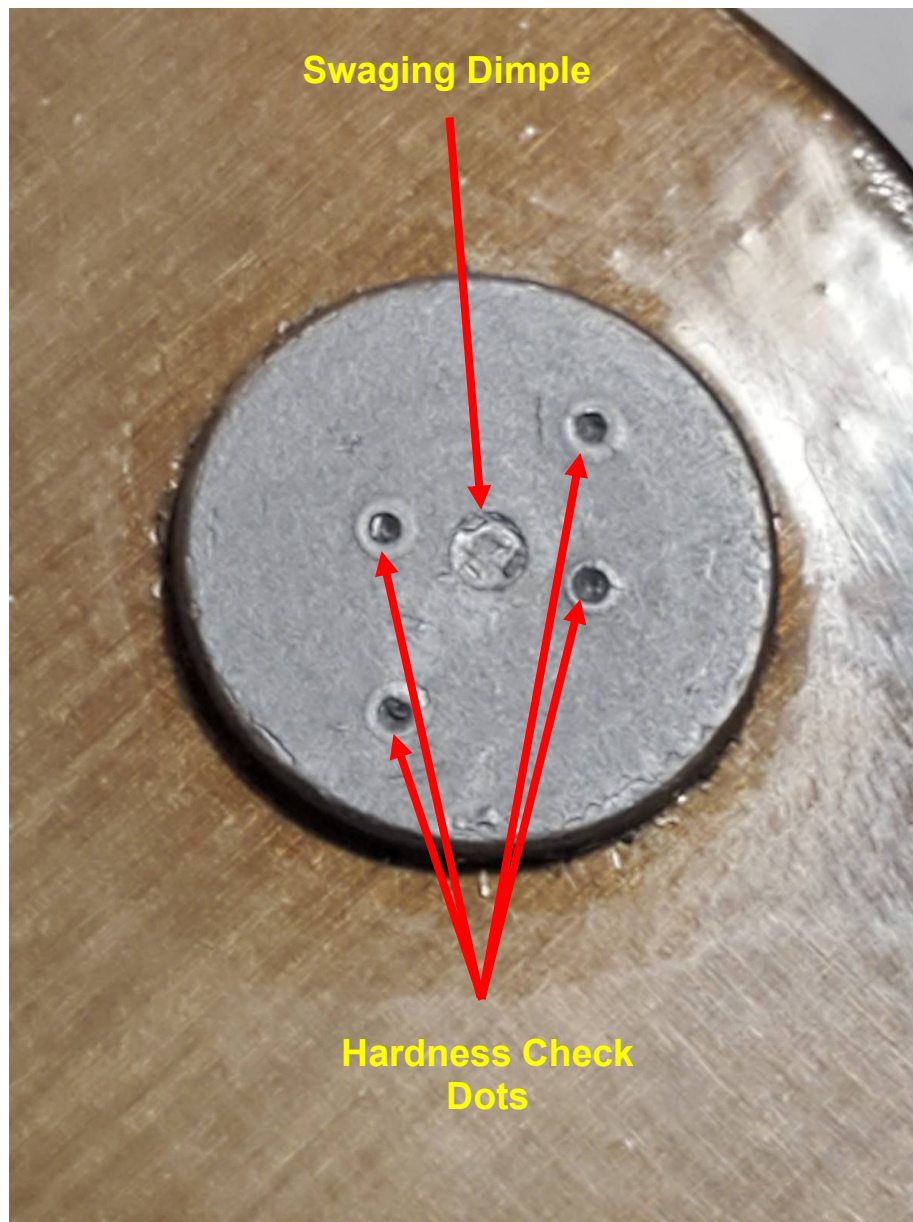
Some pivot pins may have one or more hardness check dots on the head (Figure 1). These should not be confused with the swaging dimple that should be in the center of the head of the pivot pin. The presence of a dimple indicates that the pin has been swaged properly. In some cases, there may be no dimple, or the dimple may be difficult to see. The absence of a dimple is not necessarily an indication that the pin was not swaged properly. In doubt, do the proof load check in accordance with step 7 of this ASB.

Figure 1 – Hardness check dots and swaging dimple

5. Perform a visual inspection of the pivot pin to verify if it has a swaging dimple in the center of the head of the pivot pin (Figure 1 and 3).
6. If the head of the pivot pin has the swaging dimple, go to step 8.

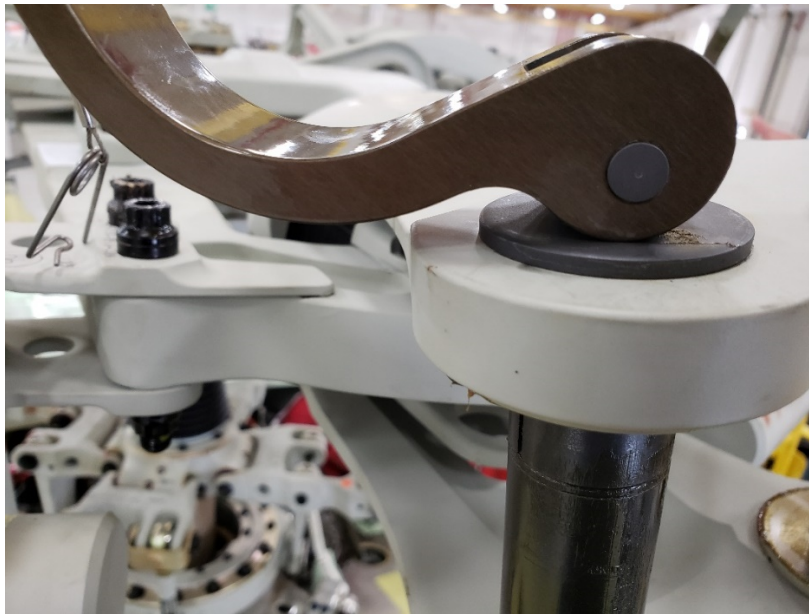
Figure 2 - Blade bolt handle in a relax position

7. If the pivot pin does not have the swaging dimple, proceed as follows.
 - a. Remove the safety pin and un-latch the bolt handle (Figure 2). Ensure the handle is in a relax position and the bolt can turn freely indicating that the tension has been removed from the collars and the handle.

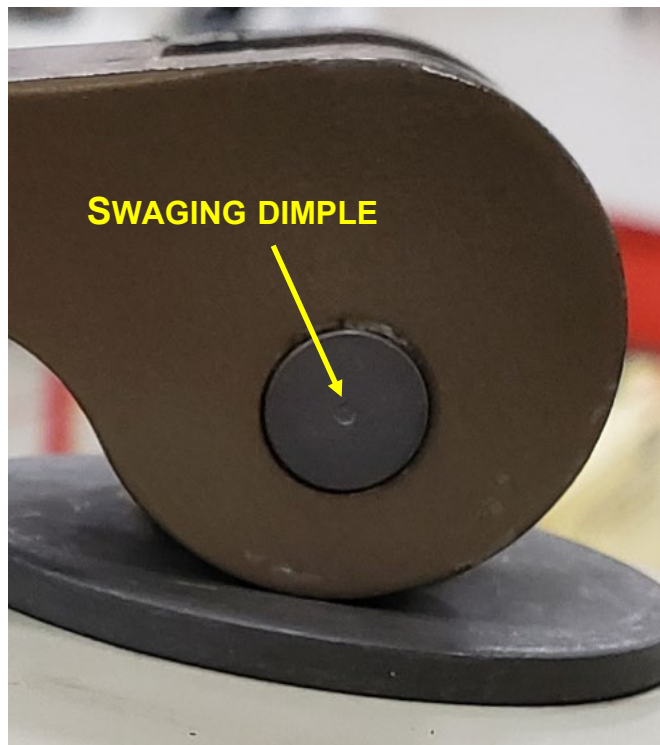
Figure 3 - Swaging dimple

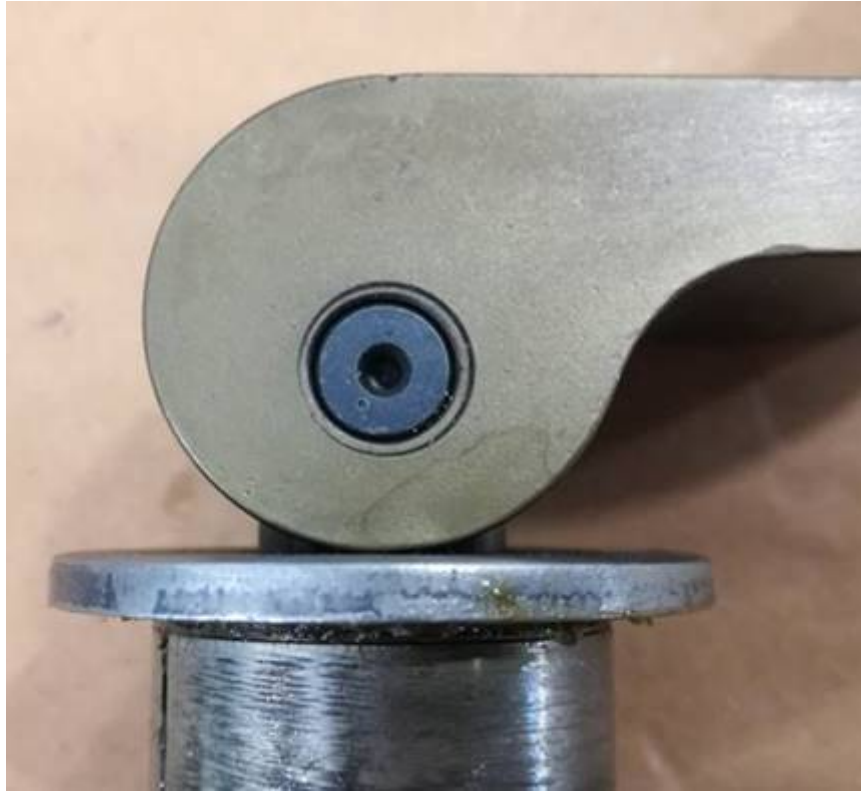
Figure 6 - Earlier Design Expandable Blade Bolt.

After the original release of this bulletin Bell was made aware that the expandable blade bolt pivot pin for bolts manufactured in 1991 and prior was a different design. This earlier design pivot pin was press-fitted with countersunk blind holes at each end for staking. Revision A of this bulletin mandates a visual inspection and a push test of the earlier style pivot pin.

Note: Earlier expandable blade bolts (1991 and prior) had a press-fitted pivot pin with countersink blind holes at each end for staking. To verify proper staking, push on the pin one side at a time.

10. Visually inspect the pivot pin for any sign of movement. Using a rounded rigid object that can fit in the countersunk blind holes of the pivot pin (Figure 6), apply hand pressure in both directions to attempt pushing out the pivot pin.

11. If the pivot pin remains in position, re-install and secure the expandable blade bolt (BHT-412-MM). Go to step 13.
12. If the pivot pin moves out of position, remove and replace the main rotor expandable blade bolt assembly with a serviceable part that meets the intent of this ASB before next flight.
13. Make an entry in the helicopter logbook and historical service records indicating findings and compliance with the revision A of this Alert Service Bulletin.
