ALERT SERVICE BULLETIN

412CF-21-71

MODEL AFFECTED: 412CF

SUBJECT: TAIL ROTOR DRIVE SHAFT ASSEMBLY 412-040-620-103 INSPECTION AND REMOVAL FROM SERVICE

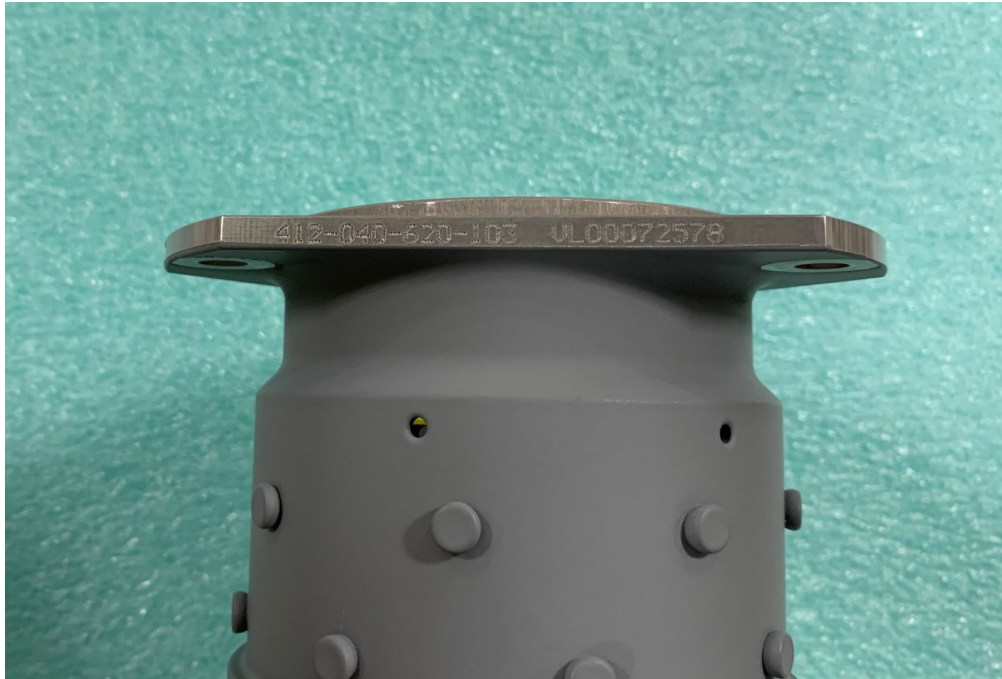
3. Verify the serial number of the tail rotor drive shaft assembly installed on the helicopter. The drive shaft assembly part number and serial number are located on the flange of the drive adapter attached to the intermediate gearbox (refer to Figure 1)

Figure 1. Location of part and serial numbers

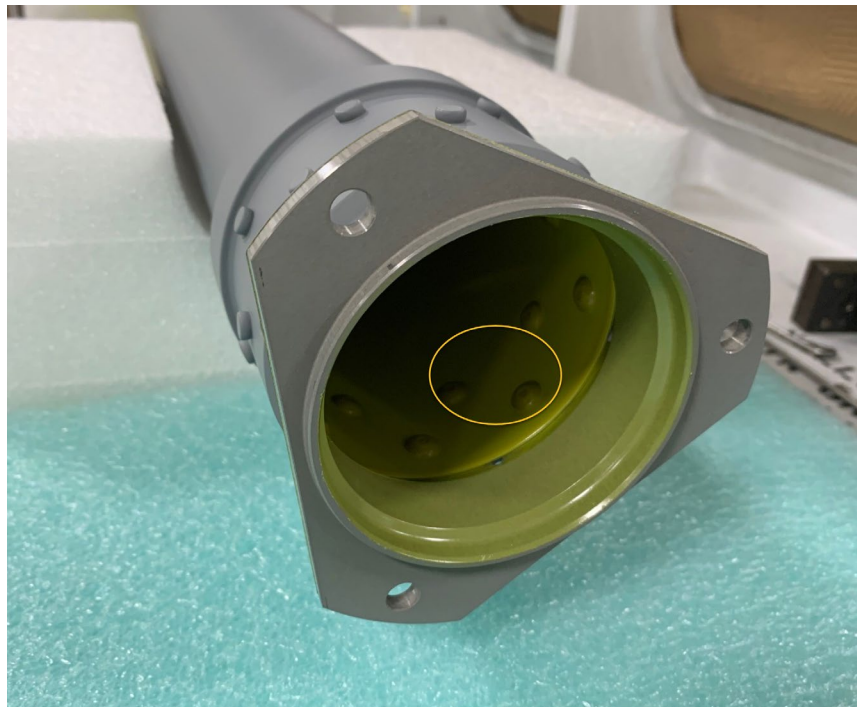
Bell examined a tail rotor drive shaft assembly 412-040-620-103 Serial Number (S/N) A-814 found with severe corrosion on the inside diameter of the drive adapter. The investigation indicates that the root cause of the corrosion damage was a lack of primer applied to the faying surfaces of the shaft outside diameter and the drive adapter inside diameter. The tail rotor drive shaft assembly serial numbers listed in the "PARTS AFFECTED" section of this bulletin and the drive shaft assembly found with the corrosion were part of the same manufacturing lot. These tail rotor drive shaft assemblies were manufactured in the 1999 timeframe and may have been sold as spares or installed on a helicopter at delivery.

- b. Remove the drive shaft assembly (Maintenance Manual, Chapter 65) and inspect the inside diameter of the drive shaft assembly at both ends for any evidence of corrosion. Figure 2 shows the location where the corrosion was found on the drive shaft assembly serial number A-814.

Figure 2. Location of corrosion on shaft assembly S/N A-814

Although this manufacturing defect is considered an isolated case, as a precautionary measure, this bulletin mandates the removal from service of the affected tail rotor drive shaft assembly serial numbers.

- c. If corrosion is found, contact Product Support Engineering for disposition.
