ALERT SERVICE BULLETIN

412RSAF-24-53

MODEL AFFECTED: 412RSAF

SUBJECT: CAP ANGLE, P/N 212-030-191-001, INSPECTION INTERVAL, REDUCTION OF.

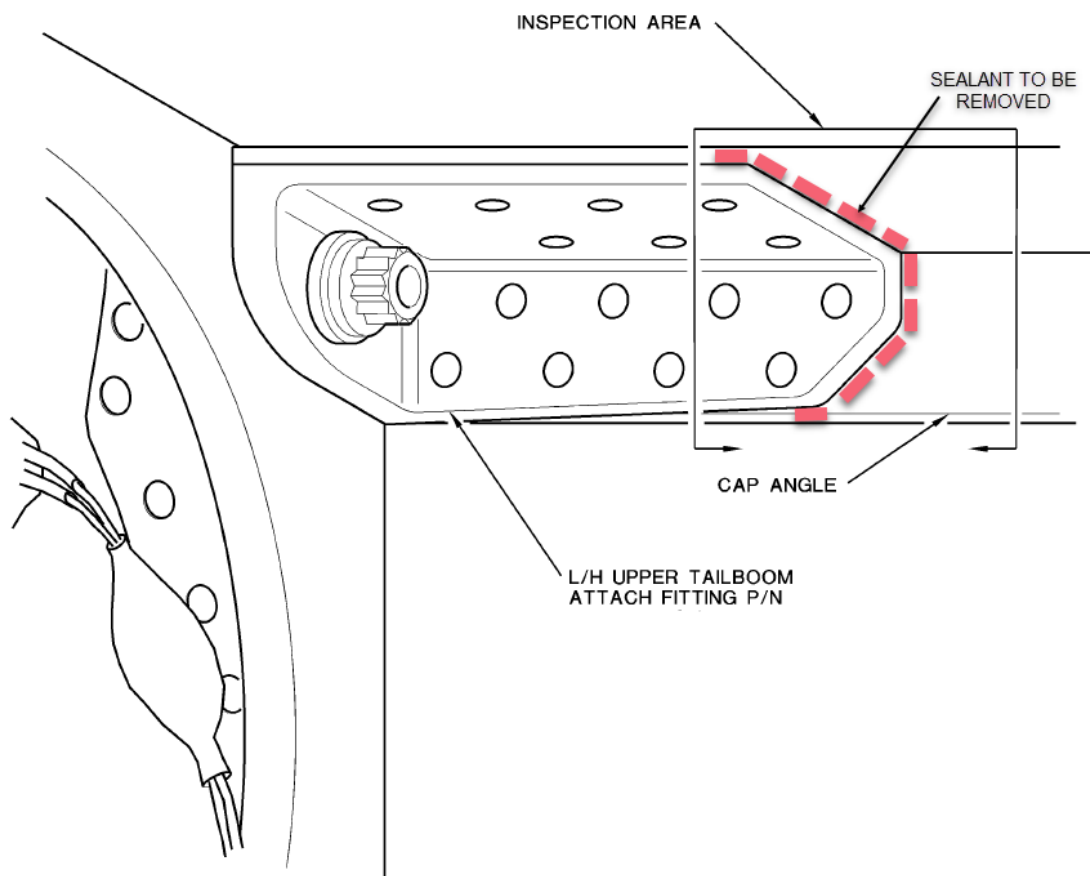
Figure1. Fuselage Tailboom Attachment Inspection.

Bell has investigated reports of fractured 212-030-191-001 cap angles. Some were found during routine inspection and some during the scheduled 100 Hours Tailboom Attachment Inspection. The investigation indicates that the model 412/412EP 100 flight hour Special Inspection interval established in 2000, introduced by the ASB 412-00-100 and the FAA AD 2000-18-09, is not adequate to detect all cracks before complete fracture of the cap angle. Back in 2000, since the model 412RSAF was not yet in service, no ASB was released. The tailboom attachment inspection was subsequently added to the Maintenance Manual Chapter 5 as a 25 Hour/30 Day inspection to be accomplished every fourth 25 Hour/30 Day inspection. This ASB changes the 25 Hour/30 Day

2. If sealant is present, remove sealant from edge of fitting (Figure 1).
3. Inspect the cap angle area shown with a 10x magnifying glass and bright light.
4. If a crack is found, replace the cap angle before further flight. If the helicopter is at a location where the cap angle cannot be replaced, contact Product Support Engineering.
5. Touch up primer if damaged during sealant removal. Paint touch up is optional. Do not reapply sealant.
6. If no cracks are found, the helicopter can be returned to service.
7. Make an entry in the helicopter logbook and historical service records indicating findings and compliance with this Alert Service Bulletin.
