ALERT SERVICE BULLETIN

427-21-44

Revision A, 6 April 2021

- MODEL AFFECTED:** 427
- SUBJECT:** TRANSMISSION OIL CHECK VALVE 209-062-520-001, INSPECTION AND REPLACEMENT OF.
- HELICOPTERS AFFECTED:** Serial numbers 56001 through 56084, 58001, and 58002.
- COMPLIANCE:**
- Part I:** Within the next 25 flight hours or 30 days, whichever comes first after the release date of this bulletin.
- Part II:** Within the next 25 flight hours or 30 days, whichever comes first after accomplishment of **Part I** and every 25 flight hours or 30 days thereafter until **Part III** is accomplished.
- Part III:** No later than 600 flight hours or 12 months, whichever comes first after accomplishment of **Part I**.

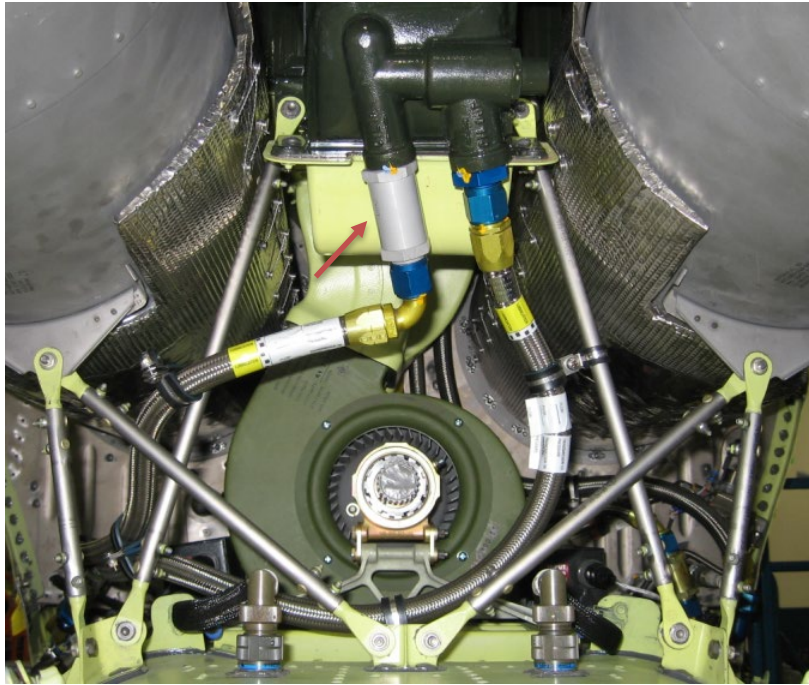
Transmission oil check valve and location
Detail A

1. Prepare the helicopter for maintenance and gain access to the transmission oil check valve. The transmission oil check valve is located on the transmission oil cooler (Figure 1, Details A).

1. Prepare the helicopter for maintenance and gain access to the transmission oil check valve (Figure 1, Detail A).
2. Replace the affected transmission oil check valve (BHT-427-MM, Chapter 79).
3. Make an entry in the helicopter logbook and historical service records indicating compliance with **Part III** of this Alert Service Bulletin.

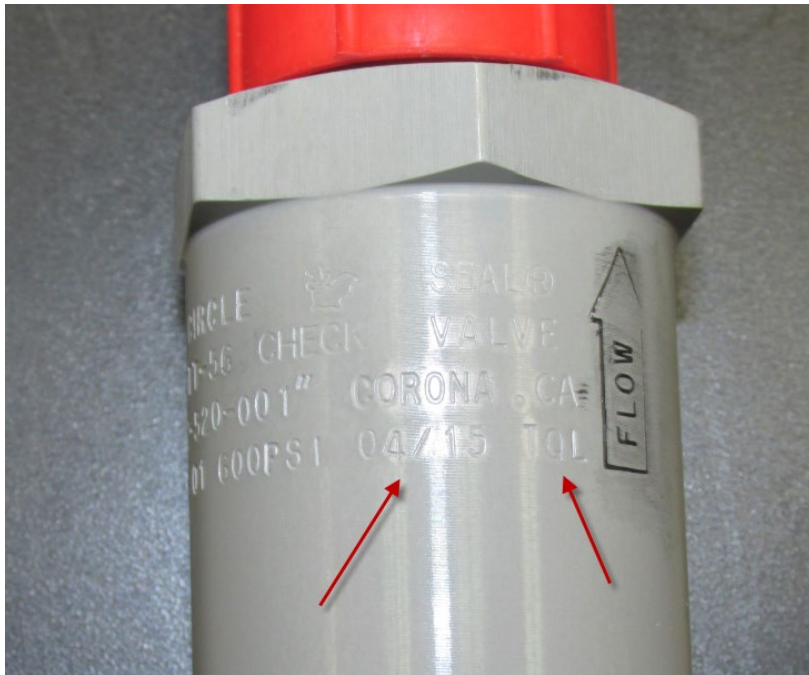
Circor Aerospace Oil Check Valve Marked "TQL"
Detail B

It is not necessary to remove the transmission oil check valve for inspection; however, some clamping may require removal for better access. Regardless of the manufacturing date, any transmission oil check valves with the "TQL" marking are not affected by this bulletin. Oil check valves manufactured by other suppliers are also not affected by this bulletin. Transmission oil check valves with the "CORONA CA" marking and without the "TQL" marking are affected by this bulletin. (Figure 1, Detail B).

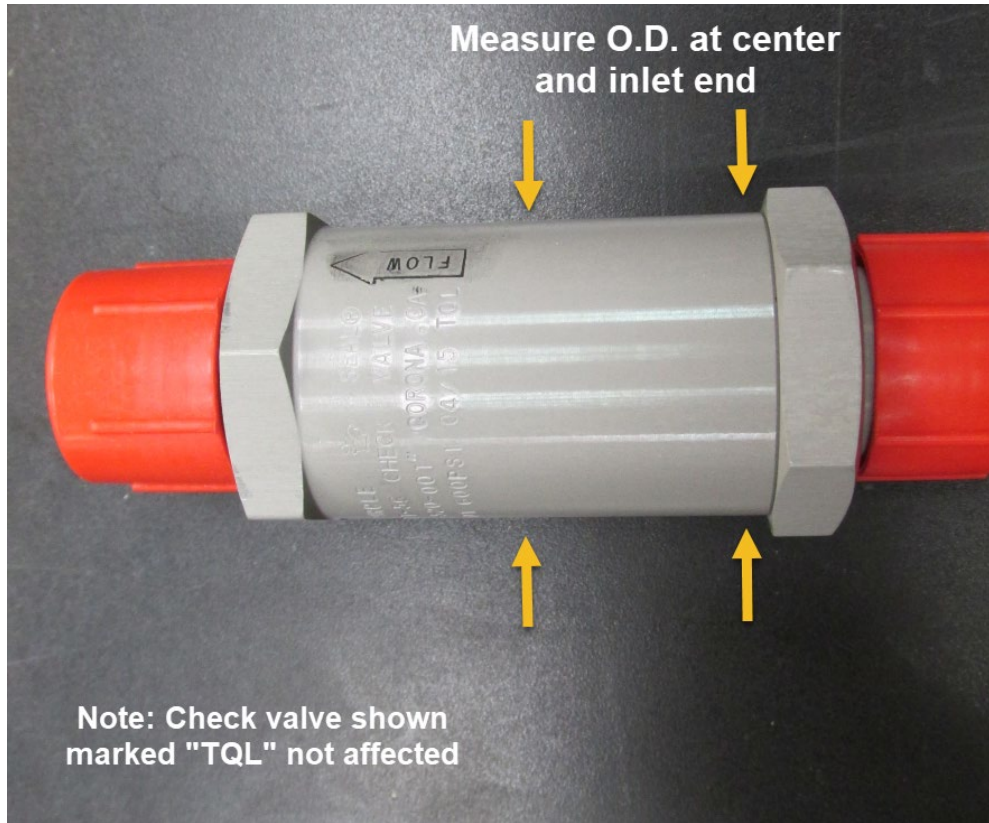
Figure 2. Transmission Oil Check Valve Outside Diameter Measurement

2. Verify if the installed check valve is affected by this bulletin.
3. If the check valve is not affected, go to step 5.
4. If the check valve is affected, proceed as follows:
 - a. Using a caliper or equivalent, measure the check valve housing at the center and record the dimension (Figure 2).
 - b. Measure the housing at the inlet end where the threaded fitting is installed and record the dimension.
 - c. If the dimension measured at the inlet end is no more than 0.003 inch (0.0762 mm) greater than the measurement at the center, the valve is serviceable and does not require accomplishment of **Part II** or **Part III** of this bulletin. Go to step 5.

- d. If the dimension measured at the inlet end is greater than 0.003 inch (0.0762 mm) when compared to the measurement at the center, the valve will require replacement. **Part III** can be accomplished immediately, or **Part II** can be accomplished until the affected check valve can be replaced in accordance with **Part III**.
- e. If the defective check valve is not replaced immediately, **Part II** must be accomplished every 25 flight hours or 30 days, whichever comes first, until **Part III** is accomplished.

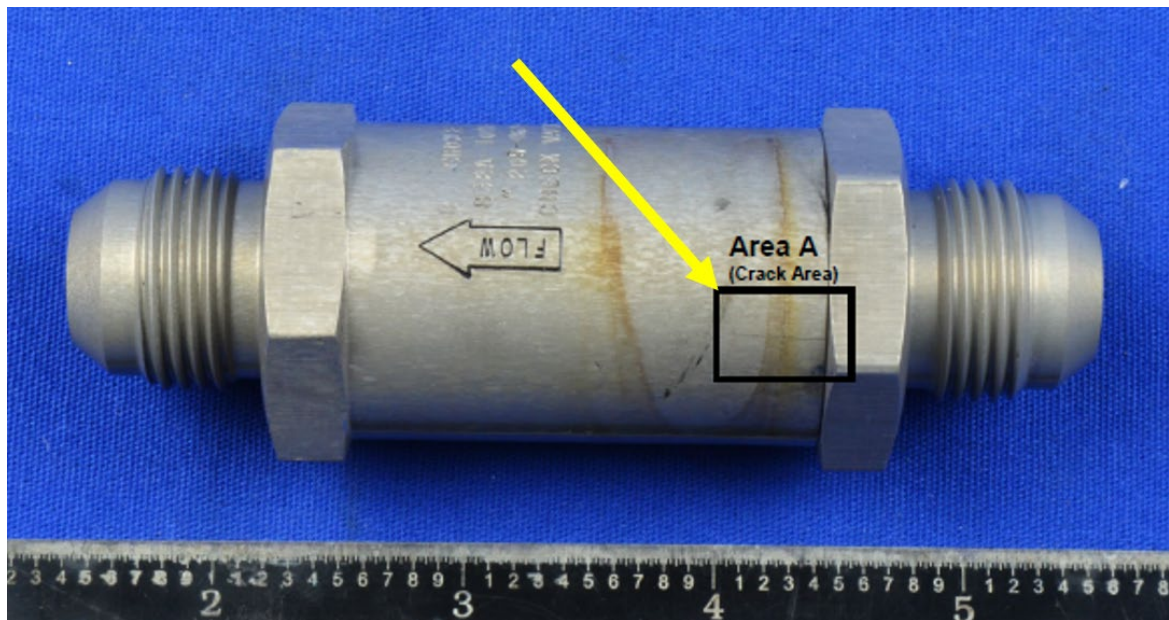
Figure 3. Cracked Oil Check Valve

A recent check valve cracking report indicates that additional oil check valves 209-062-520-001 manufactured by Circor Aerospace (Circle Seal) not having the "TQL" marking may be susceptible to cracking with time in service.

3. If a crack is found, perform, **Part III** of this bulletin prior to next flight. Figure 3 shows an example of a cracked check valve.
4. If no cracks or any other defects that would cause the check valve to be unserviceable are found, go to step 5.
