ALERT SERVICE BULLETIN

427-21-44

MODEL AFFECTED: 427

SUBJECT: TRANSMISSION OIL CHECK VALVE 209-062-520-001, INSPECTION AND REPLACEMENT OF.

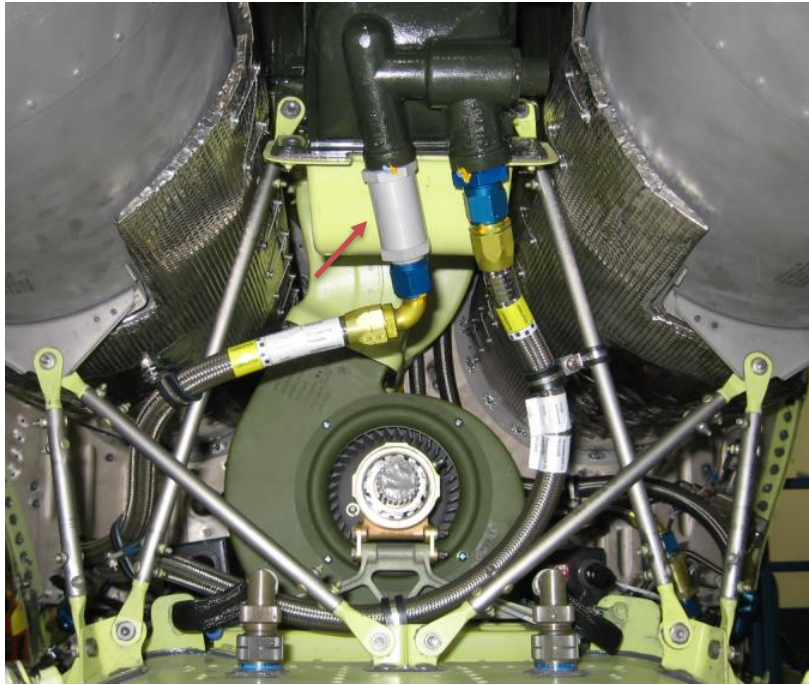
Transmission oil check valve and location
Detail A

1. Prepare the helicopter for maintenance and gain access to the transmission oil check valve. The transmission oil check valve is located on the transmission oil cooler (Figure 1, Details A).

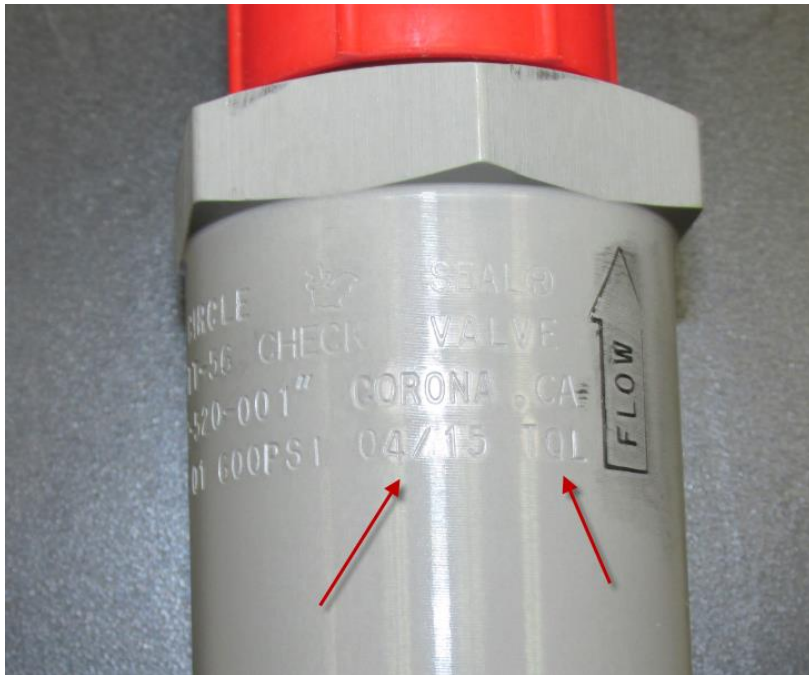
Circor Aerospace Oil Check Valve Marked "TQL"
Detail B

It is not necessary to remove the transmission oil check valve for inspection; however, some clamping may require removal for better access. Regardless of the manufacturing date, any transmission oil check valves with the "TQL" marking are not affected by this bulletin. Oil check valves manufactured by other suppliers are also not affected by this bulletin. Transmission oil check valves with the "CORONA CA" marking and without the "TQL" marking are affected by this bulletin. (Figure 1, Detail B).

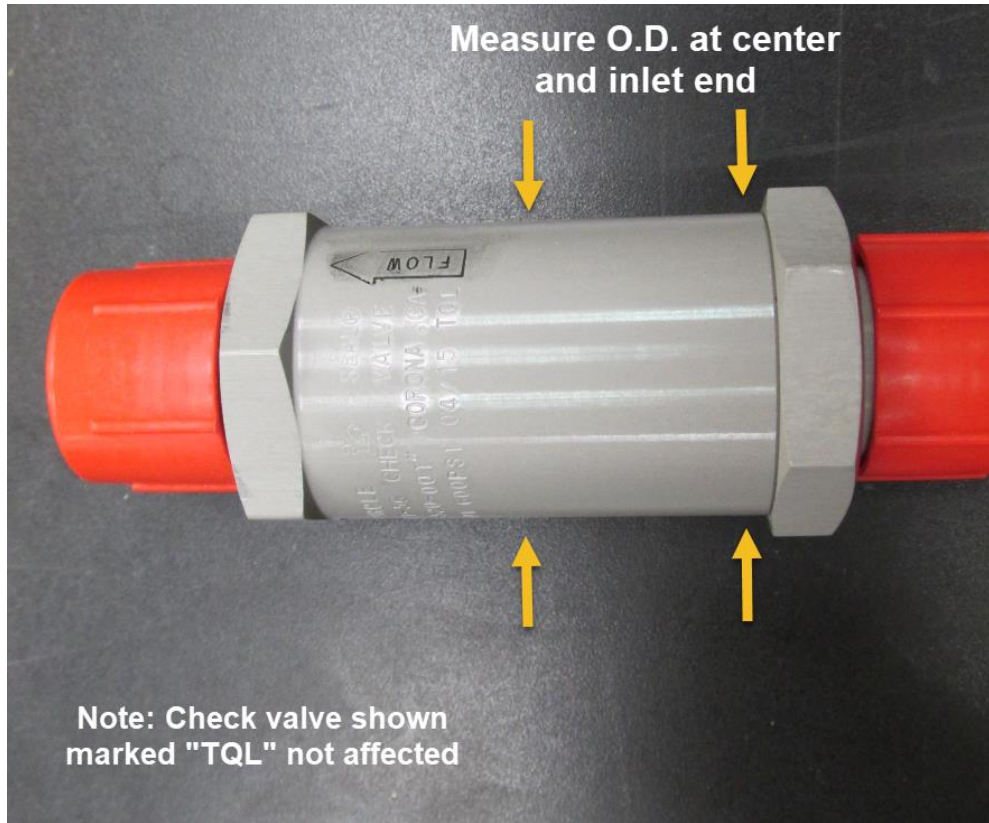
Figure 2. Transmission Oil Check Valve Outside Diameter Measurement

2. Verify if the installed check valve is affected by this bulletin.
3. If the check valve is not affected, go to step 5.
4. If the check valve is affected, proceed as follows:
 - a. Using a caliper or equivalent, measure the check valve housing at the center and record the dimension (Figure 2).
 - b. Measure the housing at the inlet end where the threaded fitting is installed and record the dimension.
 - c. If the dimension measured at the inlet end is no more than 0.003 inch (0.0762 mm) greater than the measurement at the center, the valve is serviceable and does not require accomplishment of **Part II** or **Part III** of this bulletin. Go to step 5.

- d. If the dimension measured at the inlet end is greater than 0.003 inch (0.0762 mm) when compared to the measurement at the center, the valve will require replacement. **Part III** can be accomplished immediately, or **Part II** can be accomplished until the affected check valve can be replaced in accordance with **Part III**.
- e. If the defective check valve is not replaced immediately, **Part II** must be accomplished every 25 flight hours or 30 days, whichever comes first, until **Part III** is accomplished.

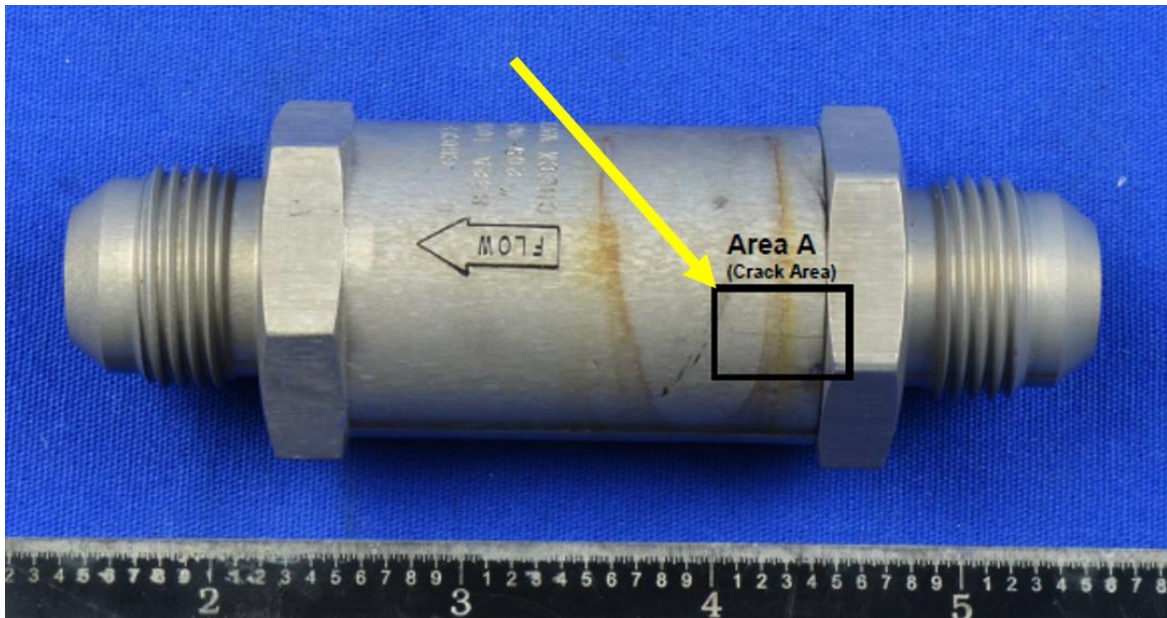
Figure 3. Cracked Oil Check Valve

1. Prepare the helicopter for maintenance and gain access to the transmission oil check valve (Figure 1, Details A).
2. Using a strong light source, visually inspect the transmission oil check valve for general condition and oil leaks. Inspect for cracks at the inlet end where the threaded fitting is installed (Figure 2).

3. If a crack is found, perform, **Part III** of this bulletin prior to next flight. Figure 3 shows an example of a cracked check valve.
4. If no cracks or any other defects that would cause the check valve to be unserviceable are found, go to step 5.

1. Prepare the helicopter for maintenance and gain access to the transmission oil check valve (Figure 1, Detail A).
2. Replace the affected transmission oil check valve (BHT-427-MM, Chapter 79).
3. Make an entry in the helicopter logbook and historical service records indicating compliance with **Part III** of this Alert Service Bulletin.
