ALERT SERVICE BULLETIN

427-21-45

MODEL AFFECTED: 427

SUBJECT: MAIN ROTOR PITCH LINK ASSEMBLY 406-010-413-125/-141, INSPECTION AND APPLICATION OF TORQUE SEAL LACQUER.

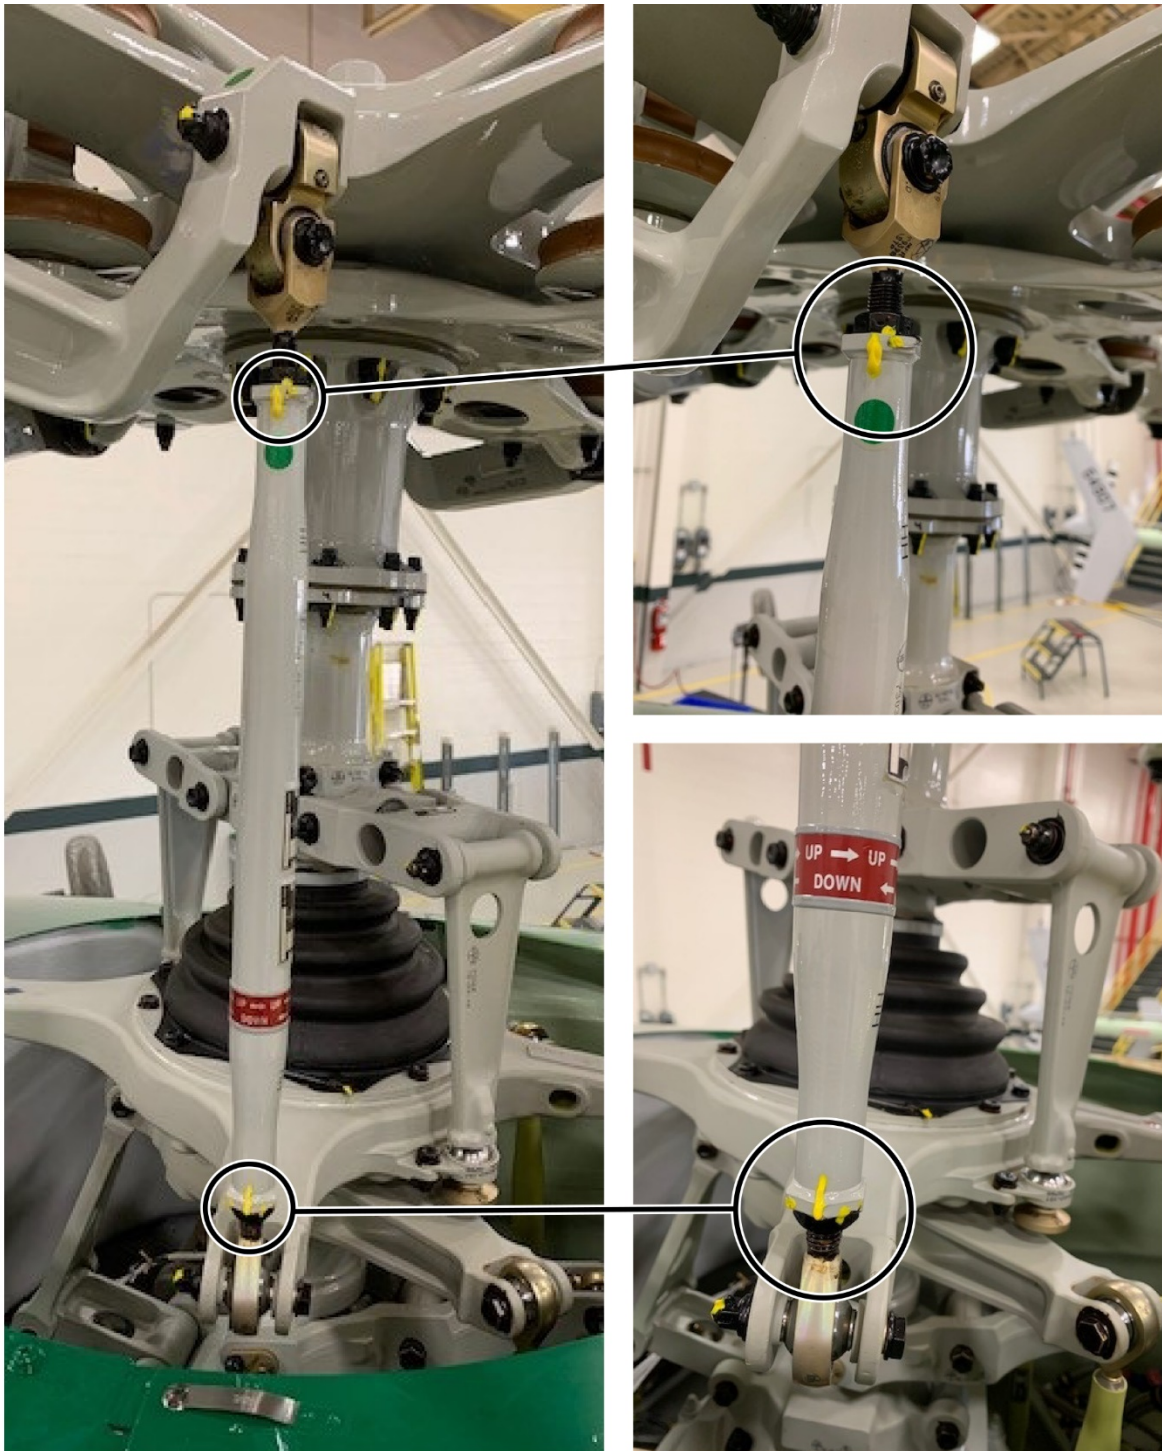
**Figure 1 – Torque Seal Lacquer (C-049) Application
(Model 407 Pitch Link Assembly Shown as an Example)**

- a. If torque seal lacquer (C-049) is missing or damaged, carry out a detailed visual inspection of the main rotor pitch link tube assembly for debonding of the insert where the torque seal lacquer (C-049) is missing or damaged. This can include, but not limited to, cracked paint, cracked sealant, and corrosion.

- (1) Remove any torque seal lacquer (C-049) residue, and clean inserts and tube with a clean cloth (C-516) moistened with dry-cleaning solvent (C-304).

- (2) If the insert is not debonded, re-apply torque seal lacquer (C-049), or equivalent, as shown (Figure 1).
 - (3) If the insert is found debonded, or suspected to be, go to step 2.c.
