ALERT SERVICE BULLETIN

429-15-21

MODEL AFFECTED: 429

SUBJECT: 429-001-523-101/-103 AND 429-001-532-101/-103
BELLCRANK ASSEMBLY INSPECTION,
INTRODUCTION OF.

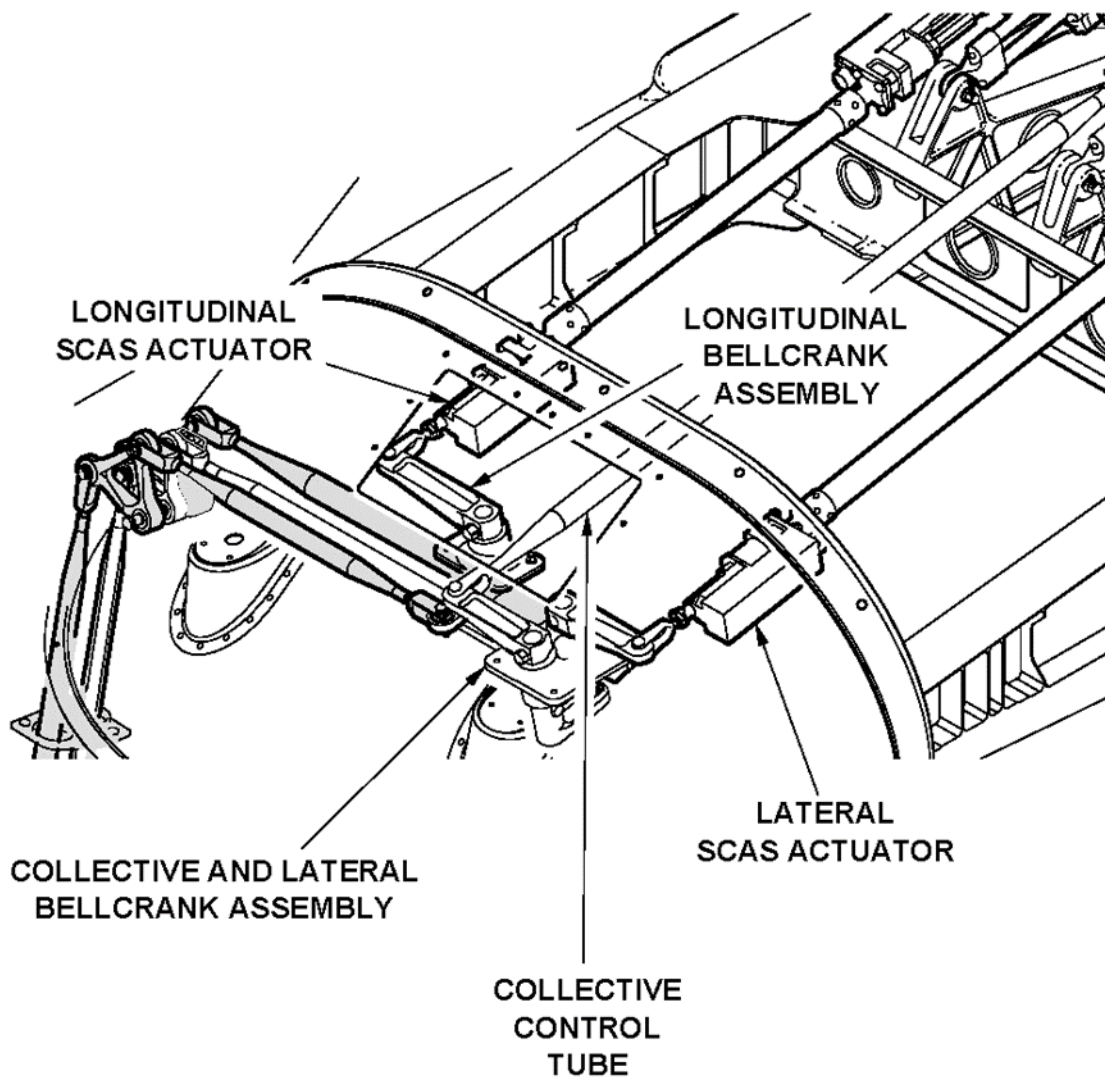
Figure 1 -Bellcrank Assemblies

Bell has received reports concerning flight control systems that have intermittent restrictions. ASB 429-14-13 was published to address helicopters which did not have air conditioning drainage modifications incorporated. The latest report involved a helicopter which did not have the air conditioning kit installed. Further investigation has determined that static and in-flight precipitation can pool at the forward portion of the roof structure providing a source of contamination for the roof mounted collective and cyclic bellcrank pivot bearings. It should be noted that rough pivot bearings could also be the cause of some Automatic Flight Control System (AFCS) faults (e.g. AP1/AP2

1. Prepare the helicopter for maintenance.
2. Disconnect the forward ends of the collective control tube, longitudinal SCAS actuator, and lateral SCAS actuator (Figure 1) (BHT-429-MM-1, Chapter 67).

3. Slowly move the cyclic stick fore/aft and laterally, and the collective stick up/down from stop to stop. If any roughness is detected in the flight control system, Perform TB 429-18-58.
4. Should discrepant pivot bearings be found that require replacement, contact Product Support Engineering to report findings.
5. Check that the MS27643-4 bearings (Item 2) in the 429-001-525-101 collective (Item 3), 429-001-527-101 lateral (Item 4), and 429-001-530-101 longitudinal (Item 5) arm assemblies rotate freely. If binding is detected in any MS27643-4 arm end bearings, perform TB 429-18-58.

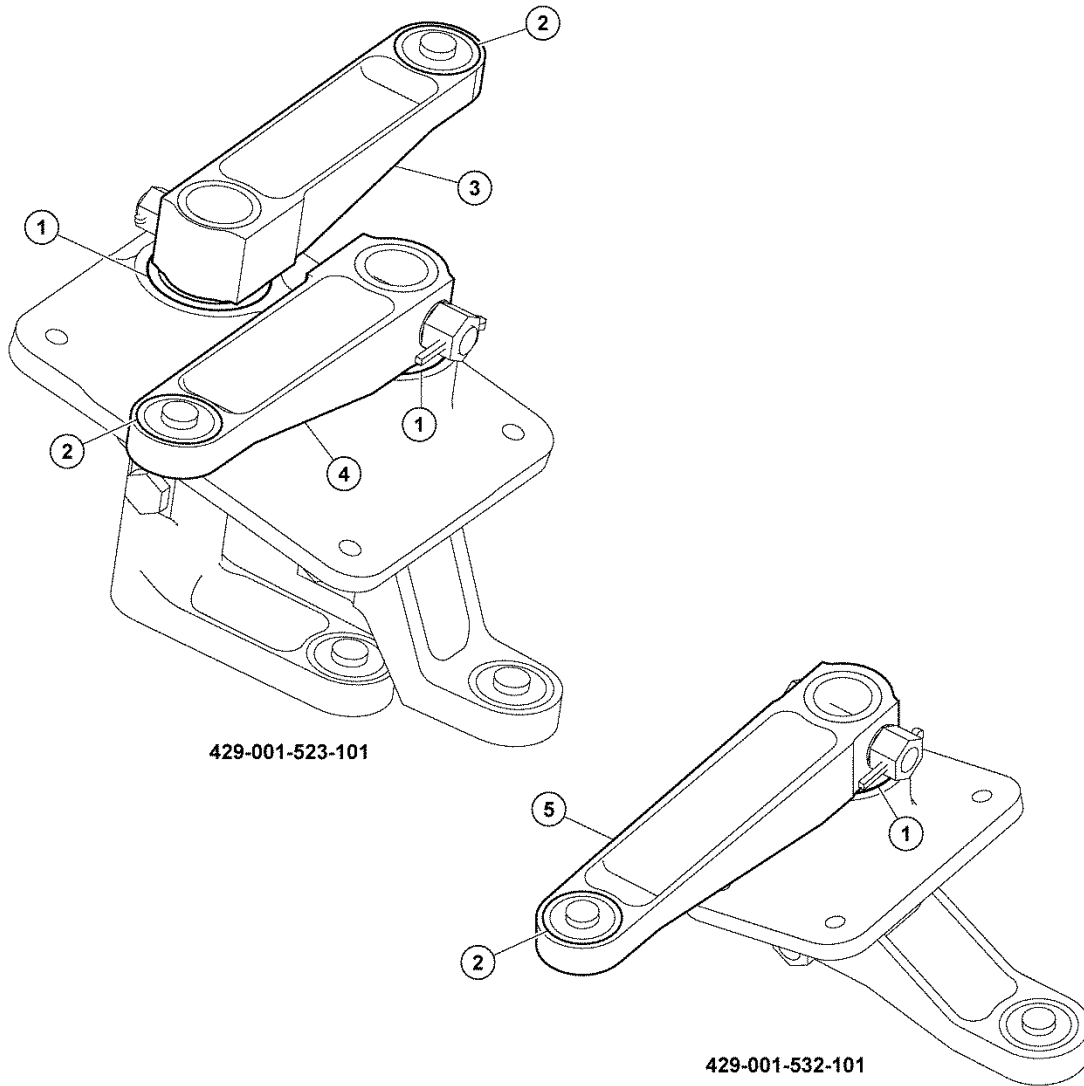
Figure 2 Bellcrank Details

1. Pivot bearing (MS27646-41) 6 Reqd
2. Bearing (MS27643-4) 3 Reqd
3. Collective arm assembly (429-001-525-101)
4. Lateral arm assembly (429-001-527-101)
5. Longitudinal arm assembly (429-001-530-101)

1. Upgrade bellcranks 429-001-523-101/-103 and 429-001-532-101/-103 in accordance with TB 429-18-58.
2. Make an entry in the helicopter logbook and historical service records indicating compliance with **Part III** of this Alert Service Bulletin, as applicable.
