ALERT SERVICE BULLETIN

429-17-35

MODEL AFFECTED: 429

SUBJECT: TAIL ROTOR BLADE 429-016-101-105,
INSPECTION OF.

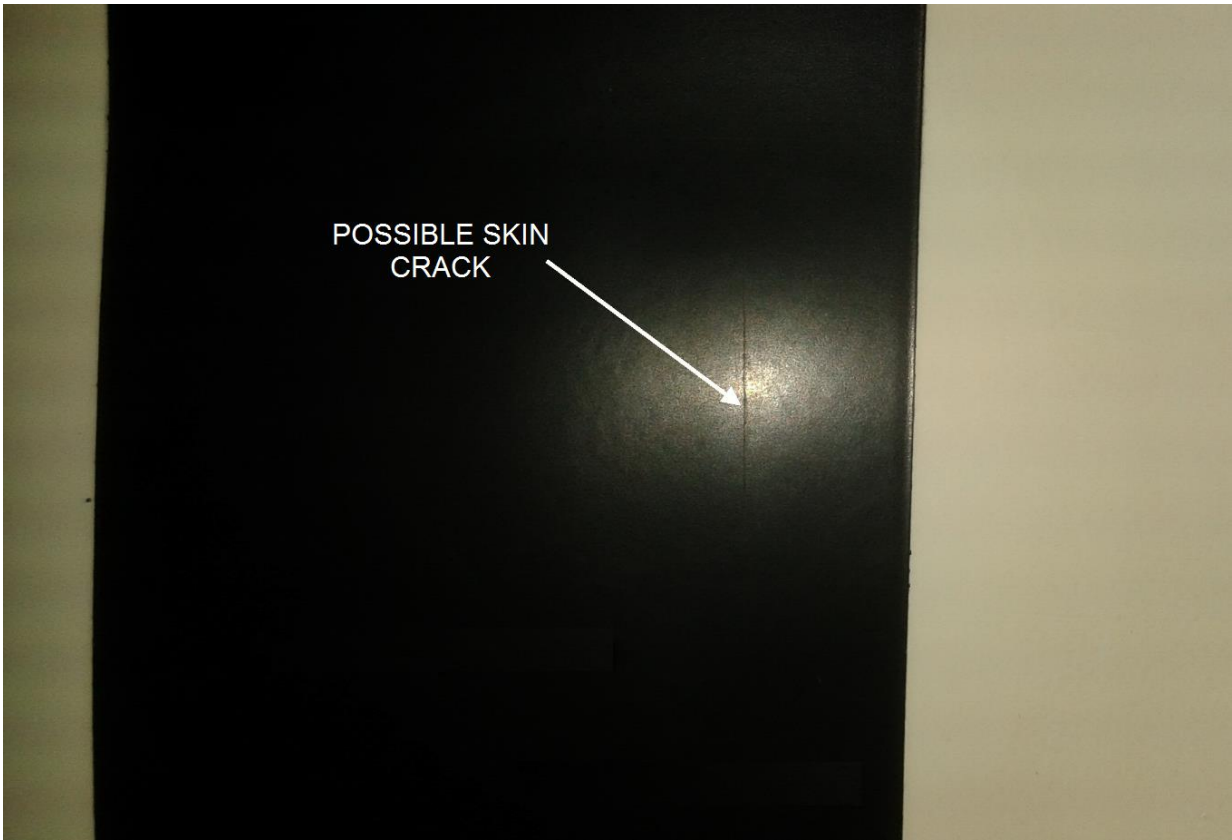
Bell Helicopter has received three reports of tail rotor blade skin cracks. As such this defect will become evident as a chordwise paint crack.

Figure 1 - Possible Skin Crack Indication

3. Carry out a general visual Inspection of all four tail rotor blade inboard and outboard skins for evidence of chordwise paint cracks.
4. Should a paint crack be detected in a tail rotor blade skin, please contact Product Support Engineering for further instructions.
5. Make an entry in the helicopter logbook and the Historical Service Record (HSR) indicating compliance with this Alert Service Bulletin.
