ALERT SERVICE BULLETIN

429-19-43

MODEL AFFECTED: 429

SUBJECT: MAIN ROTOR MAST ASSEMBLY 429-040-040-105
LOWER SPLINE INSPECTION, INTRODUCTION OF

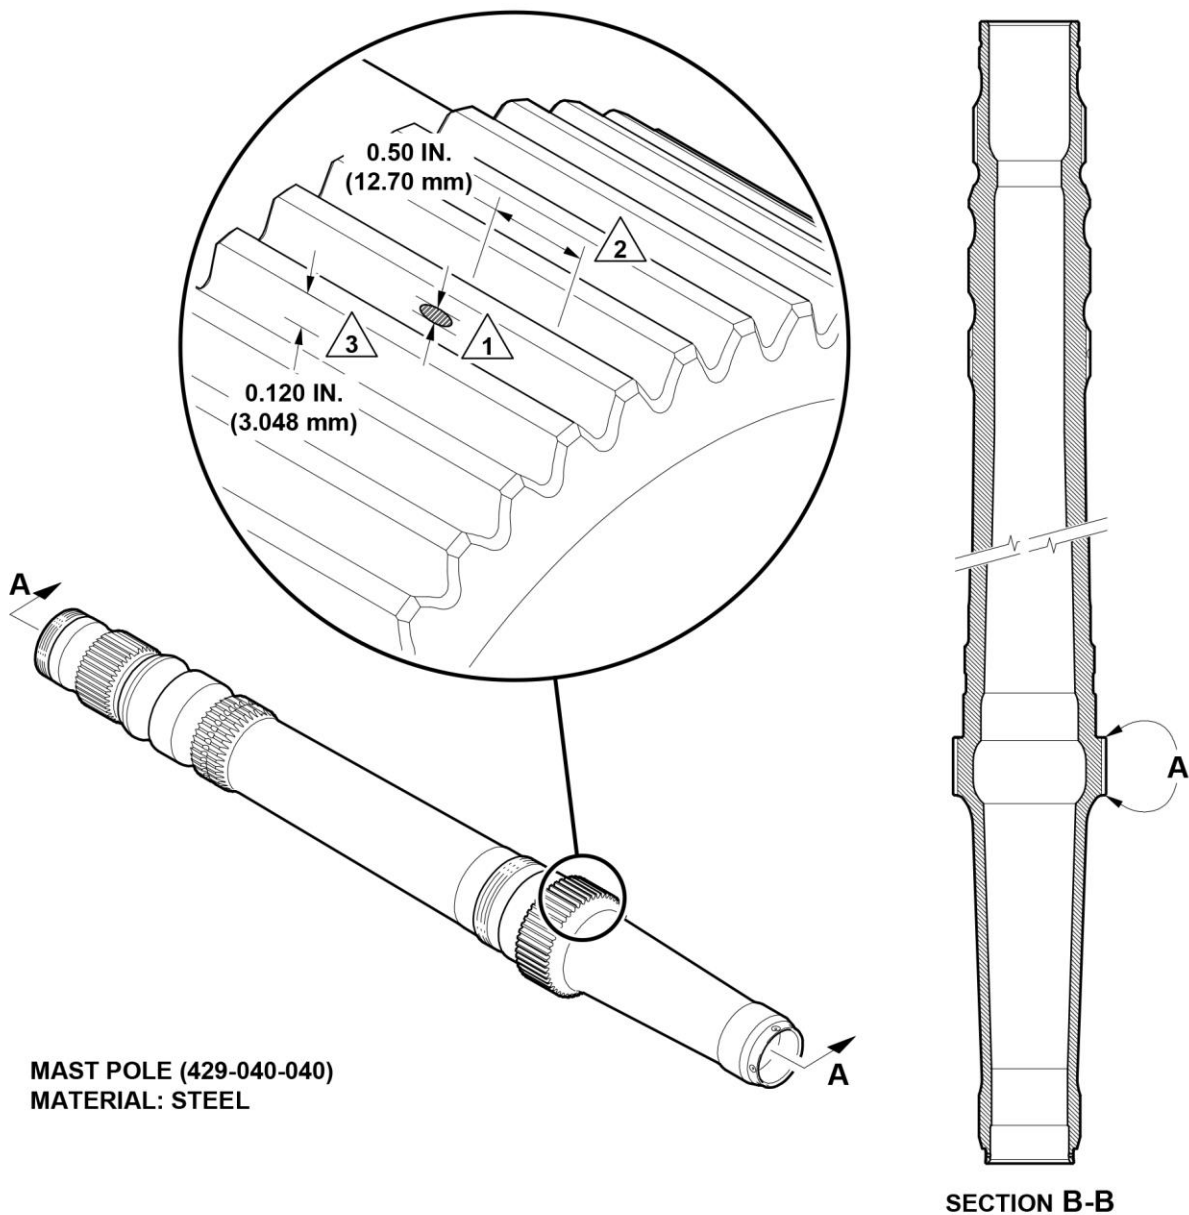
Figure 2 – Mast Pole Lower Drive Spline Mechanical Damage Limits

Bell has received reports of pitting damage on the lower splines of the mast pole assembly 429-040-040-105 as used in the 429-040-011-105 main rotor mast assembly. This Alert Service Bulletin introduces a repetitive inspection of the mast assembly lower drive splines, as well as the inner splines, of the splined shaft 429-040-301-101. The splined shaft is to be inspected concurrently with the mast assembly. Mast assemblies and splined shafts with spline tooth pitting damage beyond the limits introduced in this bulletin shall be removed from service.

NO.	REF LTR	CHARACTERISTIC	INSPECTION METHOD	LIMIT
1.	A	Mechanical damage	Visual/ measure	Pitting or missing material on the tooth face up to 0.010 inch (0.254 mm) deep is allowable as long as any single pit found is no wider than 0.050 inch (1.270 mm) when measured perpendicularly to the tooth.

- 1 The width of a single pit is to be measured perpendicular to the tooth length.
- 2 Within any 0.50 inch (12.70 mm) length of the tooth, the pits shall not exceed 25% of the area of the tooth face.
- 3 Pits shall not extend below 0.120 inch (3.048 mm) from the top of the tooth.

5. Inspect the main rotor mast assembly (1), paying particular attention to the lower drive splines. Refer to Figure 2 for damage limits.
 - a. Enter the results of the inspection in Table 1.

- b. Masts with drive spline damage beyond the limits in Figure 2 must be replaced with a serviceable 429-040-040-105S mast pole assembly.
6. Inspect the splined shaft (3) paying particular attention to the inner splines. Refer to Figure 3 for damage limits.

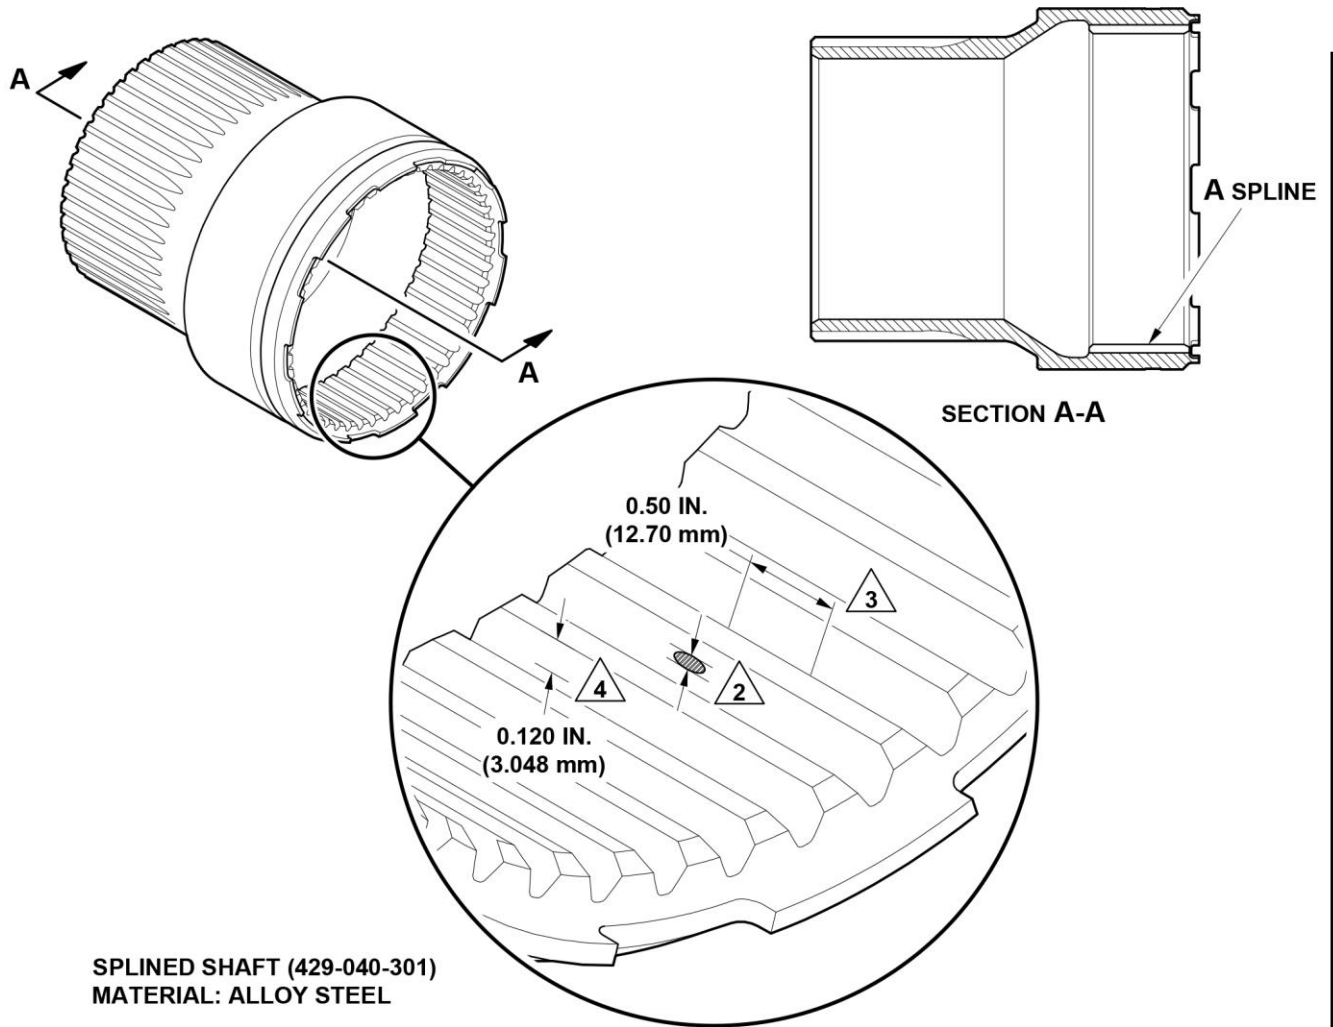
Figure 3 – Splined Shaft Mechanical Damage Limits

NO.	REF LTR	CHARACTERISTIC	INSPECTION METHOD	LIMIT
1.	A	Mechanical damage	Visual/ measure	Pitting or missing material on the tooth face up to 0.010 inch (0.254 mm) deep is allowable as long as any single pit found is no wider than 0.050 inch (1.270 mm) when measured perpendicularly to the tooth length. △1

- △1 It is acceptable to have the silver plate worn away in the spline tooth contact pattern area. Flaking of silver plating at the edge of the tooth contact pattern is a normal and acceptable condition.
- △2 The width of a single pit is to be measured perpendicular to the tooth length.
- △3 Within any 0.50 inch (12.70 mm) length of the tooth, the pits shall not exceed 25% of the area of the tooth face.
- △4 Pits shall not extend below 0.120 inch (3.048 mm) from the top of the tooth.

- a. Enter the results of the inspection in Table 1.
 - b. Splined adapters with inner spline damage beyond the allowable limits in Figure 3 must be replaced with a serviceable 429-040-301-101 splined adapter.
