ALERT SERVICE BULLETIN

429-19-43

MODEL AFFECTED: 429

SUBJECT: MAIN ROTOR MAST ASSEMBLY 429-040-040-105
LOWER SPLINE INSPECTION, INTRODUCTION OF

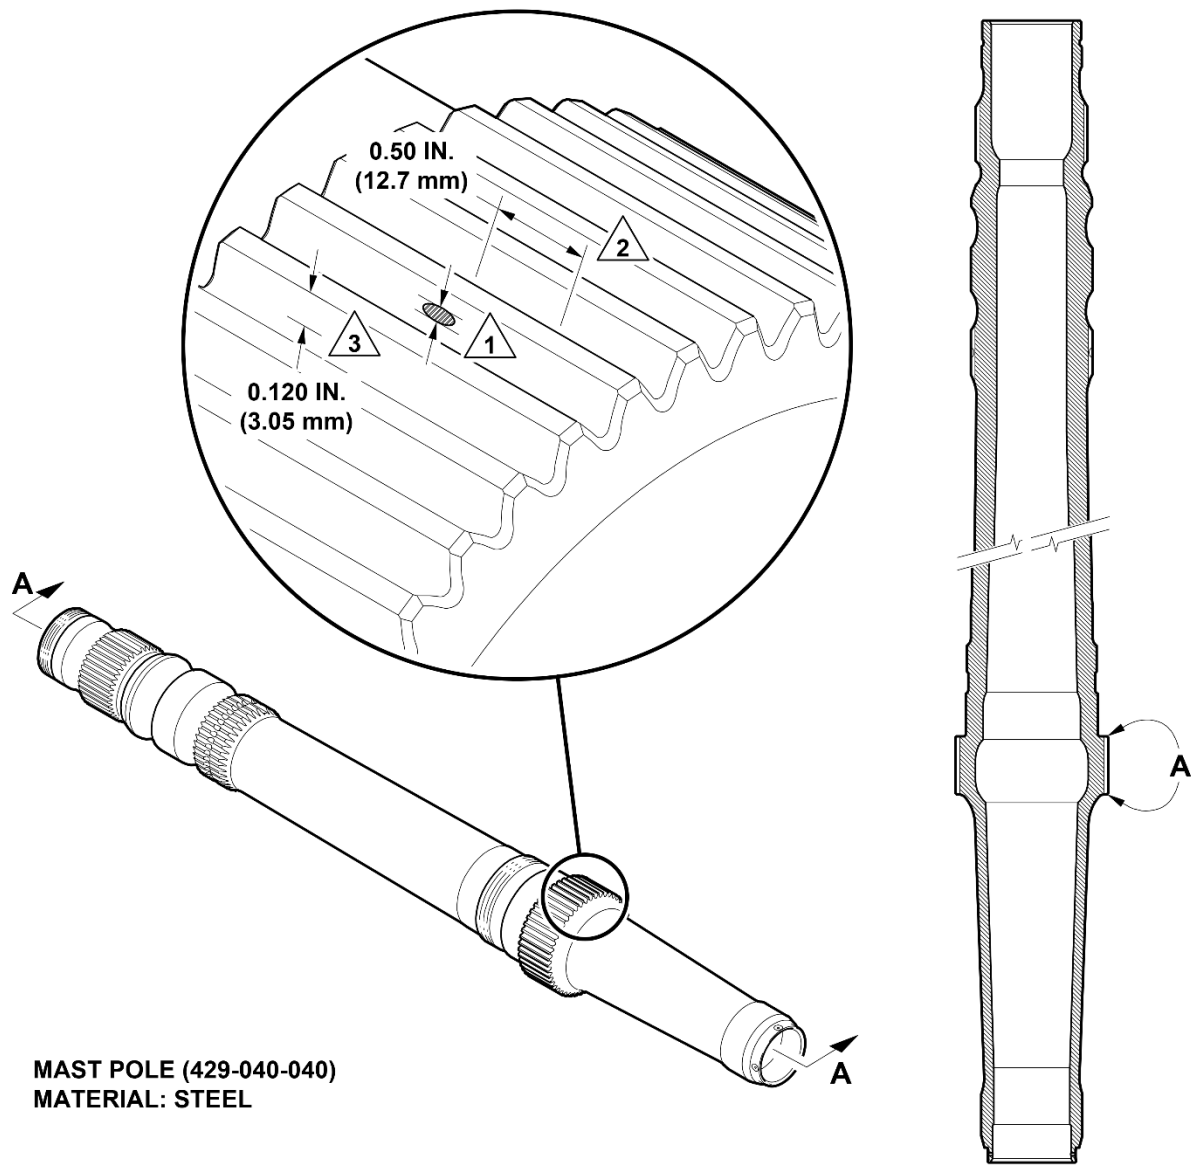
Figure 2 – Mast Pole Lower Drive Spline Mechanical Damage Limits

Bell has received reports of pitting damage on the lower splines of the mast pole assembly 429-040-040-105 as used in the 429-040-011-105 main rotor mast assembly. This Alert Service Bulletin introduces a repetitive inspection of the mast assembly lower drive splines, as well as the inner splines, of the splined shaft 429-040-301-101. The splined shaft is to be inspected concurrently with the mast assembly. Mast assemblies and splined shafts with spline tooth pitting damage beyond the limits introduced in this bulletin shall be removed from service.

NO.	REF LTR	CHARACTERISTIC	INSPECTION METHOD	LIMIT
1.	A	Mechanical damage	Visual/ measure	Pitting or missing material on the tooth face up to 0.010 inch (0.25 mm) deep is allowable as long as any single pit found is no wider than 0.050 inch (1.27 mm) when measured perpendicularly to the tooth.

- 1 The width of a single pit is to be measured perpendicular to the tooth length.
- 2 Within any 0.50 inch (12.7 mm) length of the tooth, the pits shall not exceed 25% of the area of the tooth face. It is acceptable for up to 5 teeth to have pits up to 40% of the area over a 0.50 inch (12.7 mm) length.
- 3 Pits shall not extend below 0.120 inch (3.05 mm) from the top of the tooth.

- b. Masts with drive spline damage beyond the limits in Figure 2 must be replaced with a serviceable 429-040-040-105S mast pole assembly.
6. Inspect the splined shaft (3) paying particular attention to the inner splines. Refer to Figure 3 for damage limits.

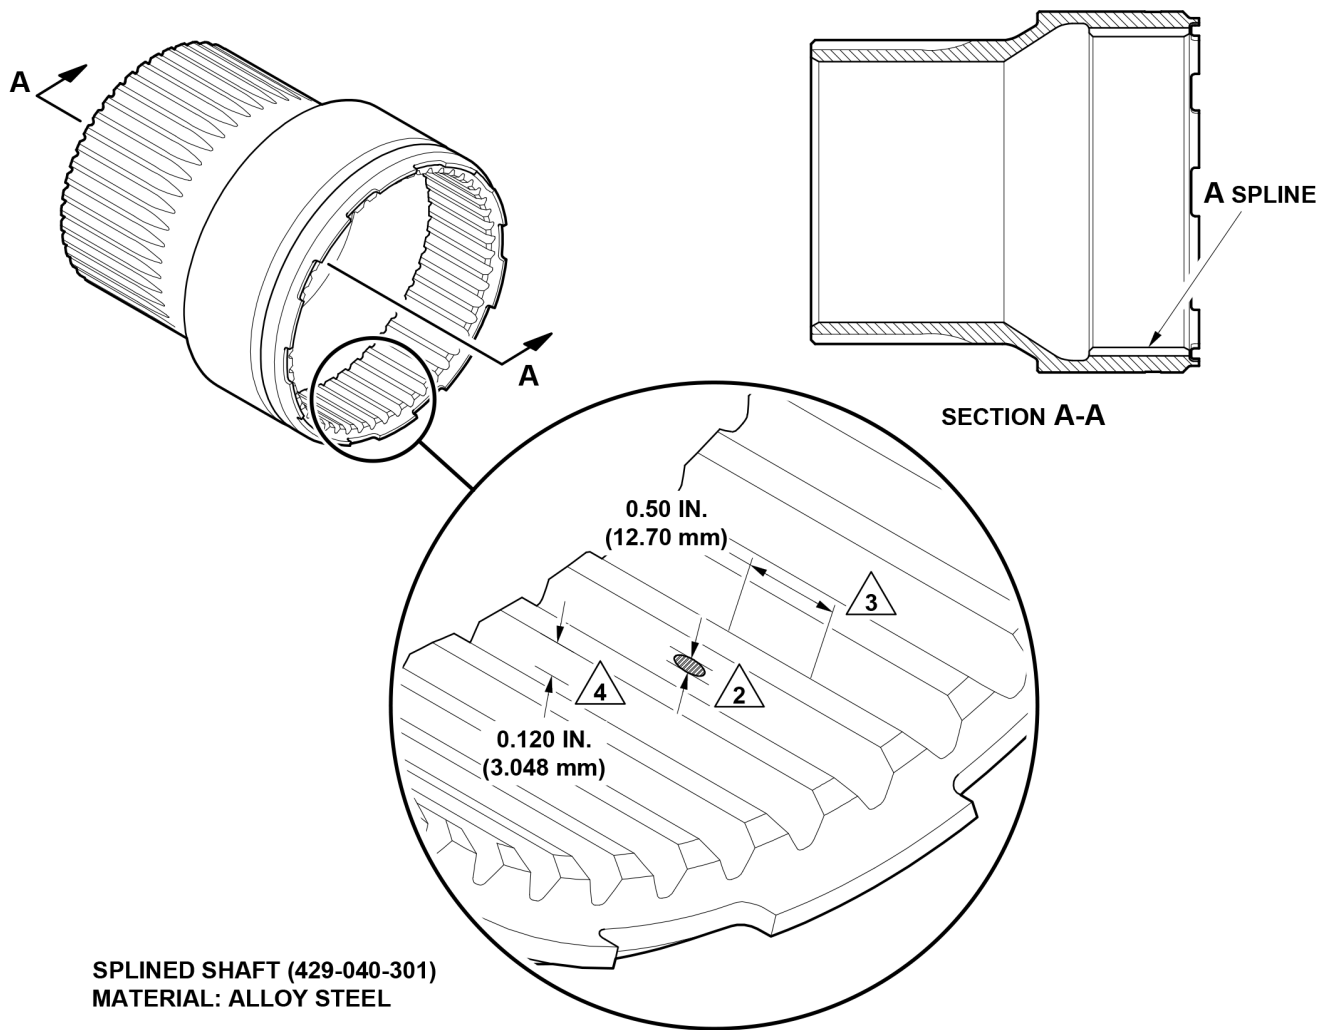
Figure 3 – Splined Shaft Mechanical Damage Limits

NO.	REF LTR	CHARACTERISTIC	INSPECTION METHOD	LIMIT
1.	A	Mechanical damage	Visual/ measure	Pitting or missing material on the tooth face up to 0.010 inch (0.254 mm) deep is allowable as long as any single pit found is no wider than 0.050 inch (1.270 mm) when measured perpendicularly to the tooth length. △1

- △1 It is acceptable to have the silver plate worn away in the spline tooth contact pattern area. Flaking of silver plating at the edge of the tooth contact pattern is a normal and acceptable condition.
- △2 The width of a single pit is to be measured perpendicular to the tooth length.
- △3 Within any 0.50 inch (12.70 mm) length of the tooth, the pits shall not exceed 25% of the area of the tooth face.
- △4 Pits shall not extend below 0.120 inch (3.048 mm) from the top of the tooth.

- a. Enter the results of the inspection in Table 1.
 - b. Splined adapters with inner spline damage beyond the allowable limits in Figure 3 must be replaced with a serviceable 429-040-301-101 splined adapter.
