ALERT SERVICE BULLETIN

429-19-43

MODEL AFFECTED: 429

SUBJECT: MAIN ROTOR MAST ASSEMBLY 429-040-011-105
LOWER SPLINE INSPECTION, INTRODUCTION OF

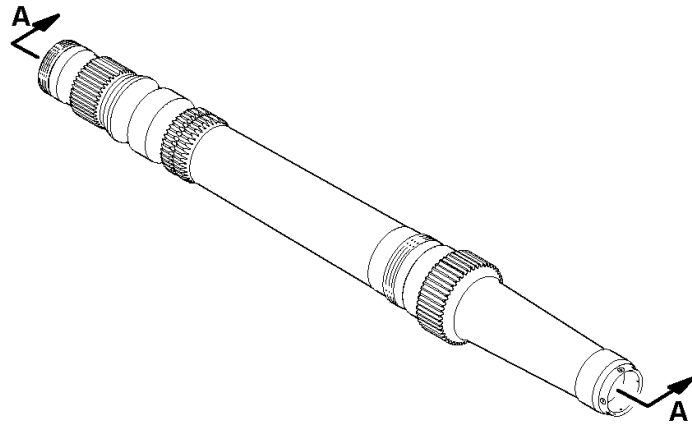
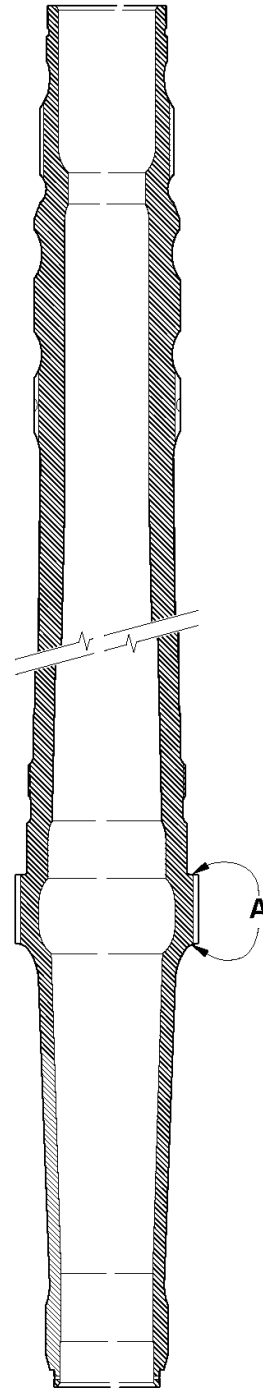
Figure 1 - Mast pole lower drive spline mechanical damage limits (page 1 of 2)

Bell has received reports of pitting damage on the lower splines of the mast assembly 429-040-040-105 as used in the 429-040-011-105 main rotor mast assembly. This Alert Service Bulletin introduces a repetitive inspection of the mast assembly lower drive splines, as well as the inner splines, of the splined shaft 429-040-301-101. Mast assemblies and splined shafts with spline tooth pitting damage beyond the limits introduced in this bulletin shall be removed from service. Applicability of this bulletin to any spare part shall be determined prior to its installation on an affected helicopter.

NO.	REF LTR	CHARACTERISTIC	INSPECTION METHOD	LIMIT
1.	A	Mechanical damage	Visual/measure	Pitting or missing material on the tooth face up to 0.010 inch deep is allowable as long as any pits found are no wider than 0.050 inch. Within any 0.50 inch length of the tooth, the pits shall not exceed 25% of the area of the tooth face and shall not extend below 0.120 inch from the top of the tooth.

- b. Masts with drive spline damage beyond the limits in Figure 1 must be replaced with a new 429-040-040-105S mast pole assembly.
5. Inspect the splined adapter 429-040-301-101 paying particular attention to the inner splines. Refer to Figure 2 for damage limits.

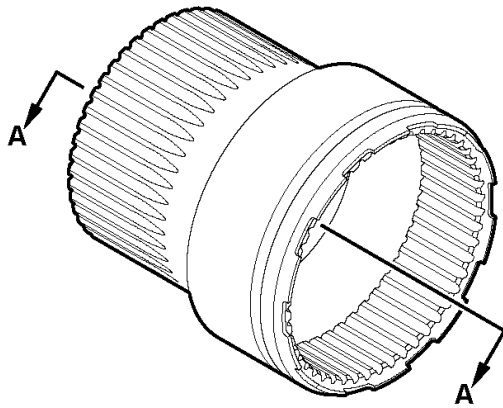
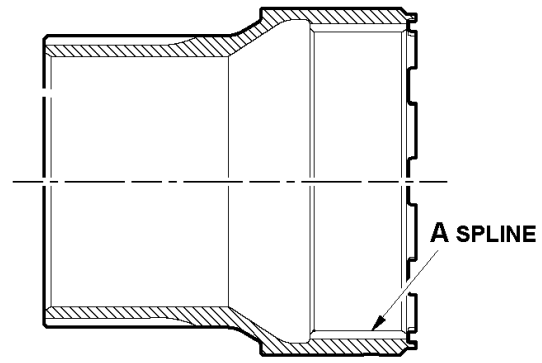
Figure 2 - Splined shaft mechanical damage limits

NO.	REF LTR	CHARACTERISTIC	INSPECTION METHOD	LIMIT
1.	A	Mechanical damage	Visual/measure	Pitting or missing material on the tooth face up to 0.010 inch deep is allowable as long as any pits found are no wider than 0.050 inch. Within any 0.50 inch length of the tooth, the pits shall not exceed 10% of the area of the tooth face and shall not extend below 0.120 inch from the top of the tooth. △ 1

△ 1 It is acceptable to have the silver plate worn away in the spline tooth contact pattern area. Flaking of silver plating at the edge of the tooth contact pattern is a normal and acceptable condition.

- a. Enter the results of the inspection in Table 1.
 - b. Splined adapters with inner spline damage beyond the allowable limits in Figure 2 must be replaced with a new 429-040-301-101 splined adapter.
