ALERT SERVICE BULLETIN

429-19-45
16 April 2019

MODEL AFFECTED: 429

SUBJECT: 429-012-120-101 CURVIC COUPLING,
INSPECTION OF

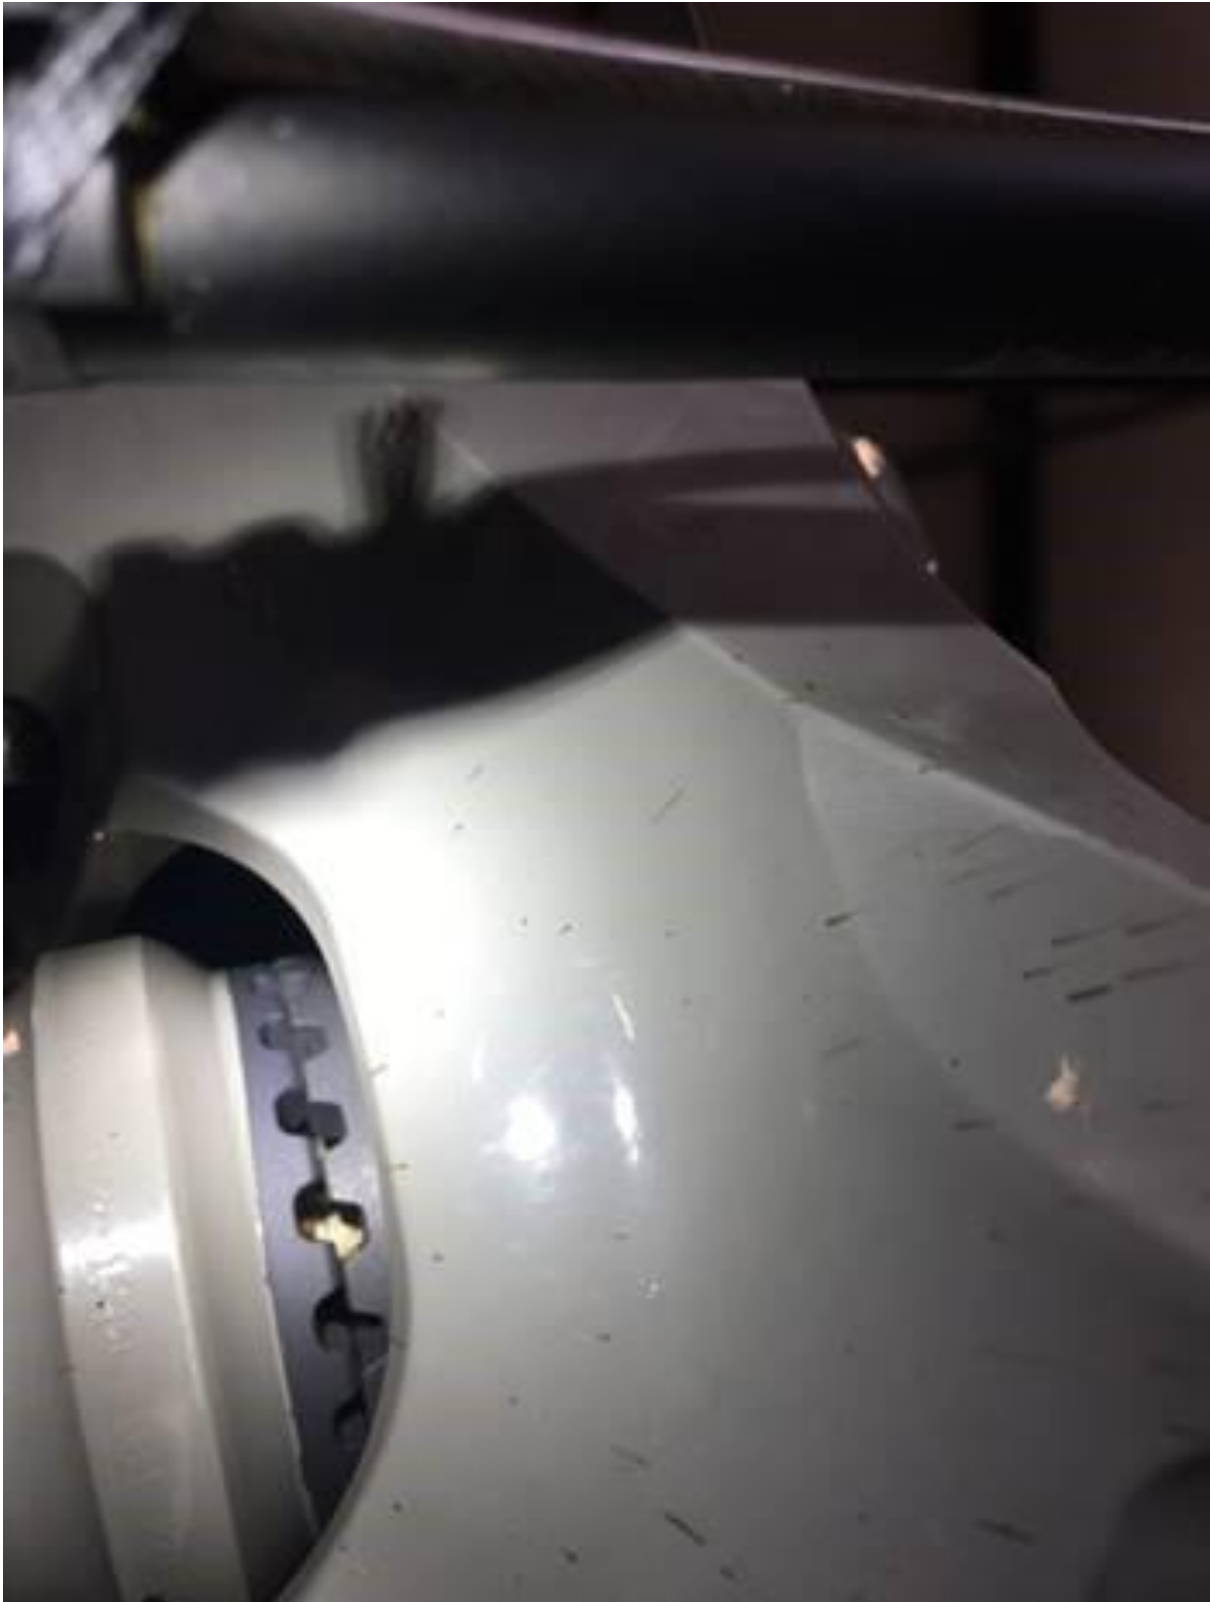
Bell has received a report of an improperly installed 429-012-120-101 Curvic Coupling. It was found that the teeth could rest on top of each other during installation of the tail rotor hub and blade assembly instead of meshing together. This Alert Service Bulletin introduces a one-time inspection for the engagement of the Curvic Coupling drive teeth. Applicability of this bulletin to any spare part shall be determined prior to its installation on an affected helicopter.

Figure 1 – Example of Improperly Engaged Curvic Coupling

5. Inspect for play between the teeth of the Curvic Coupling and both inboard and outboard flapping bearing teeth by applying a lead/lag force to the inboard and outboard hub and blade assemblies.
 - a. If play is found, proceed to step 6.
 - b. If no play is found, proceed to step 12.
6. Remove the tail rotor hub and blade assembly. (DMC-429-A-64-10-00-00A-520A-A)
7. Inspect the teeth of the 429-012-120-101 Curvic Coupling for damage. (DMC-429-A-64-10-00-00A-310A-A)
8. Inspect the teeth of the inboard and outboard flapping bearings for damage. (DMC-429-A-64-20-00-00A-310A-A)
9. Install a serviceable tail rotor hub and blade assembly. (DMC-429-A-64-10-00-00A-720A-A)

10. If the teeth of the 429-012-120-101 Curvic Coupling were found improperly engaged per Step 3, perform a rigging check of the directional control system. (DMC-429-A-67-20-00-00A-280A-A)
11. Submit any anomalies noted during inspection to Product Support Engineering at productsupport@bellflight.com. **Make sure that the following is in the subject line of the e-mail:**
 - a. Service directive number: ASB 429-19-45
 - b. Helicopter serial number
 - c. Operator name.
12. Make an entry in the helicopter logbook and historical service records indicating compliance with this Alert Service Bulletin.

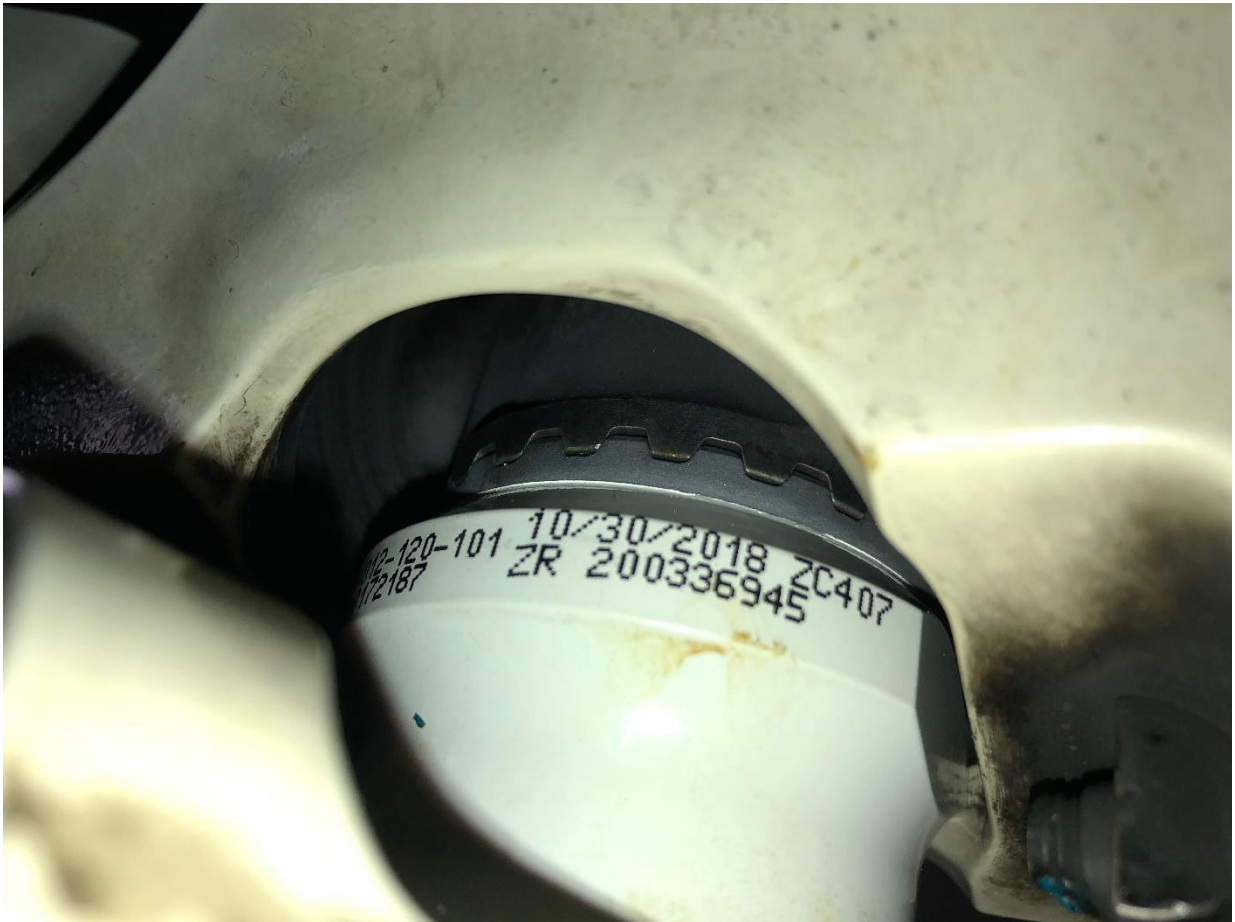
Figure 2 – Example of Properly Engaged Curvic Coupling
