ALERT SERVICE BULLETIN

429-19-47

MODEL AFFECTED: 429

SUBJECT: TAIL ROTOR GEARBOX SUPPORT RETAINING RIVETS, INSPECTION OF.

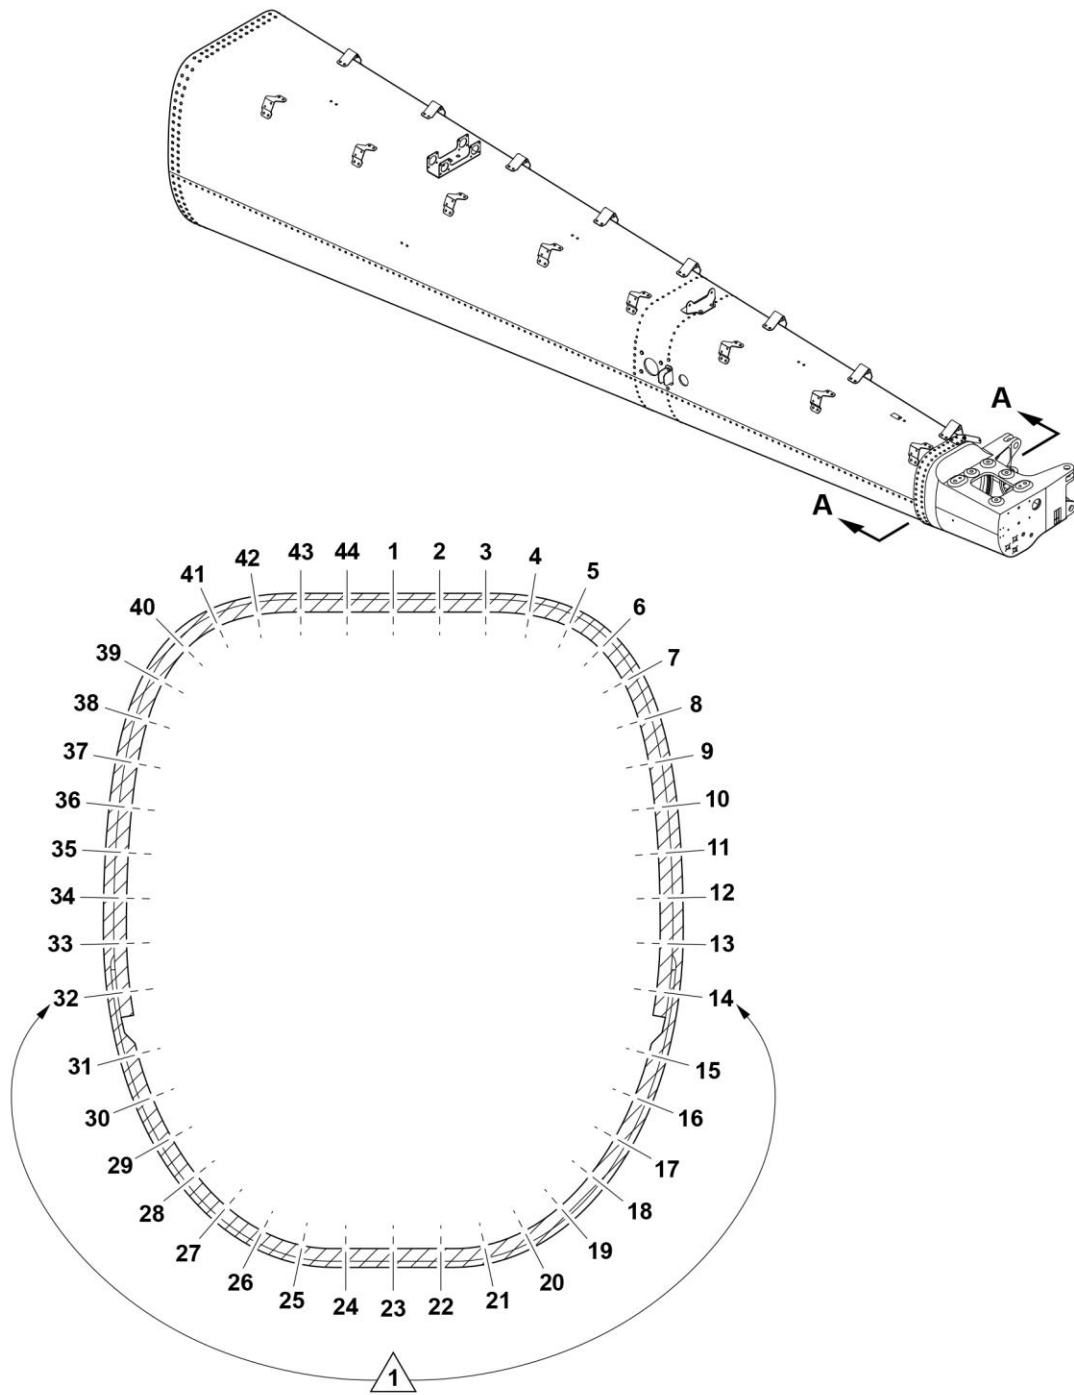
Figure 1 – Rivet Identification

Bell has received reports of failed rivets at the joint between the tailboom skin and the tail rotor gearbox support 429-034-701-101. To address this, Bell is issuing this bulletin to mandate a recurring inspection of the rivets located in that joint. Operators that have previously replaced the tail rotor gearbox support and have not yet flown 400 hours since the replacement can perform the inspection once they reach 400 flight hours on

6. With a bright light and mirror, visually inspect all the rivet tails inside of the tailboom for the following conditions:
 - a. Rivets tails that are not resting against the tailboom skin.
 - b. Missing tails, or tails resting at the bottom of the tailboom.

Failed rivets are those whose head has separated from their tail.

Perform tactile check on indicated rivet tails.

7. Do a tactile check of all the rivets identified in Figure 1 by pulling on each rivet tail.

8. Using Figure 1 to identify the position of the rivets, note the position of any discrepant rivet found during steps 5, 6, and 7 in Table 1.

9. If any discrepant rivets are found during steps 5, 6 and 7, do the following:
- a. Determine if the discrepant rivets are failed or if they are of improper length.
 - (1) If the rivets are of improper length, replace the rivets and proceed to step 10.
 - (2) If the rivets are failed, proceed to step 9.b..
 - b. Remove the edge sealant from the forward edge of the tail rotor gearbox support.
 - c. Using a feeler gauge, measure any gaps present between the tail rotor gearbox support and the tailboom skin.
 - d. Plot the location of the gaps by using Figure 1 and Table 1.
 - e. If no gaps or if gaps measuring 0.005" (1.27 mm) or less are found, replace the discrepant rivets and proceed to step 10.
 - f. Submit a structural repair request in accordance with General Information Letter GEN-18-141. Make sure to submit the information recorded in step 9.d..
