ALERT SERVICE BULLETIN

429-21-55

MODEL AFFECTED: 429

SUBJECT: MAIN ROTOR PITCH CHANGE LINK UPPER RETENTION BOLT 20-114C5P47AD, ONE-TIME INSPECTION OF.

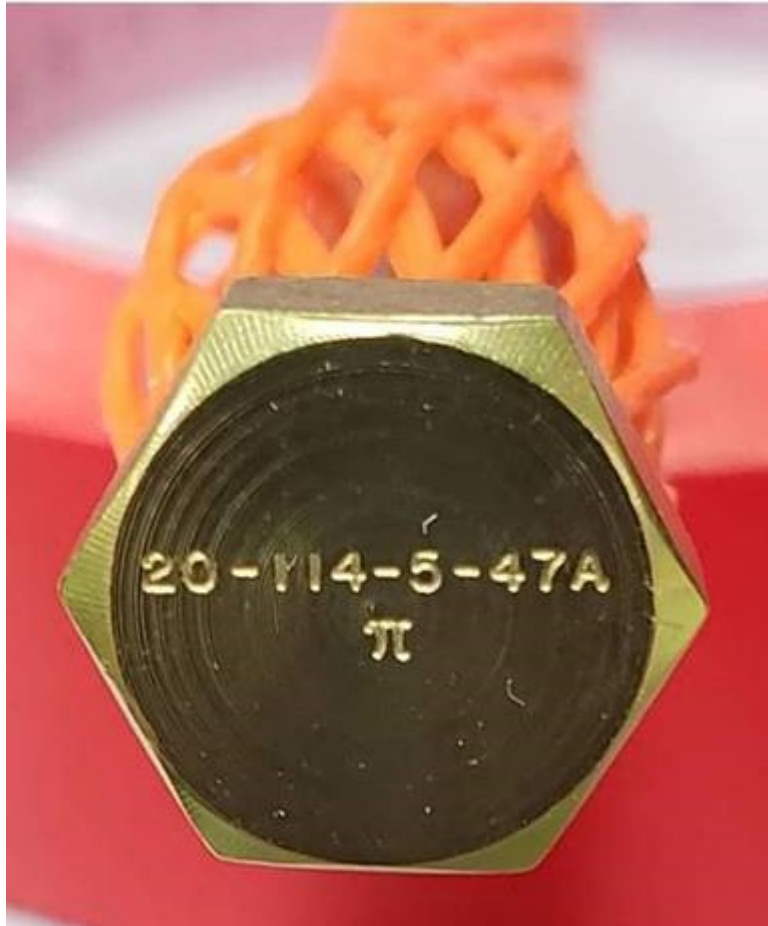
Bell has implemented a change to introduce alternate bolts in the main rotor controls. As such the main rotor pitch change link upper retaining bolt part number can either be 50-047D5-44 or 20-114C5P47AD. Bell has received a field report of non-conforming 20-114C5P47AD bolts that have a greater grip length than the specification. There is a risk that the 90-099C5 nut can bottom out on the grip when it is torqued to the specified value, resulting in an improper clamp up of the assembly. A stock purge has been performed and all non-conforming bolts have been removed from the Bell spares inventory. Some discrepant bolts may have been distributed to the field before the issue was reported. Therefore, this bulletin mandates a one-time inspection of the 20-114C5P47AD bolts to identify the manufacturer and to replace any discrepant bolts that are found. Applicability of this bulletin to any spare part shall be determined prior to its installation on an affected helicopter.

1. Prepare the helicopter for maintenance.
2. Remove the corrosion preventative compound from the four (4) main rotor pitch change link upper retention bolt heads and inspect to identify the bolts:
 - a. If the bolt head has a “**π**” (pi) symbol (Figure 1), remove (DMC-429-A-62-30-00-00A-520A-A) and proceed to step 3.
 - b. If the bolt head does not have the “**π**” (pi) symbol, proceed to step 8.

Figure 1 – Example of Main Rotor Pitch Link Upper Retention Bolt 20-114C5P47AD with the “ π ” (pi) symbol visible.

6. Discard the discrepant bolt(s) and replace with (a) serviceable 20-114C5P47AD bolt(s).
7. If you find a discrepant bolt, inform Bell Product Support Engineering by sending an e-mail at productsupport@bellflight.com. Make sure that the following information is included:
 - a. Helicopter serial number in the subject line.
 - b. ASB Number in the subject line: ASB 429-21-55
 - c. Photo of the discrepant bolt head.
8. Make an entry in the helicopter logbook and historical service records indicating compliance with this Alert Service Bulletin.
