## **ALERT SERVICE BULLETIN**

**429-22-58**

**MODEL AFFECTED:** 429

**SUBJECT:** TRANSMISSION MOUNTED BELLCRANKS AND SUPPORT, INSPECTION OF

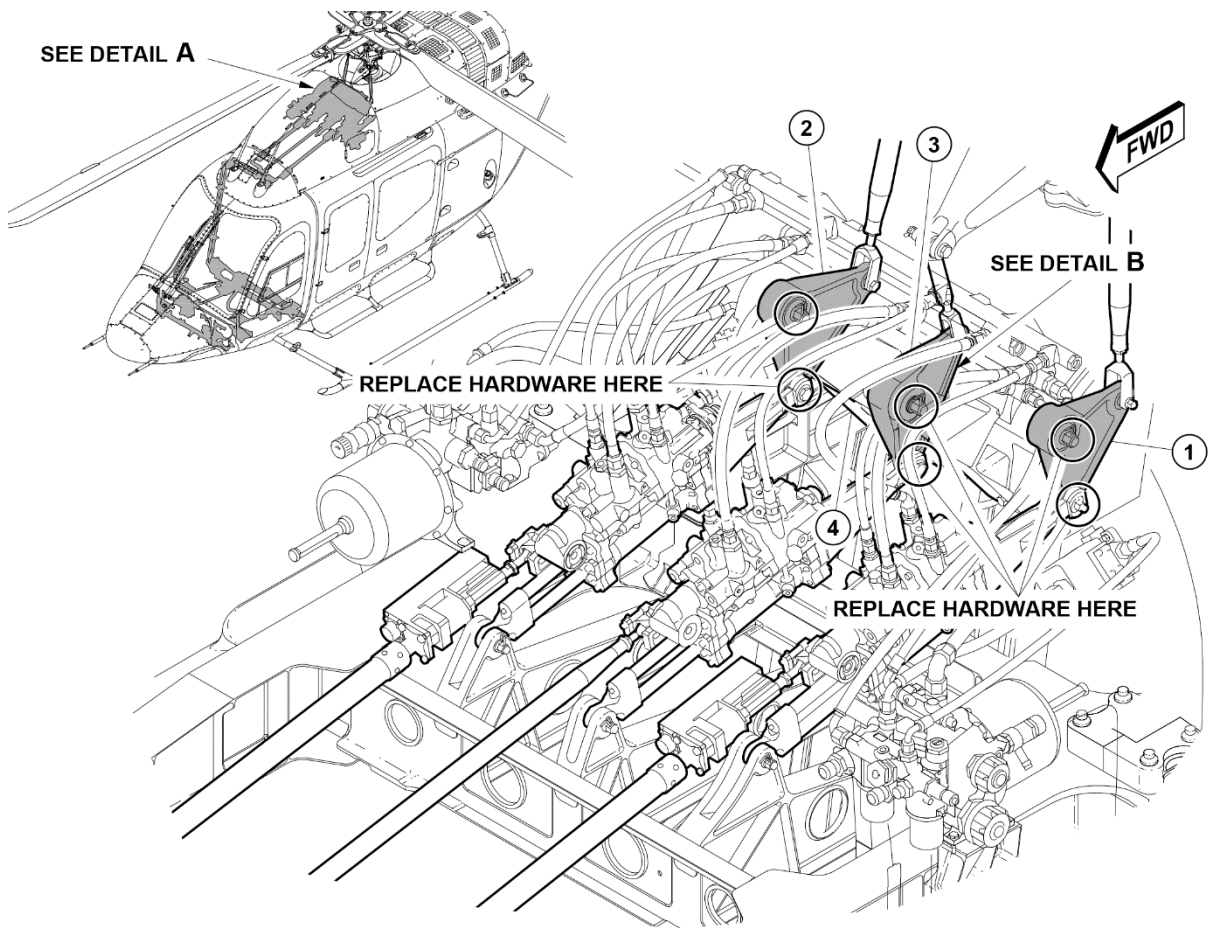
DETAIL A

Bell has discovered that low torque values were applied to the transmission mounted cyclic and collective bellcranks and support hardware on the affected helicopters. If not corrected, the lack of preload may cause fretting which may cause a fatigue crack of the bolts or the bellcrank support. This ASB requires operators to inspect the transmission mounted bellcranks and support, replace the affected hardware and install with the correct torque values. This ASB also includes a design change to replace one aluminum washer with a CRES washer.

3. Remove the transmission mounted cyclic lateral bellcrank assembly (1, Figure 1), the cyclic longitudinal bellcrank assembly (2) (refer to Cyclic Control Linkage - Removal, DMC-429-A-67-10-00-11A-520A-A) and the collective bellcrank assembly (3) (refer to Collective Control Linkage - Removal, DMC-429-A-67-10-00-04A-520A-A). Discard the hardware (bolts, nuts, washers and cotter pins) at the three bellcrank assembly pivot joints and the three servo joints indicated in Figure 1.

4. Visually inspect the transmission mounted cyclic lateral and longitudinal bellcrank assemblies (1 and 2) (refer to Cyclic Control Linkage - Inspection, DMC-429-A-67-10-00-11A-310A-A), the collective bellcrank assembly (3) (refer to Collective Control Linkage - Inspection, DMC-429-A-67-10-00-04A-310A-A) and the transmission mounted bellcrank support (4) (DMC-429-A-67-10-00-18A-310A-A), paying particular attention for fretting damage in the pivoting area of the bellcrank assemblies and adjacent areas of the support.

6. Install the transmission mounted cyclic lateral bellcrank assembly (1) and cyclic longitudinal bellcrank assembly (2) (refer to Cyclic Control Linkage - Installation, DMC-429-A-67-10-00-11A-720A-A). Torque pivot joint nuts 40 to 58 FT-LBS. Torque servo joint nuts 160 to 190 IN-LBS. Torque control tube nuts 100 to 140 IN-LBS.

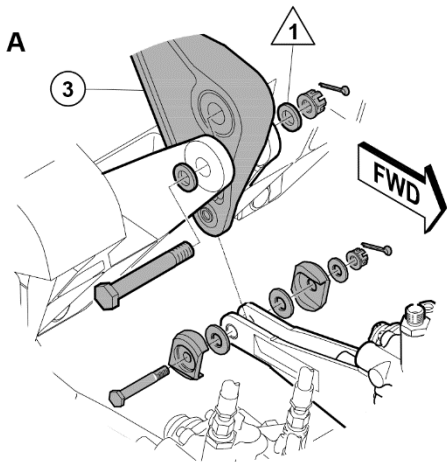
DETAIL B

1. Install CRES washer NAS1149E0683P.

5. Install the transmission mounted collective bellcrank assembly (3) (refer to Collective Control Linkage - Installation, DMC-429-A-67-10-00-04A-720A-A). Replace the aluminum washer NAS1149D0863J with a CRES washer NAS1149E0863P as per the Figure 1, Detail B. Torque pivot joint nut 40 to 58 FT-LBS. Torque servo joint nut 160 to 190 IN-LBS. Torque control tube nut 160 to 190 IN-LBS.
