## **ALERT SERVICE BULLETIN**

**429-24-63**

**MODEL AFFECTED:** 429

**SUBJECT:** TAIL ROTOR BLADE 429-016-101-105 ABRASION STRIP, INSPECTION OF.

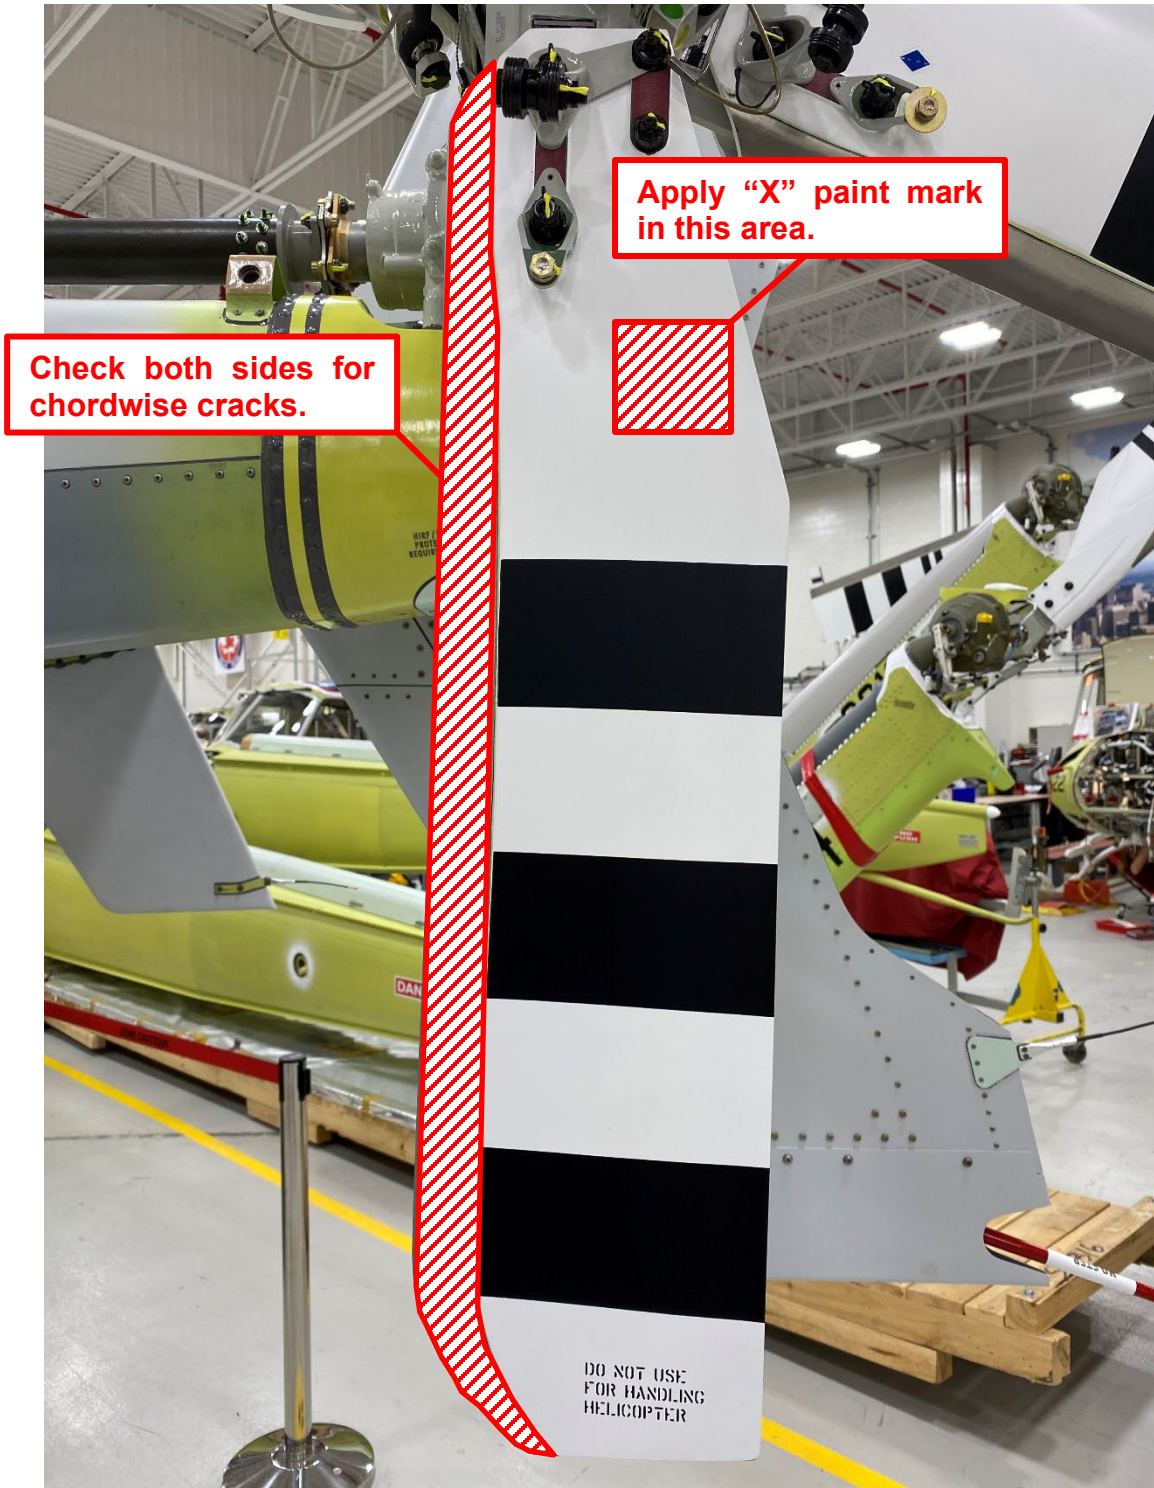
**Figure 1- Application of Paint Mark and Visual Check Zone**

4. Using a bright light, visually inspect both sides of the abrasion strip of each affected tail rotor blade for the presence of chordwise cracks. Refer to Figure 1 for zone to be inspected. If one or more cracks are found, replace the blade before next flight ([DMC-429-A-64-10-00-01A-520A-A](#) and [DMC-429-A-64-10-00-01A-720A-A](#)).

5. If the affected blade abrasion strip does not present any cracks, apply a visual identification mark on the blade with a paint marker as shown in Figure 1. The color shall be clearly visible and different than blue, orange, red and Green.

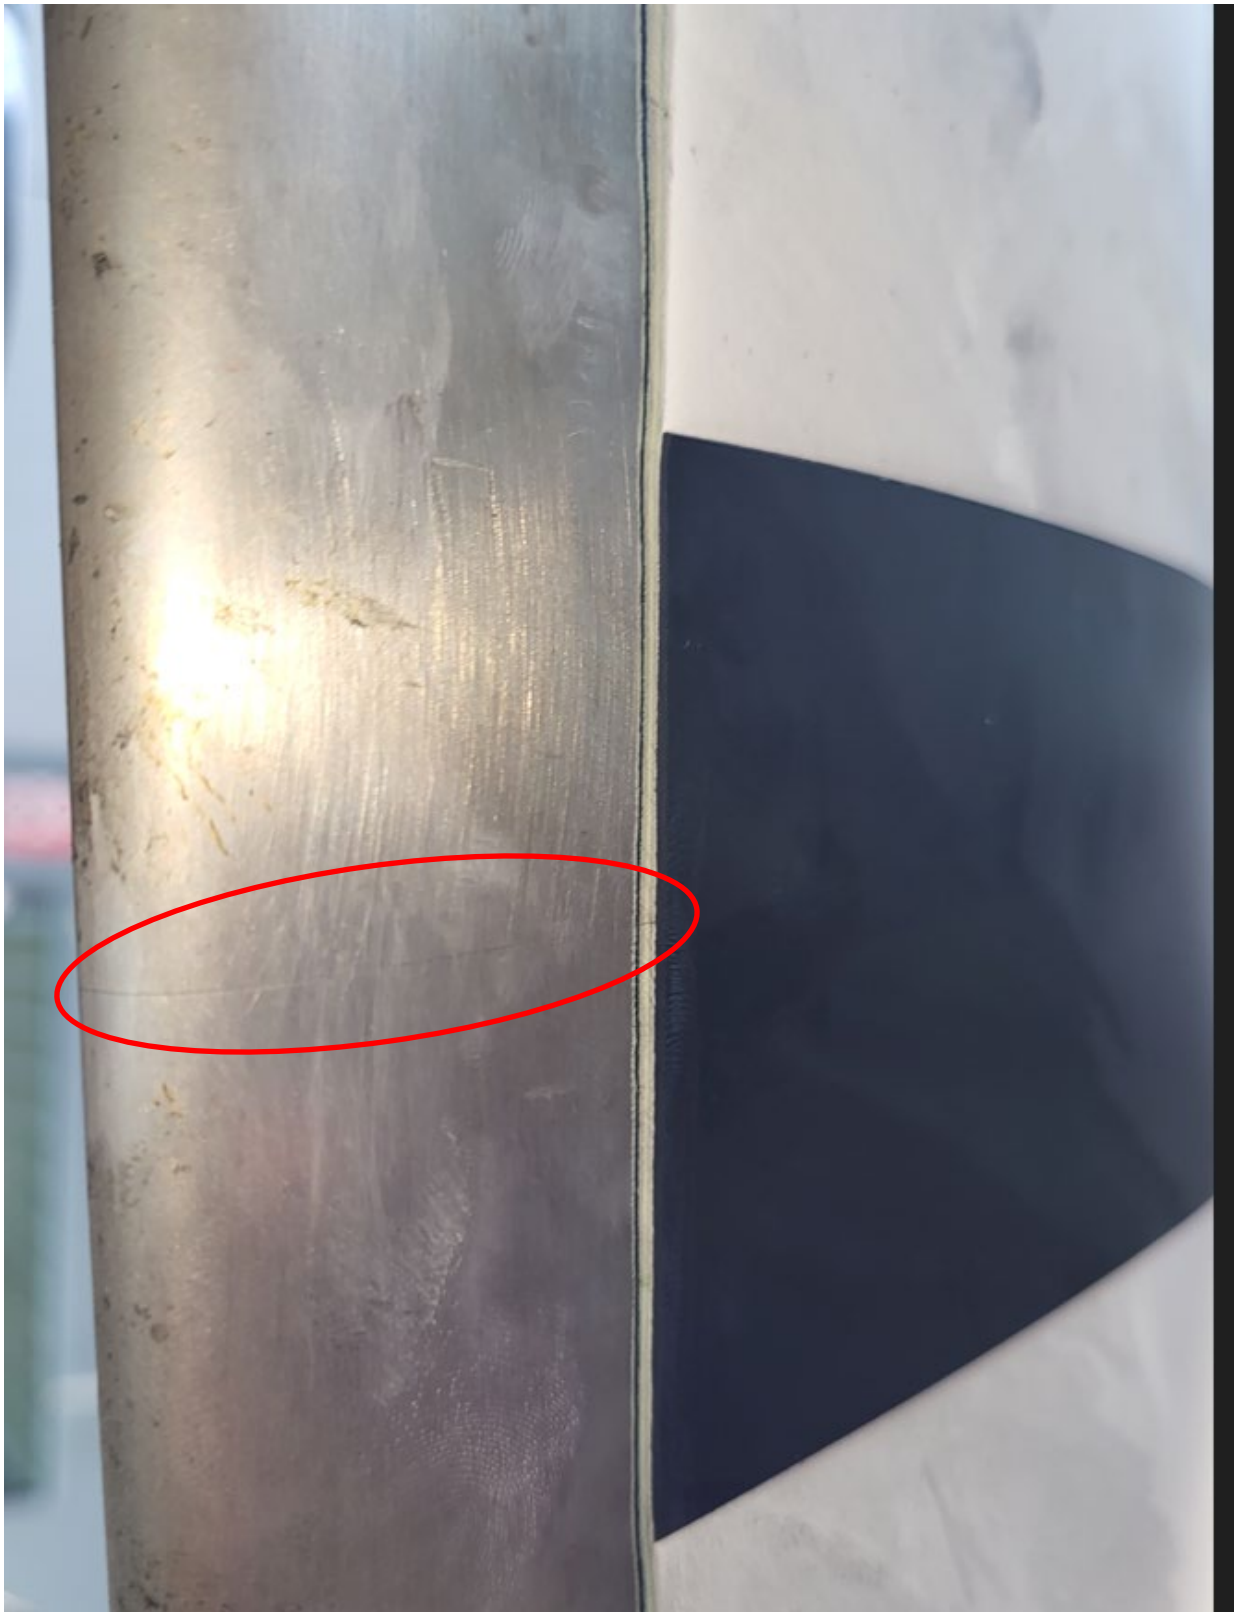
**Figure 2 - Example of a Typical Abrasion Strip Crack**

Bell has noticed a sudden increase in reports from the field of tail rotor abrasion strip cracks. Upon investigation, it was determined that a crucial step in the fabrication of the abrasion strip was missed by one of the suppliers which can result in the presence of stress risers leading to fatigue cracking of the part. This bulletin requires the marking of affected tail rotor blades and subsequent checks and inspections to capture any potential cracks until a terminating action is determined. Tail rotor blade assemblies that have been found to have cracked abrasion strips during the performance of this bulletin shall be kept until further instructions from Bell are received. If the identification of affected tail rotor blades cannot be complied with on location, or if a helicopter with affected tail rotor blade(s) is not located near a maintenance facility at the time of bulletin release, the helicopter can be ferried provided that all four tail rotor blades are checked

1. Before each engine start, visually check both sides of the abrasion strip of the tail rotor blade assemblies that are identified with the paint mark for the presence of chordwise cracks. Refer to Figure 1 for zone to be checked and Figure 2 for an example of a typical crack. If one or more cracks are found, replace the tail rotor blade assembly before next flight ([DMC-429-A-64-10-00-01A-520A-A](#) and [DMC-429-A-64-10-00-01A-720A-A](#)).
2. Make an entry in the helicopter logbook indicating compliance with **PART II** of this Alert Service Bulletin.
