## ALERT SERVICE BULLETIN

**429-24-63**

21 March 2024

- MODEL AFFECTED:** 429
- SUBJECT:** TAIL ROTOR BLADE 429-016-101-105 ABRASION STRIP, INSPECTION OF.
- HELICOPTERS AFFECTED:** **PART I:** Serial numbers 57001 and subsequent.
- PARTS II & III:** Serial numbers 57001 and subsequent, equipped with tail rotor blade serial numbers listed in Table 1.
- COMPLIANCE:**
- PART I** – Before next flight after the release of this bulletin.
- PART II** – Before each engine start after the release of this bulletin.
- PART III** – Every 25 hours after the release of this bulletin.

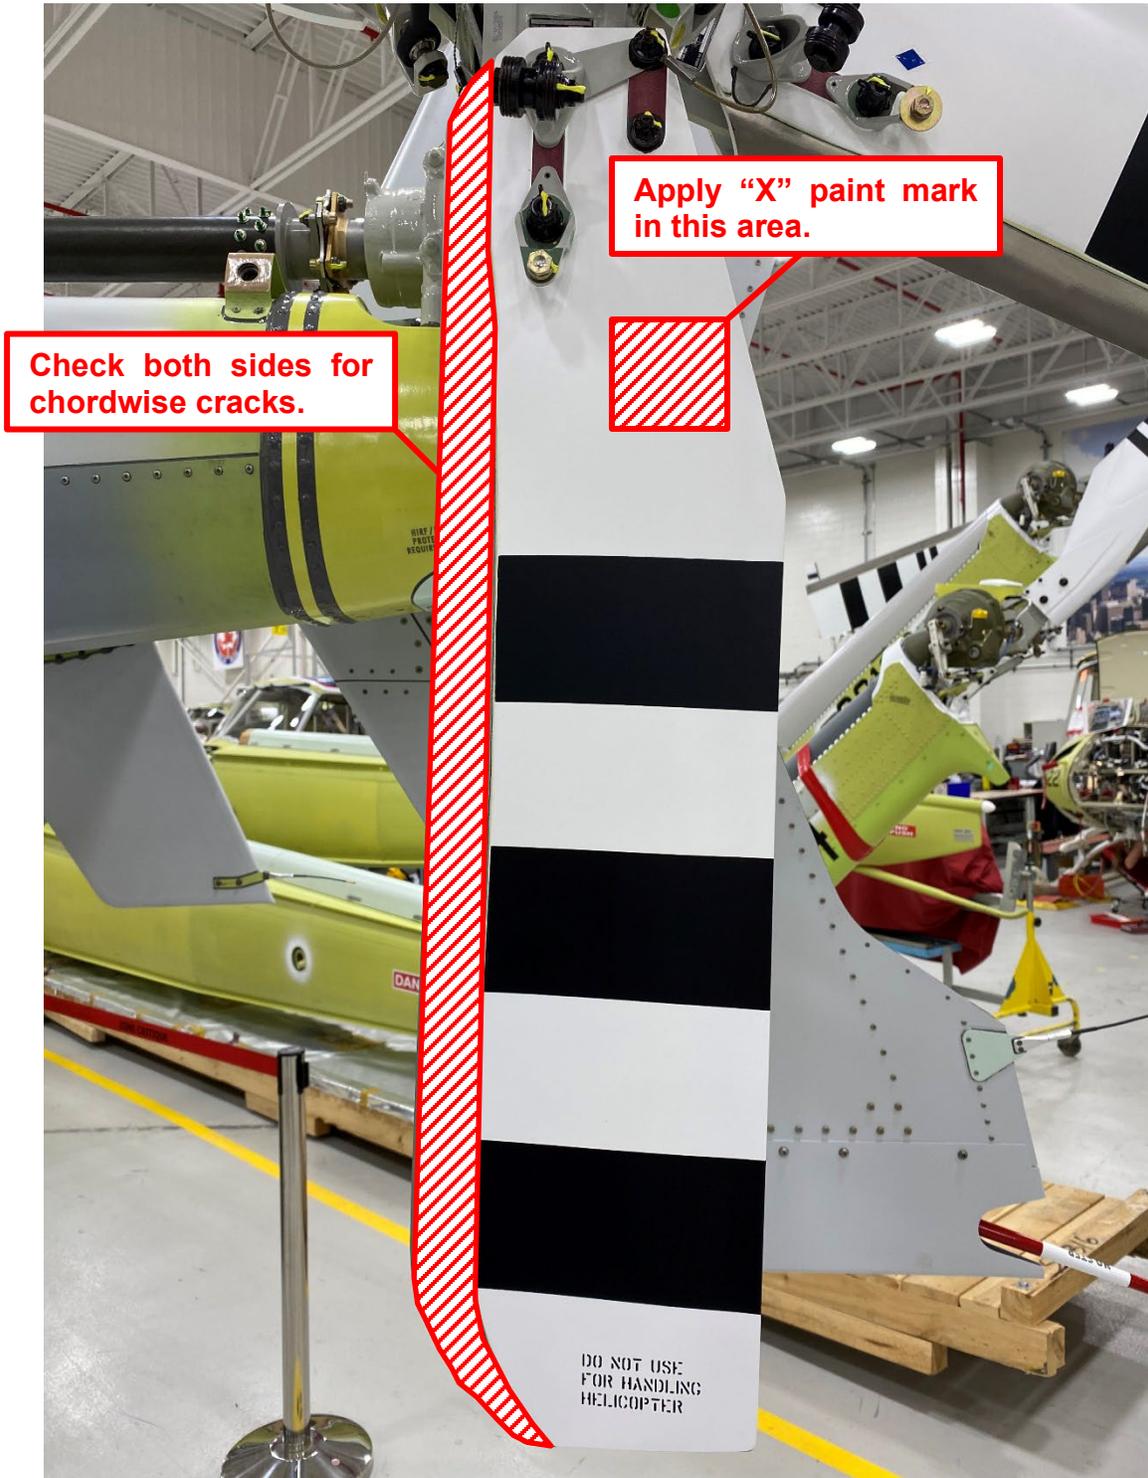
**Figure 1- Application of Paint Mark and Visual Check Zone**

4. Using a bright light, visually inspect both sides of the abrasion strip of each affected tail rotor blade for the presence of chordwise cracks. Refer to Figure 1 for zone to be inspected. If one or more cracks are found, replace the blade before next flight ([DMC-429-A-64-10-00-01A-520A-A](#) and [DMC-429-A-64-10-00-01A-720A-A](#)).

5. If the affected blade abrasion strip does not present any cracks, apply a visual identification mark on the blade with a paint marker as shown in Figure 1. The color shall be clearly visible and different than blue, orange, red and Green.

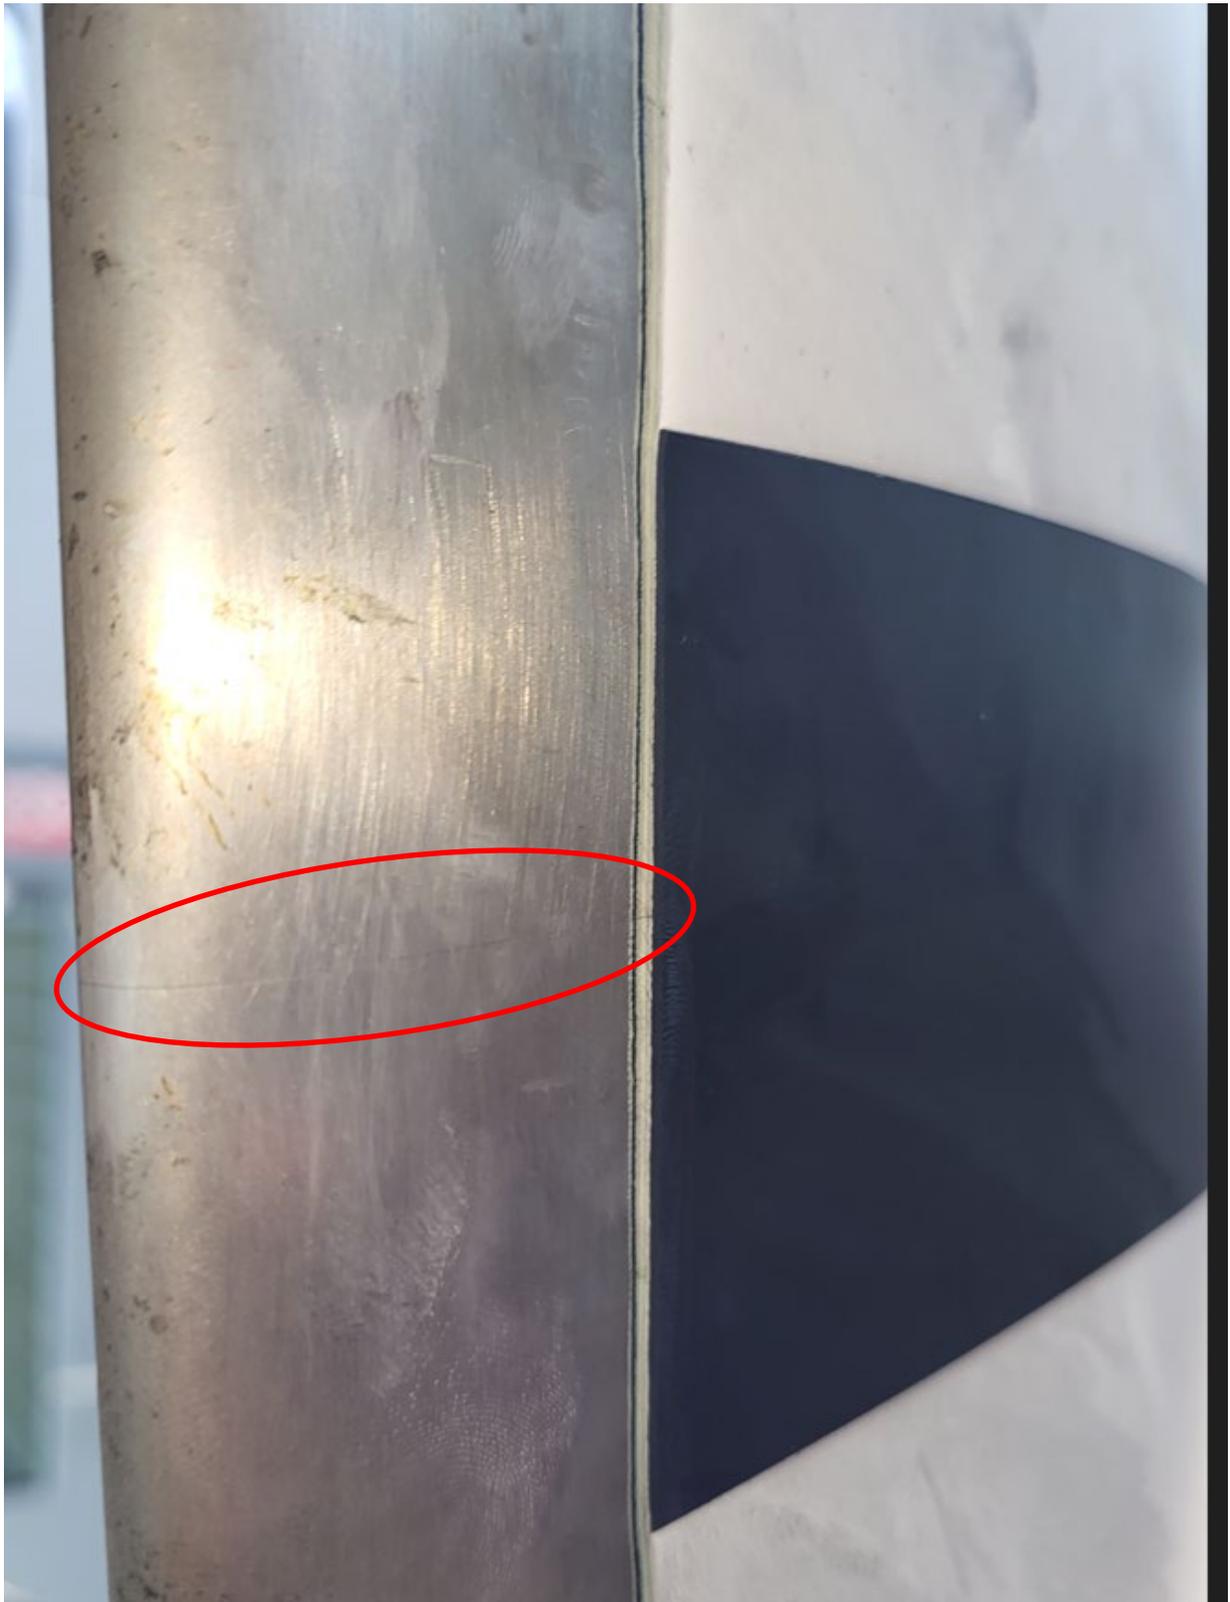
**Figure 2 - Example of a Typical Abrasion Strip Crack**

Bell has noticed a sudden increase in reports from the field of tail rotor abrasion strip cracks. Upon investigation, it was determined that a crucial step in the fabrication of the abrasion strip was missed by one of the suppliers which can result in the presence of stress risers leading to fatigue cracking of the part. This bulletin requires the marking of affected tail rotor blades and subsequent checks and inspections to capture any potential cracks until a terminating action is determined. Tail rotor blade assemblies that have been found to have cracked abrasion strips during the performance of this bulletin shall be kept until further instructions from Bell are received. If the identification of affected tail rotor blades cannot be complied with on location, or if a helicopter with affected tail rotor blade(s) is not located near a maintenance facility at the time of bulletin release, the helicopter can be ferried provided that all four tail rotor blades are checked in accordance with **PART II** and have no cracks on the abrasion strip. The ferry flight shall be completed in only one flight (one leg).

1. Before each engine start, visually check both sides of the abrasion strip of the tail rotor blade assemblies that are identified with the paint mark for the presence of chordwise cracks. Refer to Figure 1 for zone to be checked and Figure 2 for an example of a typical crack. If one or more cracks are found, replace the tail rotor blade assembly before next flight ([DMC-429-A-64-10-00-01A-520A-A](#) and [DMC-429-A-64-10-00-01A-720A-A](#)).
2. Make an entry in the helicopter logbook indicating compliance with **PART II** of this Alert Service Bulletin.
