## ALERT SERVICE BULLETIN

**429-24-63**

**MODEL AFFECTED:** 429

**SUBJECT:** TAIL ROTOR BLADE 429-016-101-105 ABRASION STRIP, INSPECTION OF.

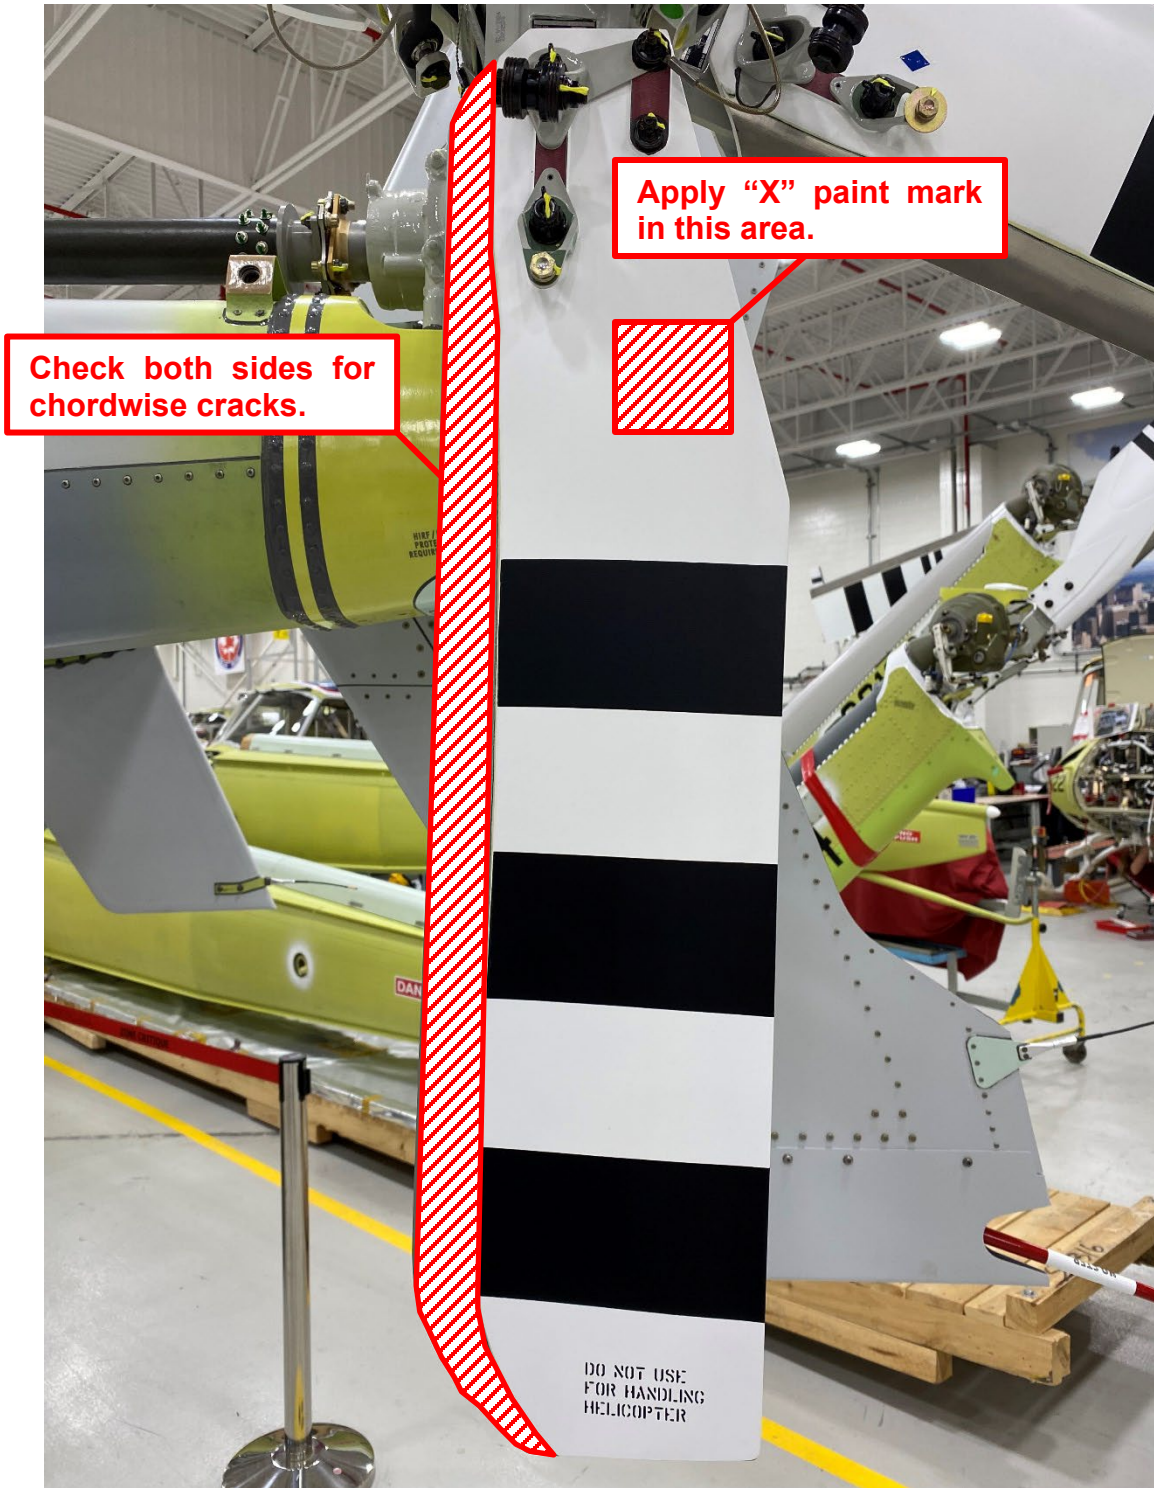
**Figure 1- Application of Paint Mark and Visual Check Zone**

4. Using a bright light, visually inspect both sides of the abrasion strip of each affected tail rotor blade for the presence of chordwise cracks. Refer to Figure 1 for zone to be inspected. If one or more cracks are found, replace the blade before next flight ([DMC-429-A-64-10-00-01A-520A-A](#) and [DMC-429-A-64-10-00-01A-720A-A](#)).

5. If the affected blade abrasion strip does not present any cracks, apply a visual identification mark on the blade with a paint marker as shown in Figure 1. The color shall be clearly visible and different than blue, orange, red and Green.
