ALERT SERVICE BULLETIN

430-22-61

MODEL AFFECTED: 430

SUBJECT: MAIN ROTOR PITCH LINK ASSEMBLY
COMPONENTS - INSPECTION AND
AIRWORTHINESS LIFE REVISION OF

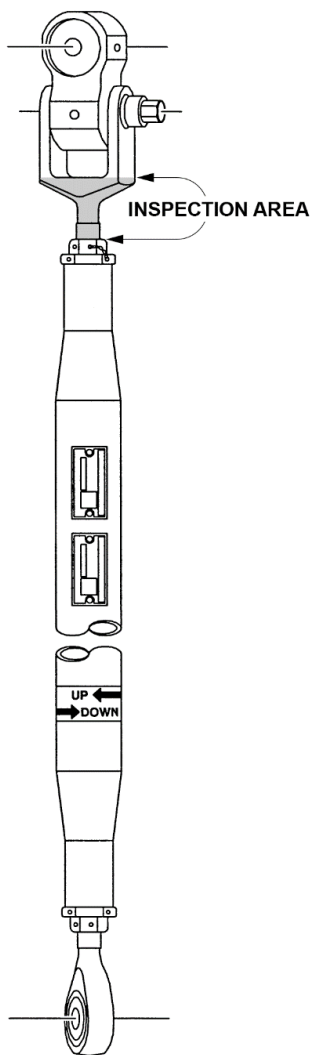
Figure 1 – Main Rotor Pitch Link Assembly Clevis 10X Inspection Area.

3. Perform a detailed visual inspection of the neck and threaded area of the installed pitch link clevises using a 10X magnifying glass (Figure 1). Inspect for corrosion and mechanical damage (BHT-430-CR&O, Chapter 62).
 - a. If no cracks are found, go to step 5.
 - b. If cracks are found, replace the pitch link clevis (BHT-430-CR&O, Chapter 62).
4. Replace any clevises that are beyond allowable damage limits (BHT-430-CR&O, Chapter 62) and report findings to Bell Product Support Engineering at productsupport@bellflight.com.
5. Make an entry in the helicopter logbook and historical service records indicating findings and compliance with **PART II** of this Alert Service Bulletin.

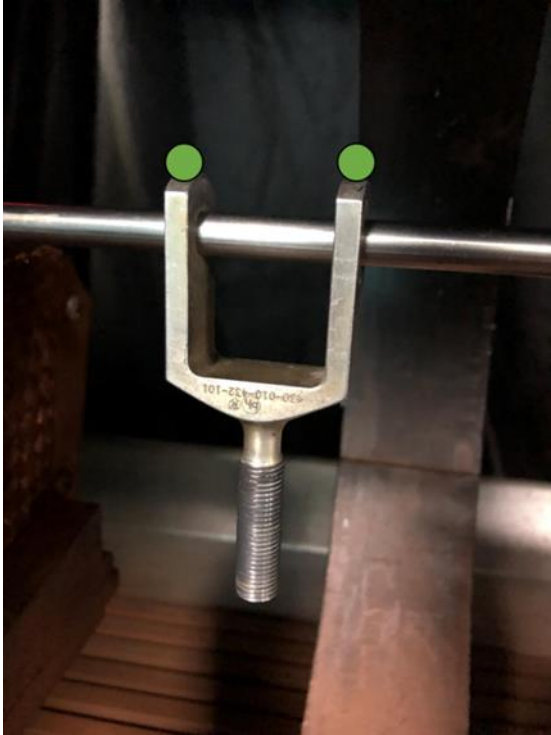
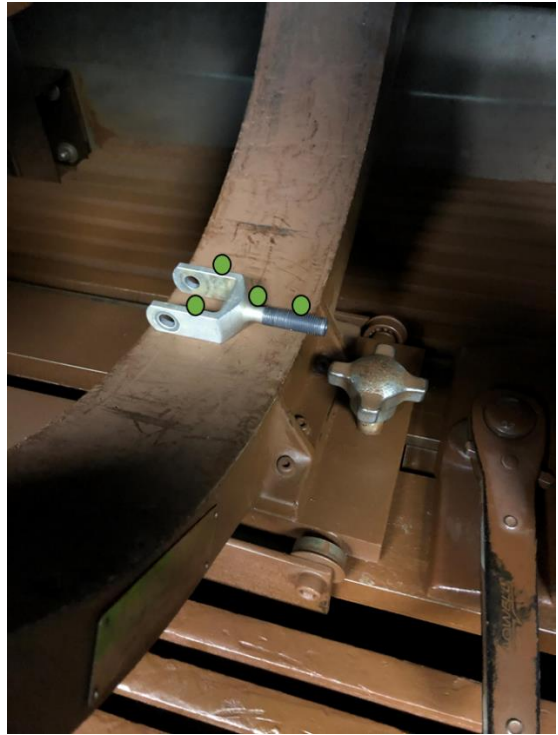
Figure 2 – Magnetic Particle Inspection (MPI).

- c. Perform a Magnetic Particle Inspection (MPI) of the clevises as shown in Figures 2 and 3. Perform a demagnetization between Shot #1 and Shot #2, and again upon completion of the inspection. Refer to BHT-ALL-SPM, Chapter 6, for additional information about the magnetic particle inspection procedures.

Shot #1	Shot #2
Central bar through clevis holes	Coil shot, bottom of 5-turn coil
600 Amps – Demagnetize before Shot #2	400 Amps

- e. Replace any clevises that have signs of cracking and report findings to Bell Product Support Engineering at productsupport@bellflight.com.
2. If no anomalies are found during the magnetic particle inspection, perform selective brush cadmium plating to replace any missing cadmium plating. Following the brush cadmium plating, apply the chromate conversion coating (BHT-ALL-SPM, Chapter 3).

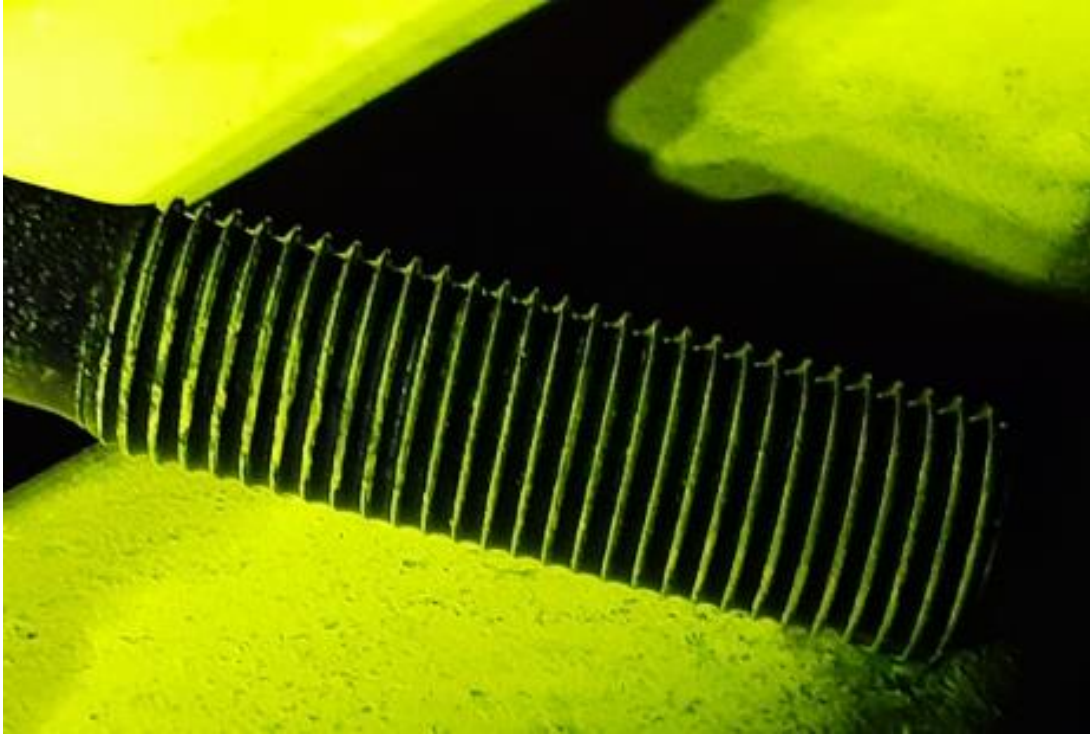
Figure 3 – Photo of Shot #2 of Magnetic Particle Inspection (MPI)

- d. Use a 10X magnifying glass under ultraviolet (UV) lighting to inspect the neck and thread root areas. When inspecting threads, only check the root areas after Shot #2. Top of threads may have fluorescence. If excessive fluorescence is observed on the threads that have been in contact with the coil, rotate the part 180 degrees and perform Shot #2 again.

1. Top of threads may show fluorescence. Inspect root areas for indication of cracking.
2. Due to the fine threads on the clevis, it is recommended that the inspection of the root areas be accomplished using a 10X magnifying glass under UV lighting.
