ALERT SERVICE BULLETIN

505-19-11

MODEL AFFECTED: 505

SUBJECT: TAIL ROTOR BLADE ROOT END, INSPECTION OF

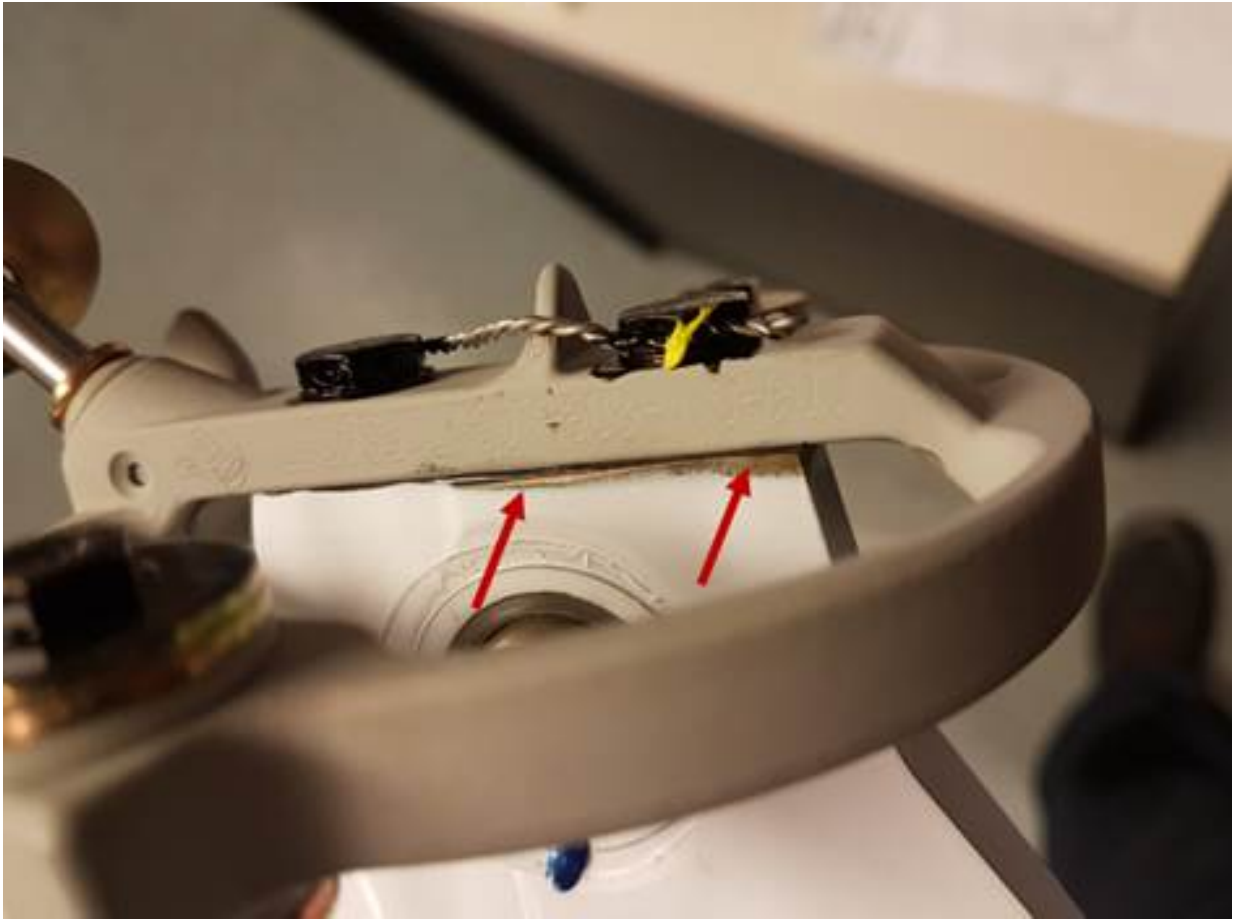
Bell has become aware of a condition that affects the installation of the pitch horn assembly to tail rotor blade root end. Per the assembly instructions, sealant is applied to cover any remaining bare unpainted sections of the tail rotor blade root end. It is possible that some tail rotor blade assemblies delivered are missing this sealant.

FIGURE 1 - Tail Rotor Blade Root End without Sealant

- b. Confirm there is no exposed unpainted tail rotor blade root end surfaces adjacent to the pitch horn (Figure 1).
 - c. If surfaces are found properly sealed (Figure 2), go to step 3.

- d. If some bare metal surfaces are found exposed (Figure 1), inspect for corrosion.
 - (1) If no corrosion is found, apply a smooth coat of sealant (C-308) to all sections of unpainted surfaces of tail rotor blade root end. Blend into pitch horn face and fair smooth (Figure 2). Allow sufficient time for sealant (C-308) to cure before flight. Go to step 3.

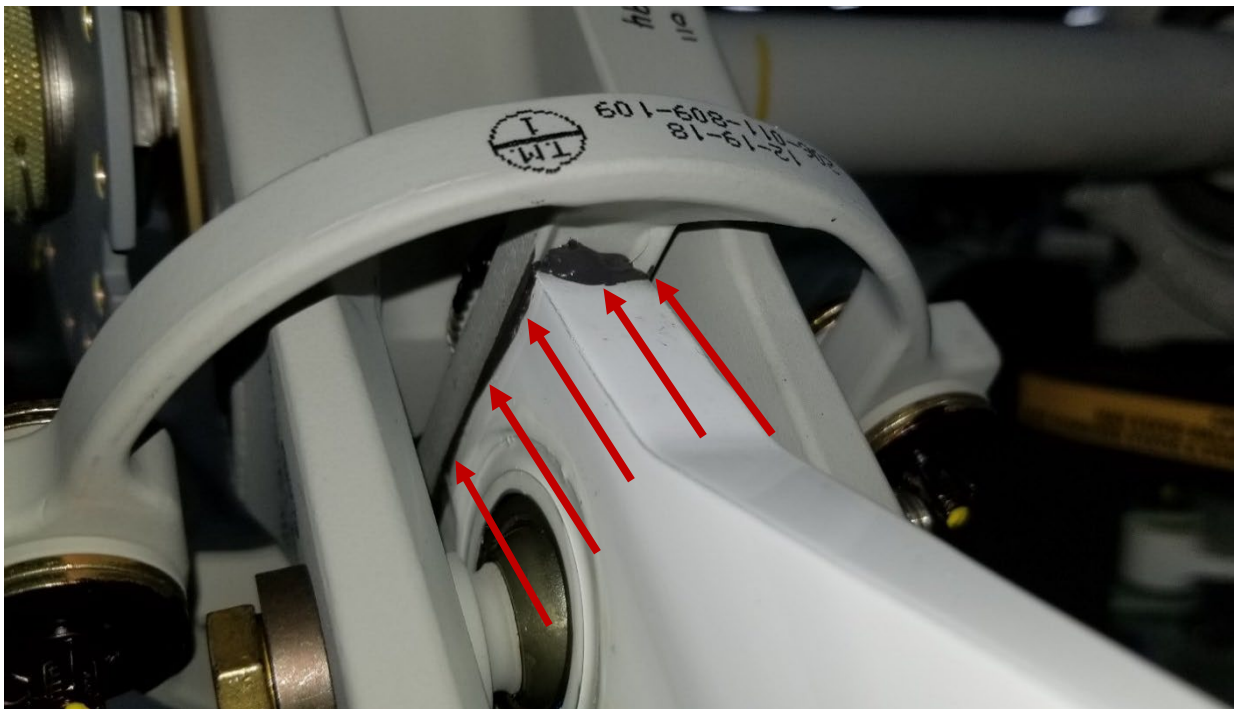
FIGURE 2 - Tail Rotor Blade Root End with Sealant Applied

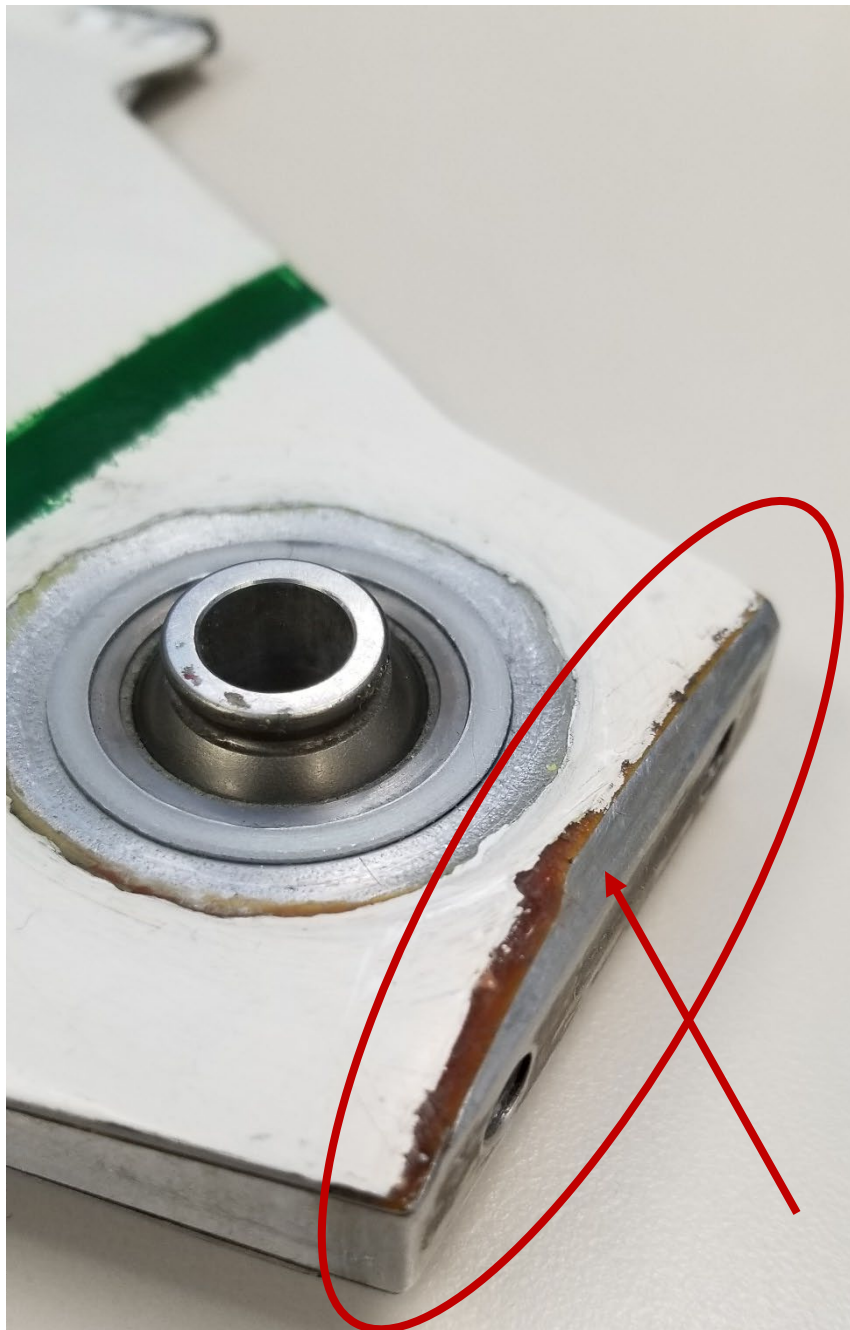
FIGURE 3 – Example of Tail Rotor Blade Root End Tapered Aluminum Butt Block

- (2) If surface corrosion is present on tapered area of the aluminum butt block of the tail rotor blade (Figure 3), report findings including location, size, and depth of damage found to Product Support Engineering (PSE) at productsupport@bellflight.com. Photos would also be a benefit for evaluation. PSE will provide maintenance actions required for completion of the ASB.
