ALERT SERVICE BULLETIN

505-20-19

MODEL AFFECTED: 505

SUBJECT: MAIN ROTOR BLADES P/N 206-015-001-119 ROOT END DOUBLERS, INSPECTION OF.

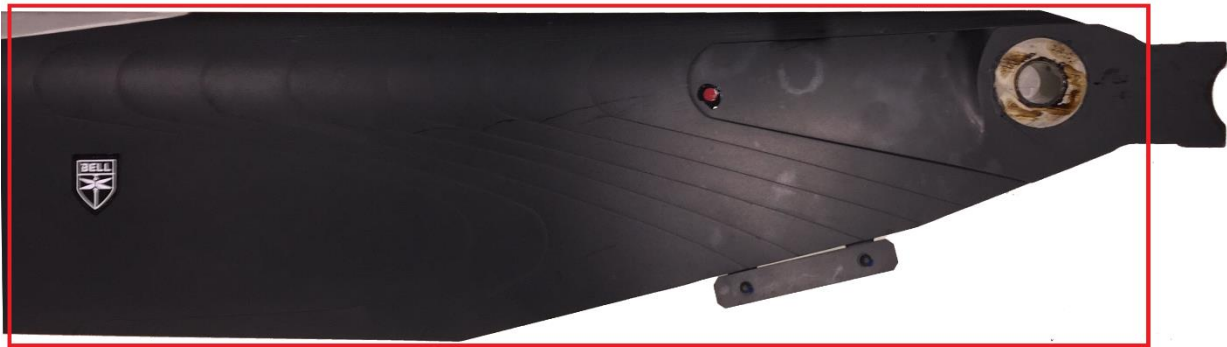
Figure 1. Area to be inspected with 3X- power magnifying glass, from STA 15.0 to STA 58.0 (upper and lower surfaces).

2. Wipe the area to be inspected (Figure 1 and 2) with an alcohol-soaked cloth (C-385) and wipe dry with a clean cloth.
3. Visually inspect the main rotor blade upper and lower grip plates and doublers for signs of cracks, corrosion, and edge voids as follows. Pay particular attention to the bond lines between the doublers, grip plates, and skin:
 - a. Using a 3X power magnifying glass and strong light source carry out a detailed visual inspection of the top and bottom inspection areas (Figure 1).
 - b. Check for evidence of a dark line between the doublers, grip plates, and skin with excess alcohol bleeding out for possible edge voids (Figure 2).

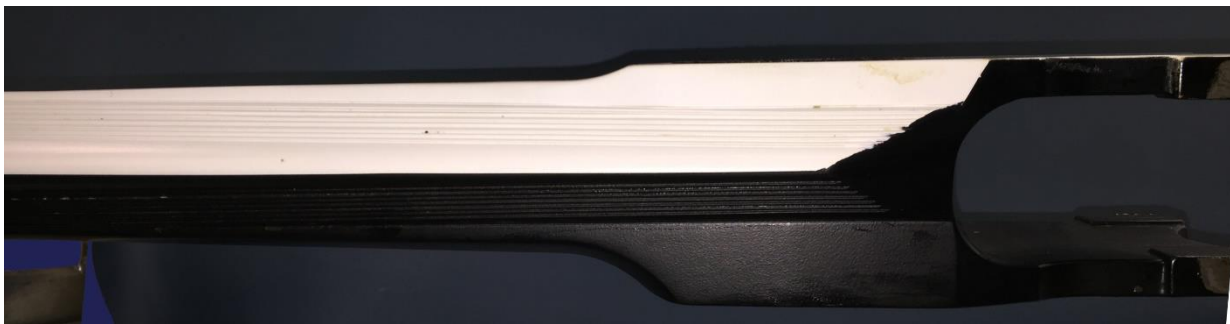
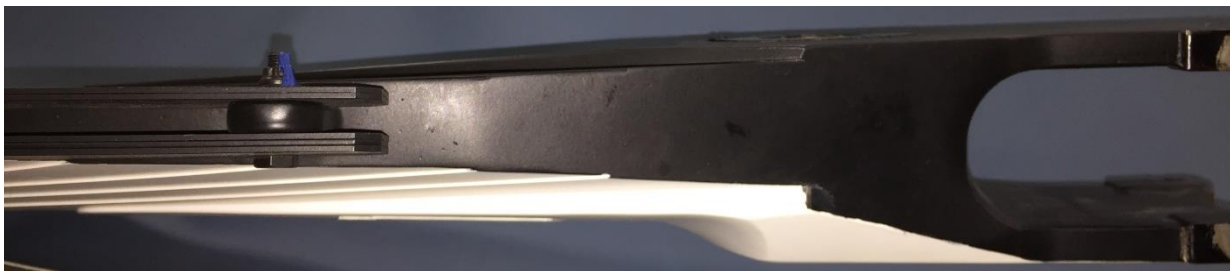
Any potential cracks in the bond lines between the doublers or grip plates will be indicated by the presence of excess alcohol bleeding out of an edge void. This excess alcohol in the void will appear as a dark line between the bond lines of the doublers. Proceed with the inspection of an area immediately after the alcohol wipe.

Figure 2. Inspect the leading edge from STA 15.0 to STA 58.0 and trailing edge from STA 15.0 to STA 56.0 of the blade for crack between each doublers and the grip plates.

- c. If cracks in the finish are found between doublers, grip plates and skin edges, sand the affected area in a spanwise direction with an abrasive cloth or paper (C-406) 180 to 220 grit to determine if the grip plate/doublers are cracked or voided.

- d. If edge voids between the grip plate/doublers/skin are found, determine the depth and length with a 0.0015 inch (0.038 mm) feeler gauge. If edge voids are suspected near the outboard tip of the grip plate/doublers, carry out a tap test of the affected area. Contact Product Support Engineering for voids limits and repair instructions.
 - e. Refinish the sanded area ([DMC-505-A-62-10-01-00A-250A-A](#)).
4. Following the inspection, apply a light coat of preservative oil (C-125) to all surfaces of the blade ([DMC-505-A-62-10-01-00A-250A-B](#)).
 5. Make an entry in the helicopter logbook and historical service records of the helicopter and the main rotor blade indicating findings and compliance with **PART II** of this Alert Service Bulletin.
