ALERT SERVICE BULLETIN

505-21-20

MODEL AFFECTED: 505

SUBJECT: PILOT COLLECTIVE STICK AND GRIP ASSEMBLY
M207-20M478-041/-043/-047, ONE-TIME DETAILED
INSPECTION OF.

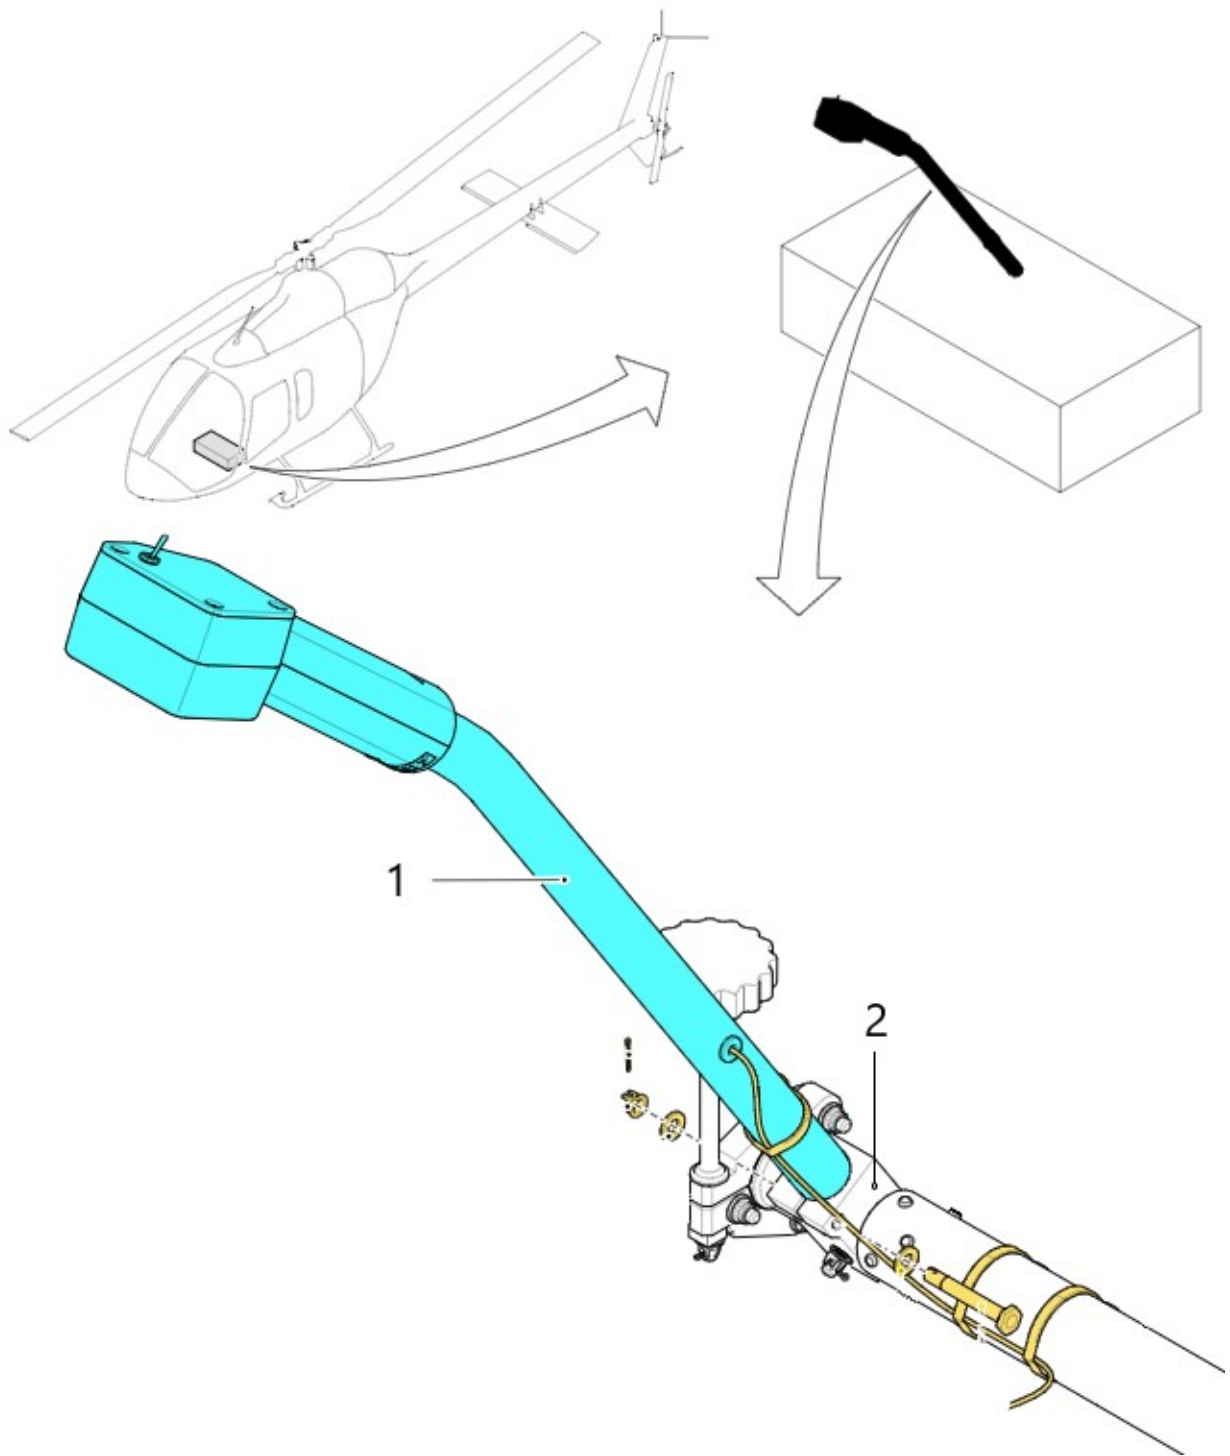
FIGURE 1 – Pilot Collective Stick and Jackshaft Assembly

Bell has received a report where a pilot collective stick assembly broke above the cabin floor at the junction with the collective jackshaft. This finding occurred during a pilot pre-flight check of flight controls for travel per BHT-505-FM Rotorcraft Flight Manual instructions.

2. Prepare the helicopter for maintenance.
3. Remove pilot collective stick and grip assembly (1, Figure 1) ([DMC-505-A-67-11-01-00A-520A-A](#)) from jackshaft assembly (2).
