ALERT SERVICE BULLETIN

505-21-21

MODEL AFFECTED: 505

SUBJECT: SUMP DRAIN FITTING GROMMET NAS557-18C,
INSTALLATION OF

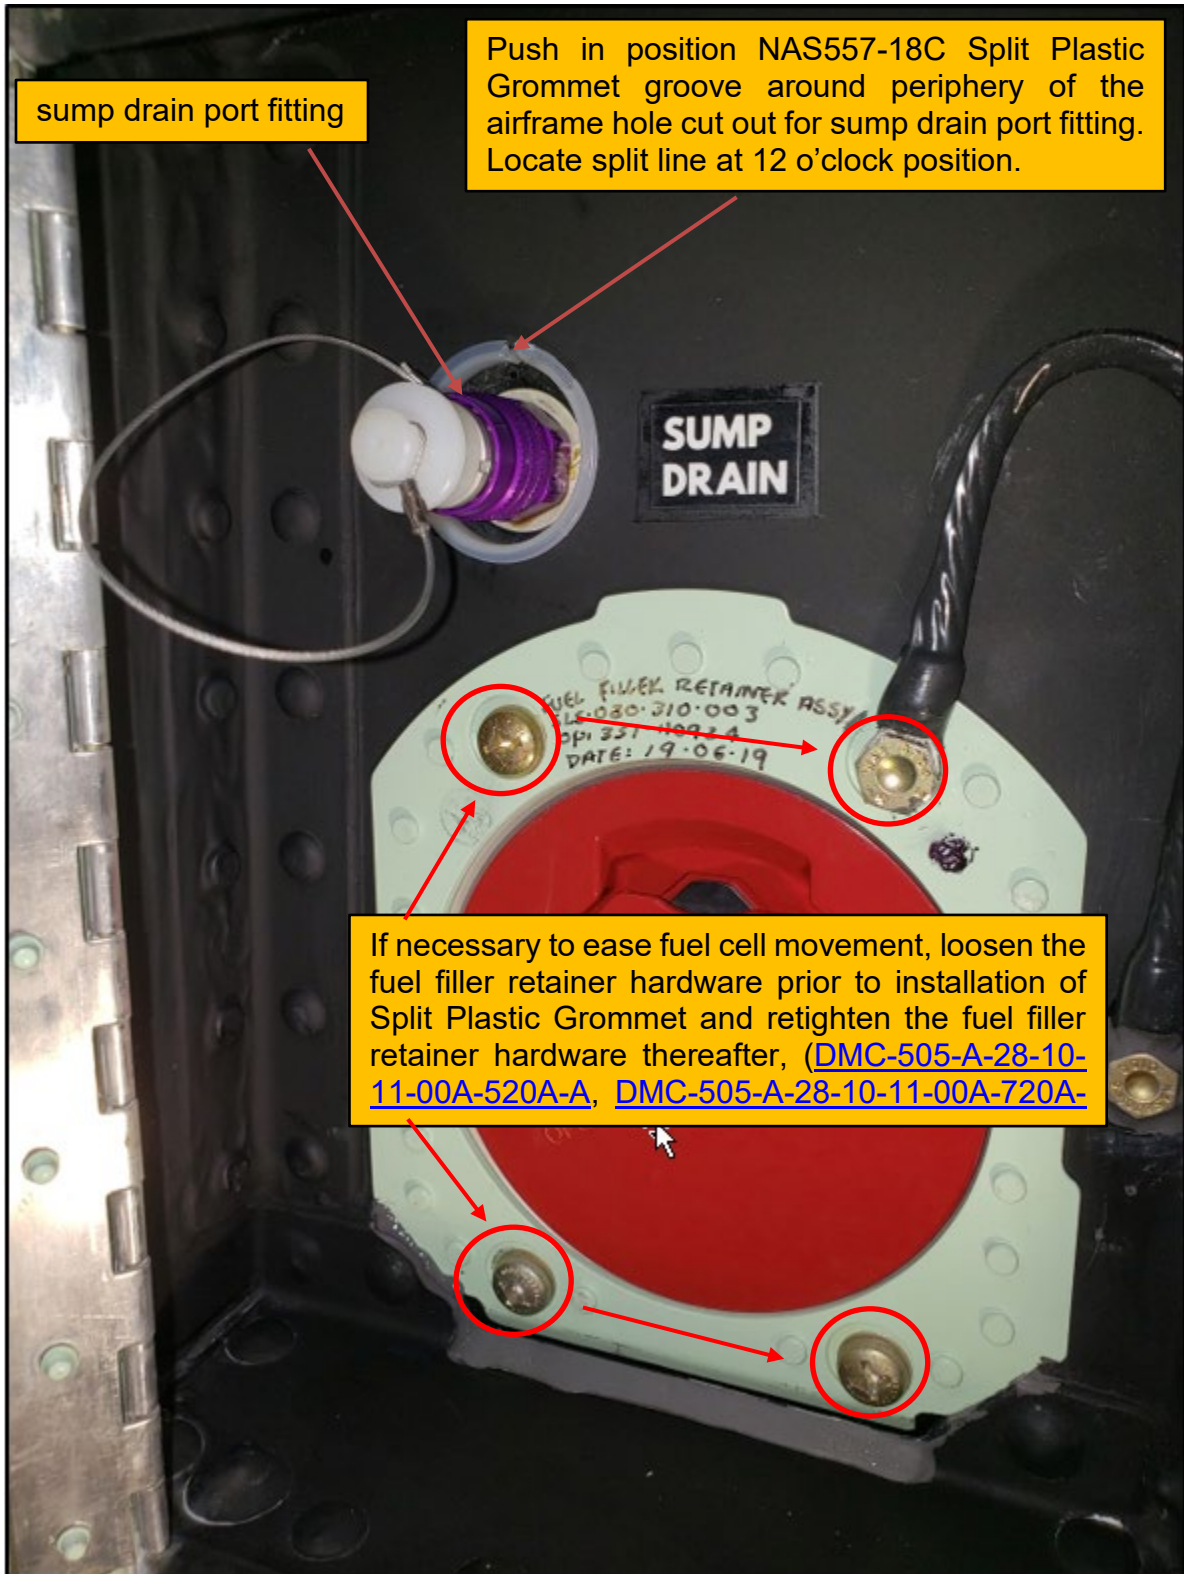
FIGURE 1 – Fuel Filler Compartment (Zone 172)

During airframe drop testing activity, it was discovered that by adding a frangible split plastic grommet interface to the airframe cutout where the sump drain fitting passes through provided an additional safeguard to the integrity of this installation following an impact.

1. Prepare the helicopter for maintenance.
2. Gain access to the fuel filler compartment (Zone 172), [DMC-505-A-06-30-00-00A-030A-A](#).
3. Locate sump drain port fitting (Figure 1).

If necessary to ease fuel cell movement, loosen the fuel filler retainer hardware prior to installation of Split Plastic Grommet and retighten the fuel filler retainer hardware thereafter, ([DMC-505-A-28-10-11-00A-520A-A](#), [DMC-505-A-28-10-11-00A-720A-A](#)) (Figure 1).

- a. Push in position NAS557-18C Split Plastic Grommet groove around periphery of the airframe hole cut out for sump drain port fitting (Figure 1).
 - (1) Locate split line at 12 o'clock position.
4. Close access to the fuel filler compartment (Zone 172), [DMC-505-A-06-30-00-00A-030A-A](#).
5. Make an entry in the helicopter logbook and historical service records indicating compliance with this Alert Service Bulletin.
