ALERT SERVICE BULLETIN

505-21-26

MODEL AFFECTED: 505

SUBJECT: FUEL CELL VENT PREFLIGHT INSPECTION,
ADDITION OF

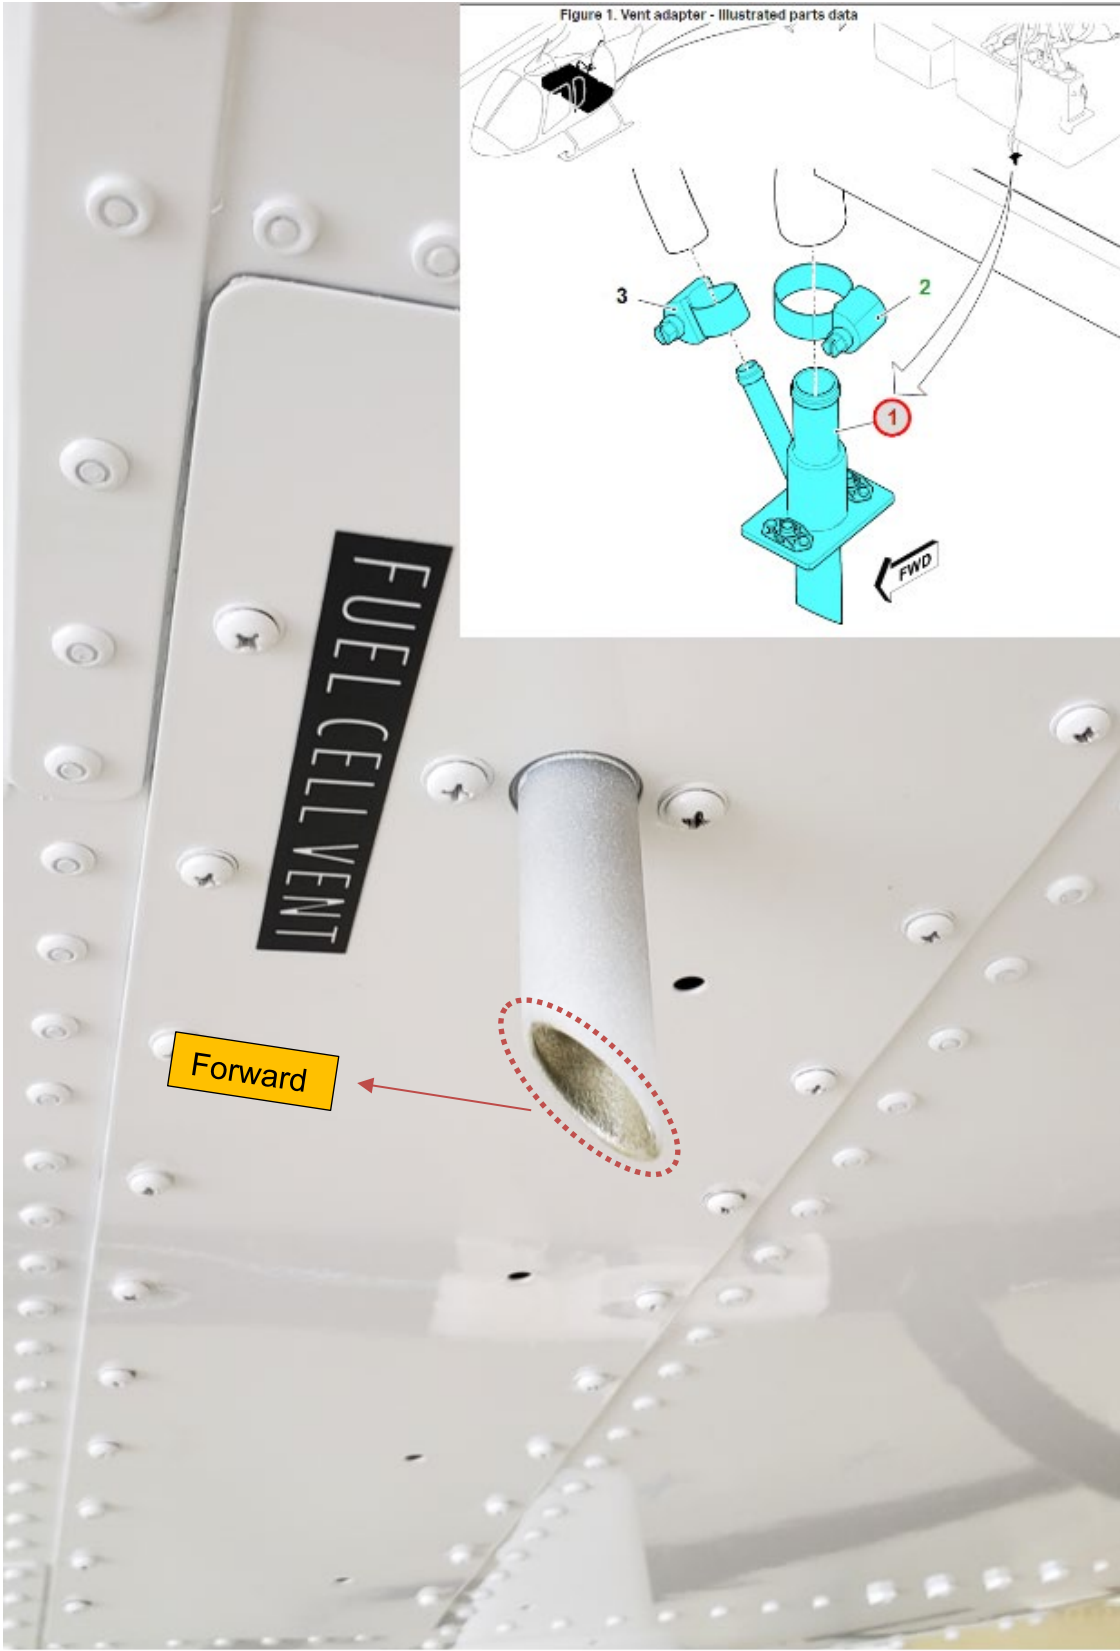
Figure 1 – Fuselage – Front

Bell has received a field report where a damaged fuel cell vent fitting created an air flow vacuum out of the fuel cell causing the fuel indication to fluctuate proportional to the airspeed. The suction effects in such an occurrence could collapse the fuel cell bladder thereby indicating a higher fuel quantity total than actually exists. Jointly as the fuel cell empties during the flight, activation of the fuel low level sensor could be delayed.

Both the forward and aft vent lines are joined into a single vent line which exits at the bottom of the fuselage on the left side of the control tunnel. A scarf cut on the outlet of the vent line is oriented forward to slightly pressurize the fuel vent system while in forward flight.

1. Prepare the helicopter for maintenance.
2. Inspect the fuel vent tube for damage and ensure the bevel (scarf) is facing forward (Figure 1). The tube should have smooth edges and be free of chips or cracks.
3. Insert applicable BHT-505-FM-1 Rev. 8 or BHT-505-FM-2 Rev. 2 Rotorcraft Flight Manual Revision.
4. Communicate to the Model 505 pilots and maintenance personnel the contents of the newly inserted Rotorcraft Flight Manual Revision change.
 - (1) Review paragraph 2-3-B-8, Fuselage – Front, Item 10, Vents and Drains – Condition and Security.
 - (2) Familiarize crew with fuel cell vent criteria for shape and opening facing forward (Figure 1).
 - (a) The Manufacturer's Data BHT-505-MD-1 and BHT-505-MD-2, Section 1, paragraph 1-24-C offers the following description.
