## **ALERT SERVICE BULLETIN**

**505-21-27**  
**7 OCTOBER 2021**

**MODEL AFFECTED:** 505

**SUBJECT:** GENESYS THIRD AXIS AUTOPILOT  
INSTALLATION FOR POSSIBLE CHAFFING WITH  
TAIL ROTOR CONTROL CABLE, INSPECTION OF.

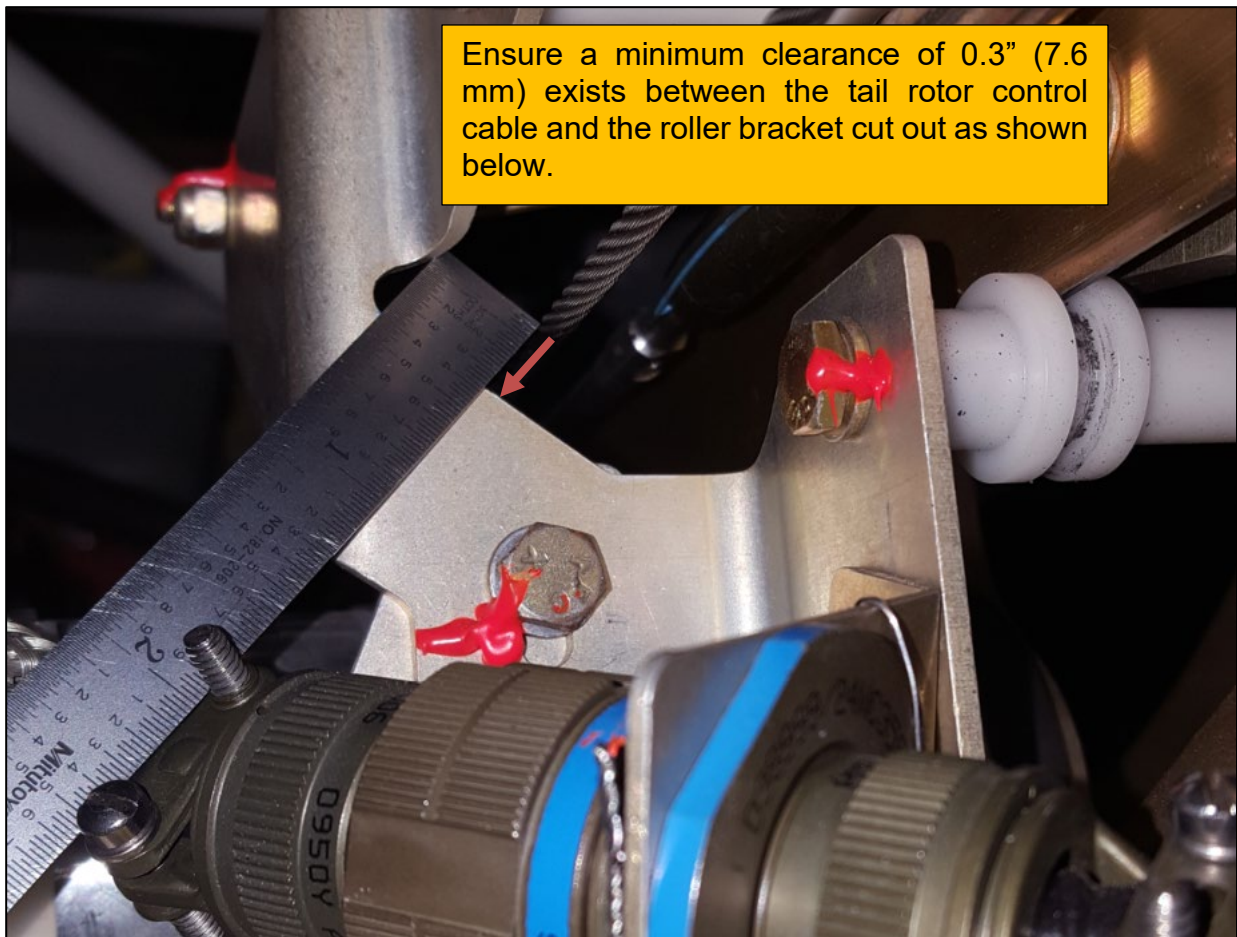
**Figure 1 – Roller Bracket Assembly Installation**

- a. Gain access to roller bracket assembly installation as shown in Figure 1.
  - b. Inspect the right forward tail rotor control cable in the area of the roller bracket assembly for any signs of contact. Move the tail rotor pedals through the full range of motion and inspect the tail rotor control cable M207-20M489-041 for chaffing damage (Figure 2). If there is no chaffing damage go to step 3.

- (3) If chaffing damage is found cable assembly M207-20M489-041 must be replaced.
3. Ensure a minimum clearance of 0.3" (7.6 mm) exists between the tail rotor control cable and the roller bracket cut out. Refer to Genesys Install Instructions ST-974-II-0001 for height adjustment options of the roller bracket assembly position.

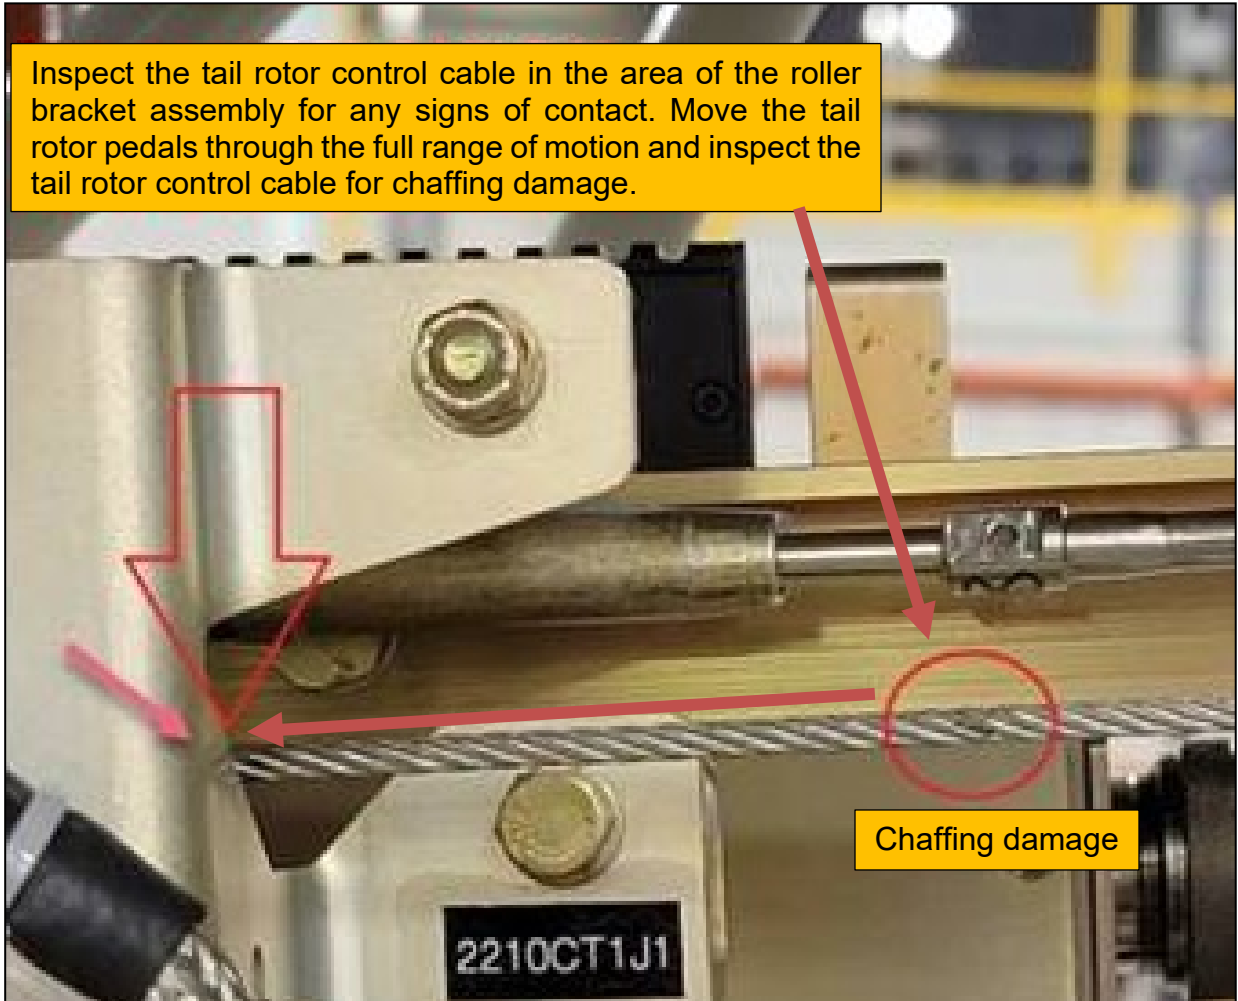
**Figure 2 – Tail Rotor Control Cable Chaffing Damage Example**
