## ALERT SERVICE BULLETIN

**505-24-38**

**MODEL AFFECTED:** 505

**SUBJECT:** VERTICAL STABILIZER ASSEMBLY, TOP END CAP ASSEMBLY, INSPECTION OF.

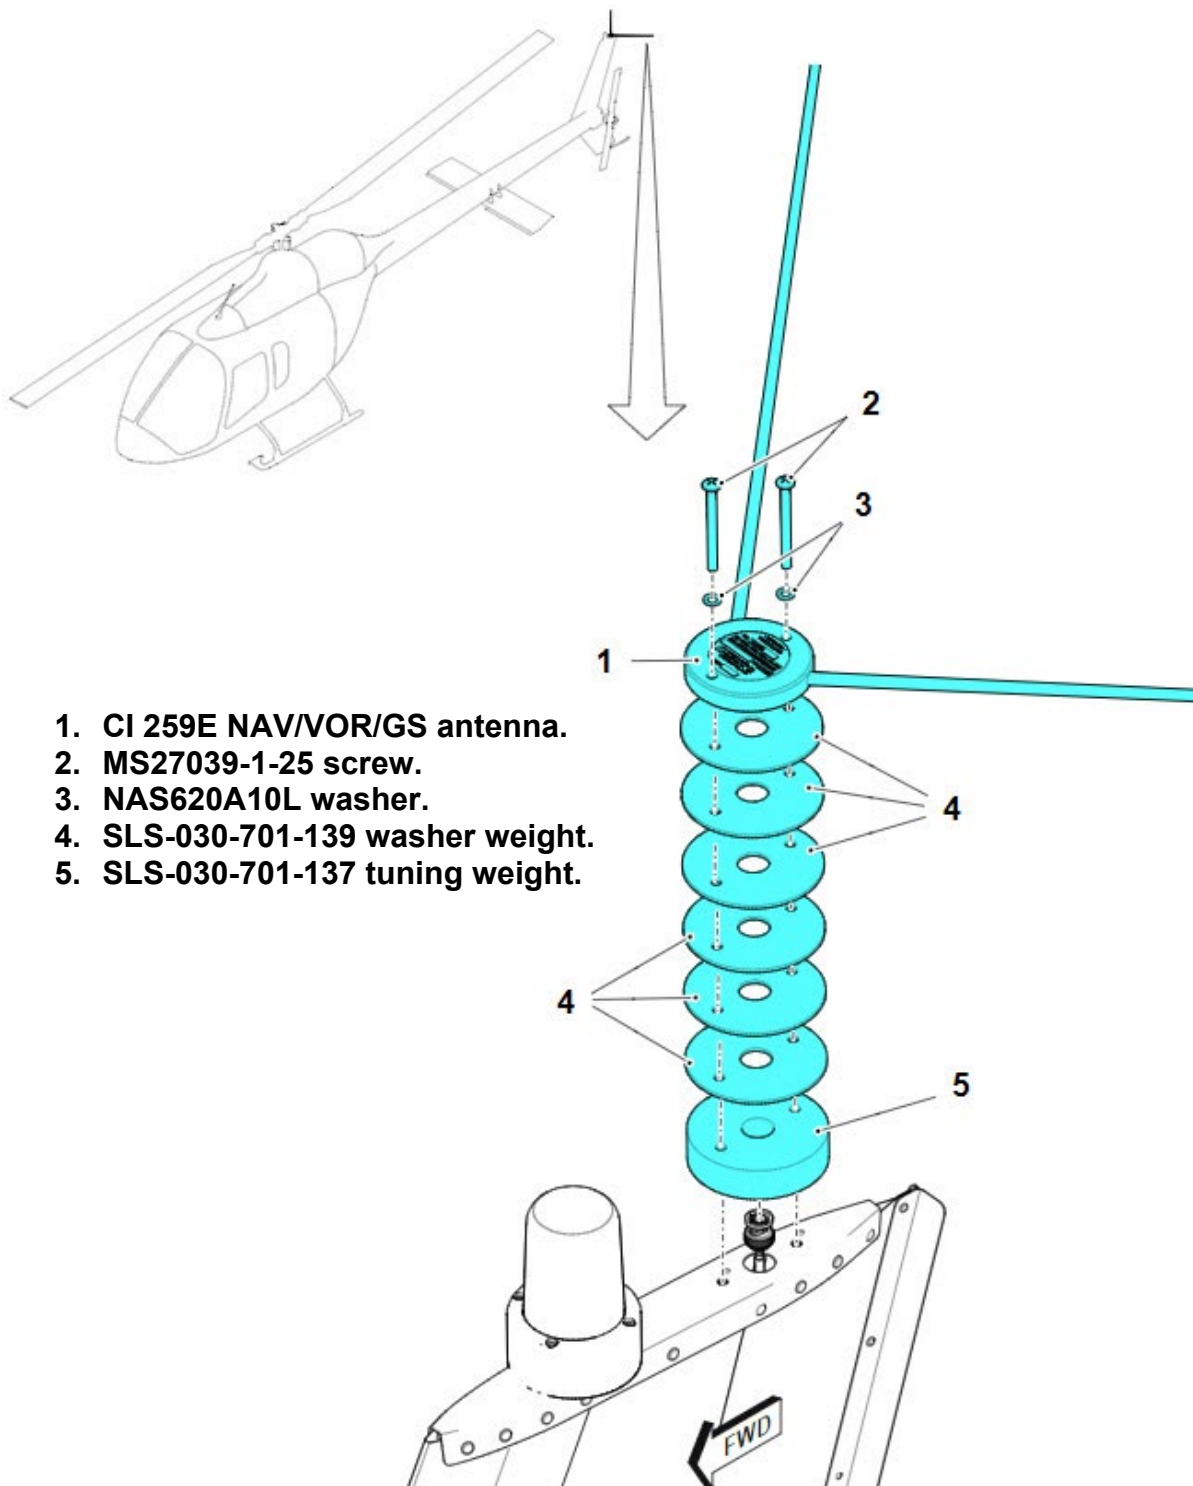
**Figure 1 – NAV/VOR/GS Antenna and Tuning Weight Installation  
(helicopter serial numbers 65011 through 65169)**

Helicopters serial number 65011 through 65169 have been delivered with five tuning weight washers SLS-030-701-139 and one tuning weight SLS-030-701-137 installed. Serial numbers 65170 and subsequent will have one tuning weight SLS-030-701-141 installed (Figures 1 and 2).

9. Install the tuning weight(s) to the surface of the top end cap assembly. Apply sufficient torque to the retaining screws (2, Figure 1 and 2) until sealant (C-251) squeeze-out occurs between the top end cap assembly and the tuning weight. Allow the sealant to cure.
10. Once the sealant (C-251) has cured, remove the tuning weight(s).
11. Remove the tape (C-454) from the top end cap assembly.

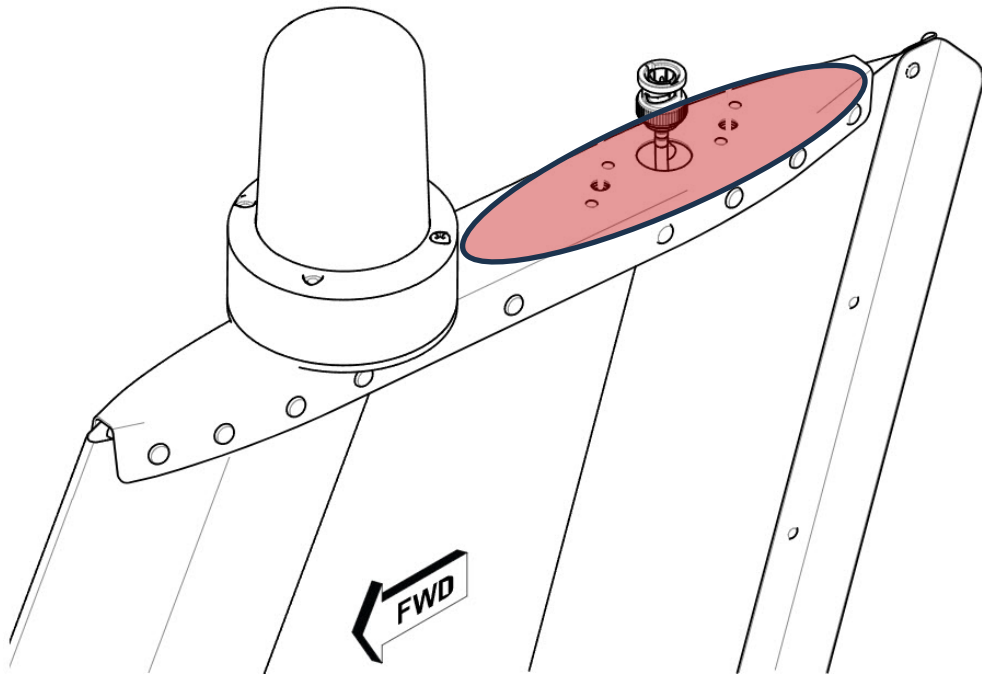
**Figure 3 – Area of Detailed inspection**

Bell has received reports of the top end cap assemblies of the vertical stabilizer assembly found cracked, and in two cases, departure of the NAV/VOR/GS antenna and tuning weight from the helicopters while in flight.

2. Remove the NAV/VOR/GS antenna and tuning weight(s) ([DMC-505-A-34-52-02-00A-520A-A](#)).
3. Secure the NAV/VOR/GS antenna coaxial cable so that it does not fall into the vertical stabilizer assembly.
4. Remove any residual sealant (C-251) that may be present on the top end cap and tuning weight.
5. Using isopropyl alcohol (C-385) clean the surface of the top end cap assembly and allow to dry.
6. Perform a detailed inspection for any cracks of the top end cap assembly in area indicated (Figure 3).
  - a. If no cracks are found, go to step 7.

- b. If a crack is found, replacement of the cracked top end cap assembly, by accomplishment of **PART II**, shall be accomplished prior to next flight. Complete the remaining steps of **PART I** following accomplishment of **PART II**.

4. Perform a detailed inspection for any cracks of the top end cap assembly in area indicated (Figure 3).
  - a. If no cracks are found, go to step 5.
  - b. If a crack is found, replacement of the cracked top end cap assembly, by accomplishment of **PART II**, shall be accomplished prior to next flight.
