ALERT SERVICE BULLETIN

505-24-42

MODEL AFFECTED: 505

SUBJECT: TAIL ROTOR PITCH LINK ASSEMBLY
INSTALLATION, ONE-TIME INSPECTION OF.

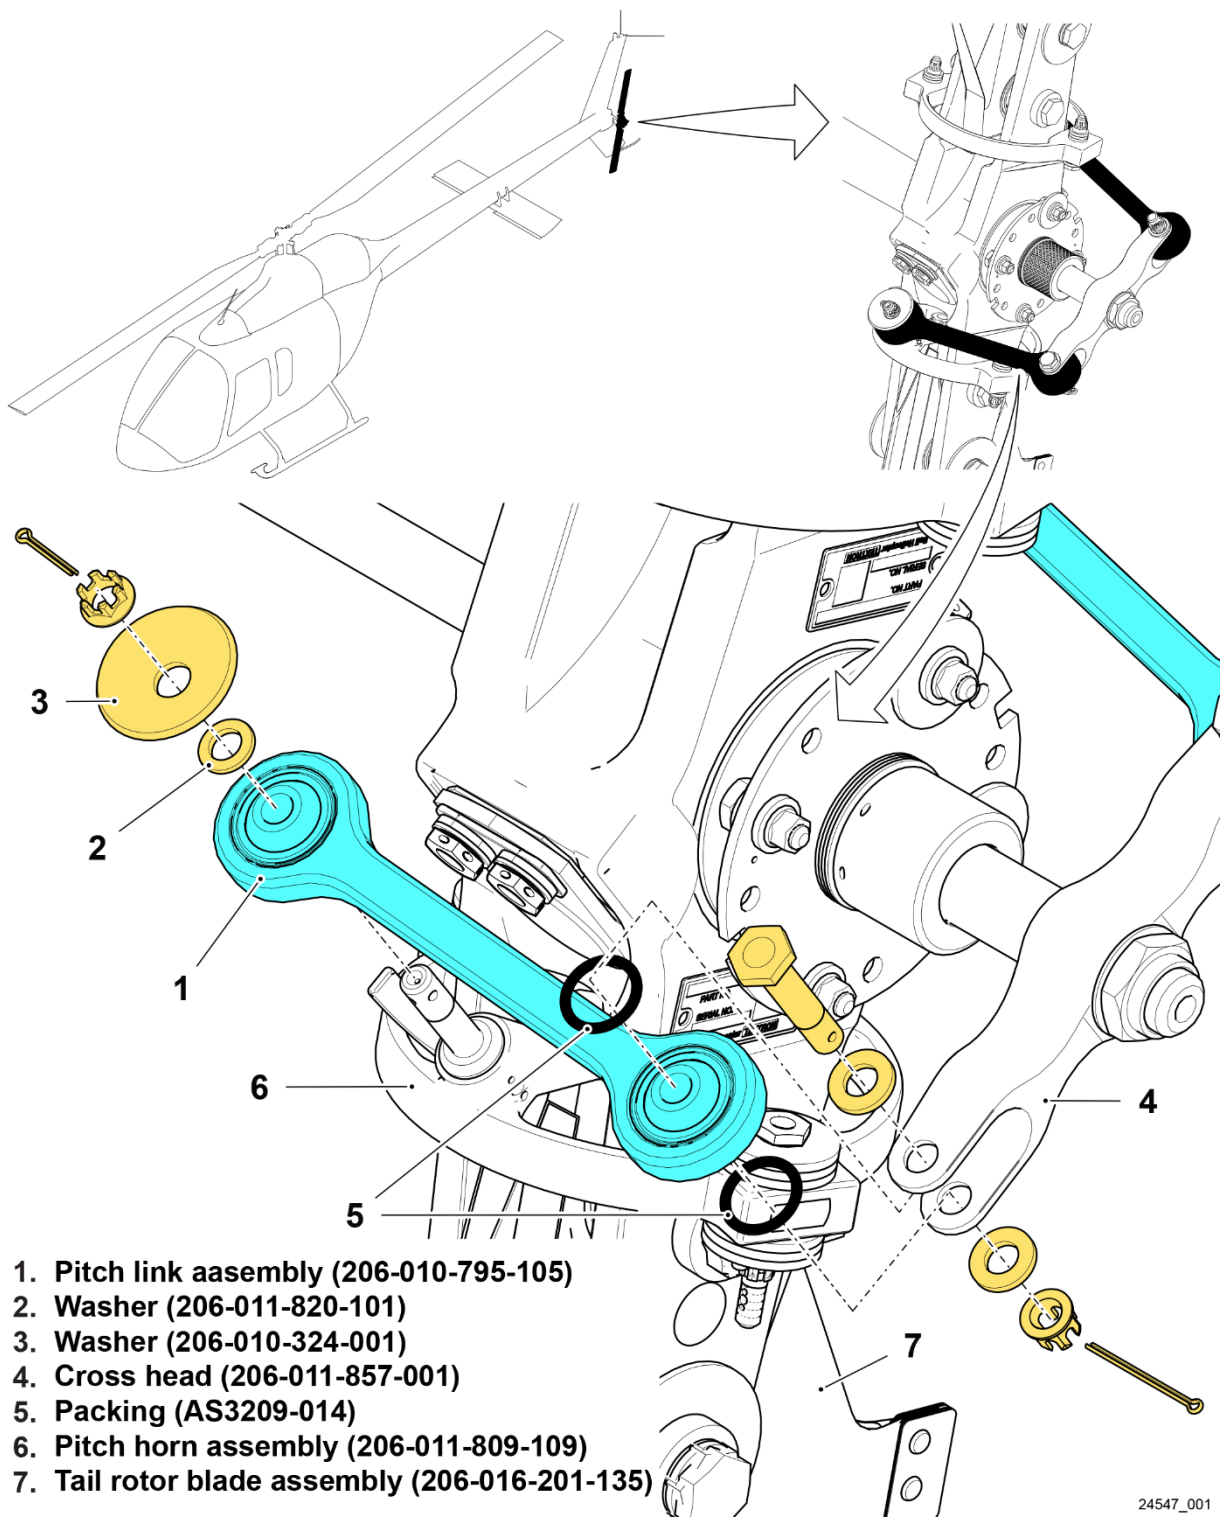
Figure 1 – Tail Rotor Pitch Link Assembly Installation

Bell has been made aware of a quality escape in the production installation of the tail rotor pitch link assemblies. A washer was installed in the wrong location and must be correctly installed if found in that condition. If the condition is not corrected, the tail rotor blade assembly pitch horn stud could fracture during operation and loss of tail rotor control will occur.

2. Inspect the tail rotor pitch link assembly (1) installation for proper installation of washer (2). The washer (2) is to be between the pitch link assembly (1) and the conical washer (3).

3. For tail rotor pitch link assemblies (1) with improperly installed washer (2), visually inspect the affected tail rotor pitch link assembly (1) for **any** signs of contact between the pitch link assembly (1) and conical washer (3) or pitch horn assembly (6).

4. Remove pitch link assembly(s) (1) ([DMC-505-A-64-30-02-00A-520A-A](#)).
5. Install pitch link assembly(s) (1) with the correct location of washer (2) and conical washer (3) (Figure 1 and [DMC-505-A-64-30-02-00A-720A-A](#)).

2. Remove and discard tail rotor pitch link(s) (1, Figure 1) that had signs of contact found in step 3.b. of **PART I**.
3. Remove and discard packings (5).
4. Remove and discard conical washer(s) (3).
5. Remove tail rotor blade assembly(s) (7) of associated pitch link assembly (1) that has been removed in step 2 ([DMC-505-A-64-10-01-00A-520A-A](#)).
6. Remove pitch horn(s) (6) from tail rotor blade assembly(s) (7) and discard ([DMC-505-A-64-10-01-00A-530A-A](#)).
7. Install new or serviceable pitch horn(s) (6) to tail rotor blade assembly(s) (7) ([DMC-505-A-64-10-01-00A-710A-A](#)).
